Subject: City of Haverhill, MA NPDES Permit #MA 0101621
Consent Decree Submittal (Civil Action No. 16-11698-IT)
Compliance Report Number 11 – July 1, 2021 through December 31, 2021

CITY OF HAVERHILL, MASSACHUSETTS

NPDES PERMIT No. MA0101621

COMPLIANCE REPORT No. 11

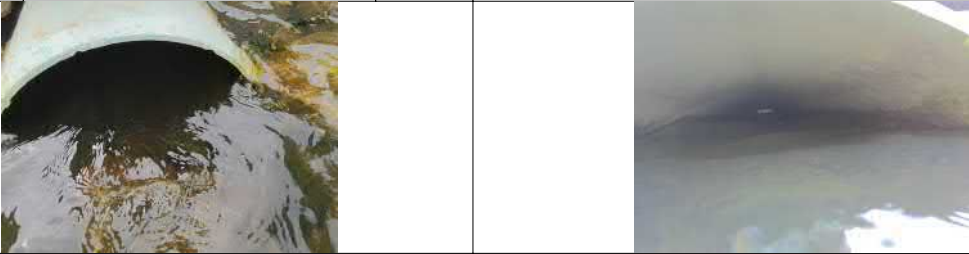
Haverhill IDDE Inspection Form Outfall

SECTION 1: BACKGROUND DATA									
ASSET ID:		KL0769				OUTFALL ID:		KL0769	
Date/Time:		2021-08-09 13:38:00							
Temperature: °F		70				Inspector(s):		Andrew Salois	
Street Name/Structure Location:		Cross Country							
Previous Precipitation Date/End Time:		2021-08-05 14:20:00				Amount (inches):		0.8	
Pictures

SECTION 2: OUTFALL PIPE ASSET DESCRIPTION									
Location	Upstream Asset ID	Material		Shape	Diameter/Dimension (in.)	Submerged			
Outfall Pipe		Poly Vinyl Chloride		Circle	24	In Water:		Partially	
						With Sediment:		No	
SECTION 3: OUTFALL PIPE PHYSICAL INDICATORS									
Indicator		Indicator Present?		Indicator Description					
Asset Damage		None							
Deposits/Stains		None							
Pool Quality		None							
Pipe Algae/Growth		None							
*Do physical indicators suggest an illicit discharge is present (Y/N):									
Is Inlet Pipe No.1 Flowing?								Estimated GPM:	
Comments :
