# Haverhill

April 29, 2015

Subject: City of Haverhill NPDES Permit # MA0101621  
Infiltration Inflow Report 2014

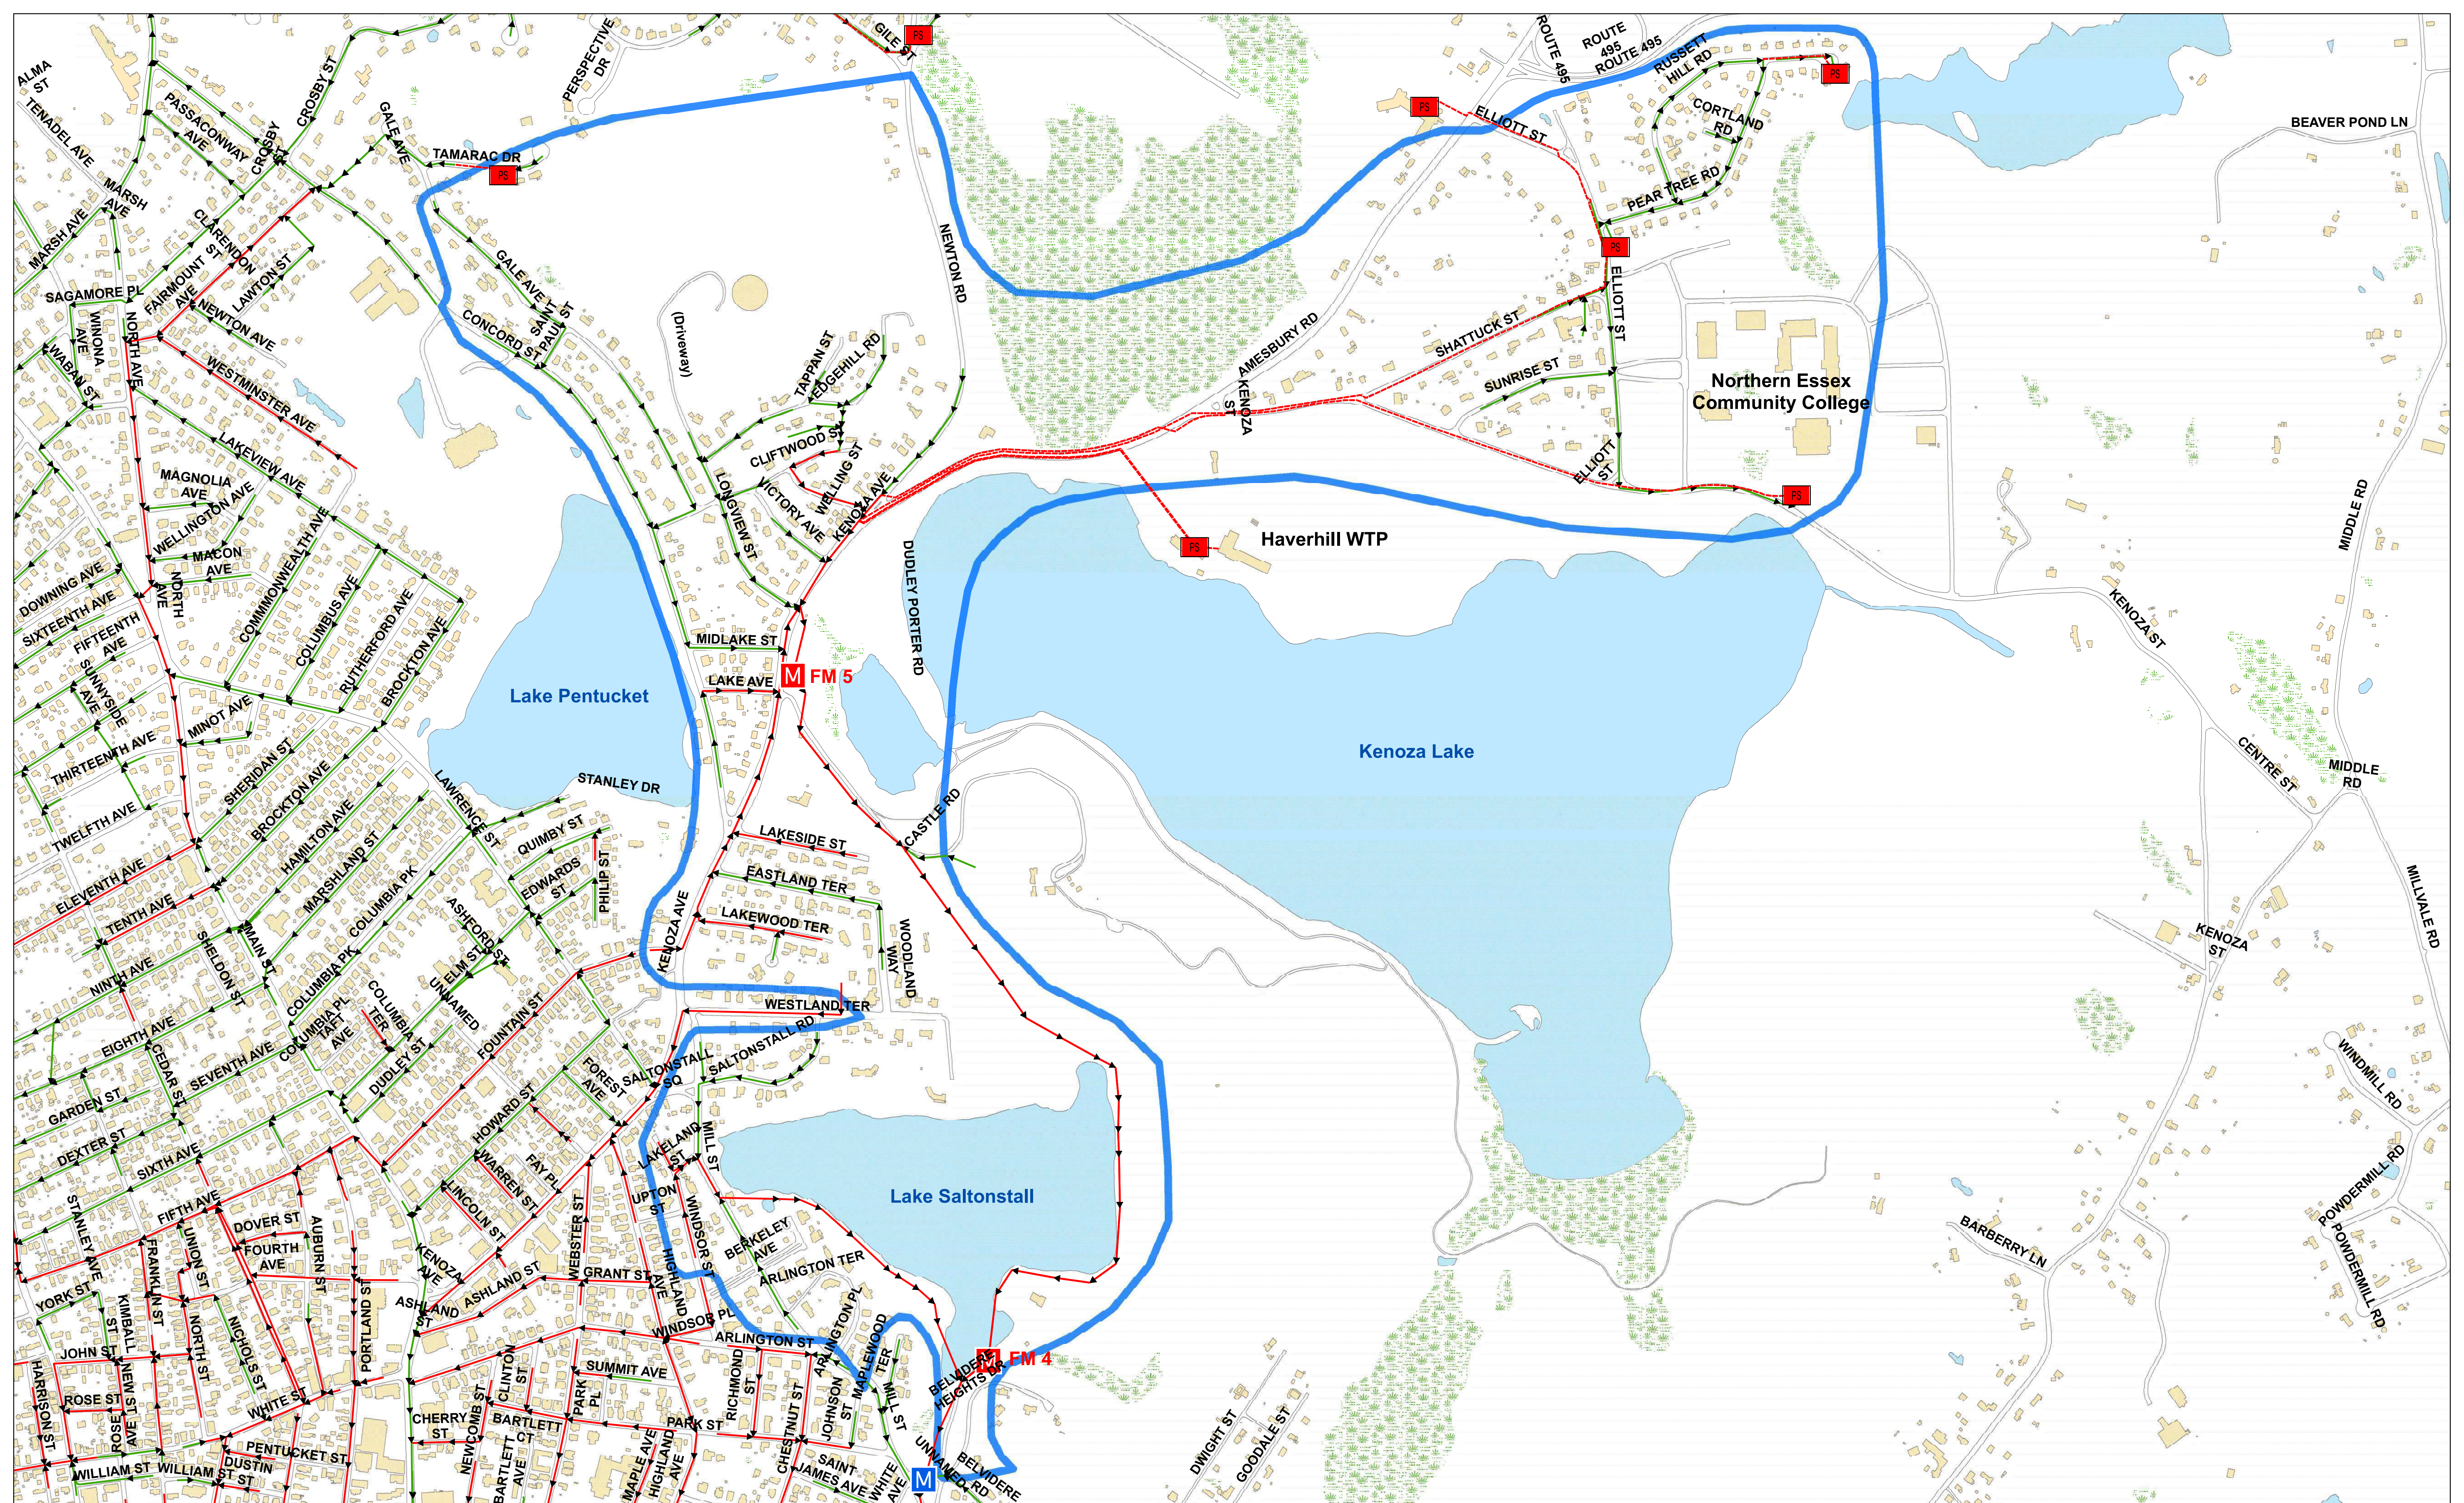
City of Haverhill, Massachusetts  
CSO LTCP Phase IIA - Infiltration/Inflow Study  
Figure 1 - Area 14 Temporary Flow Meter Locations  
January 2015

The city investigated infiltration and inflow in Sewer area 14 (Figure 1) and 23 (Figure 2) which were identified as having high extraneous flows. The 2010 Phase II LTCP flow metering program which showed that these areas had higher flows during high groundwater periods, but didn't necessarily exceed state standards for excessive flows per inch-dia-mile. Sewer Areas 14 and 23 comprise approximately 39,270 linear feet and 54,000 linear feet of pipe, respectively. The investigation of each sewer area included temporary flow monitoring, spot gauging and

Sewer Area 14 and 23 – The field investigations and flow data collected in these two sewer areas will be used to evaluate the areas to develop recommendations and costs for sewer system improvements.
