Subject: City of Haverhill, MA NPDES Permit #MA 0101621
Consent Decree Submittal (Civil Action No. 16-11698-IT)
Compliance Report Number 6 – January 1, 2019 through June 30, 2019

CITY OF HAVERHILL, MASSACHUSETTS

COMPLIANCE REPORT No. 6

JANUARY THROUGH JUNE 2019

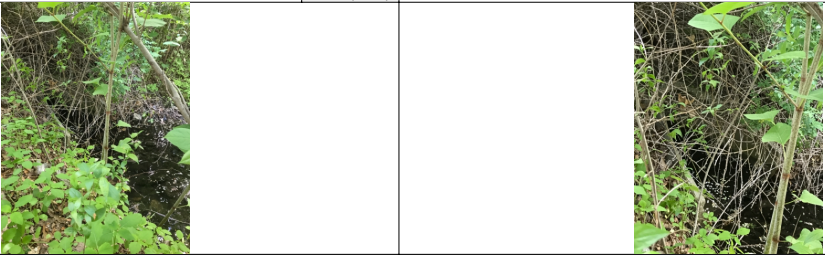
SECTION 1: BACKGROUND DATA									
ASSET ID: JC1028					OUTFALL ID: JC1028				
Date/Time: 2019-05-23 7:32:00									
Temperature: °F 54					Inspector(s): Carrie Prescott Brett Baron Erin McGuire				
Street Name/Structure Location: Cross Country									
Previous Precipitation Date/End Time: 2019-05-20 4:00:00					Amount (inches): 0.06				
Pictures

SECTION 2: OUTFALL PIPE ASSET DESCRIPTION									
Location	Upstream Asset ID	Material		Shape	Diameter/Dimension (in.)	Submerged			
Outfall Pipe	DMH-8058	Reinforced Concrete		Circle	18	In Water:		No	
						With Sediment:		No	
SECTION 3: OUTFALL PIPE PHYSICAL INDICATORS									
Indicator		Indicator Present?		Indicator Description					
Asset Damage		None							
Deposits/Stains		Flow Line							
Pool Quality		None							
Pipe Algae/Growth		None							
*Do physical indicators suggest an illicit discharge is present (Y/N):		No							
Is Inlet Pipe No.1 Flowing?		Yes		Moderate		Estimated GPM:		5

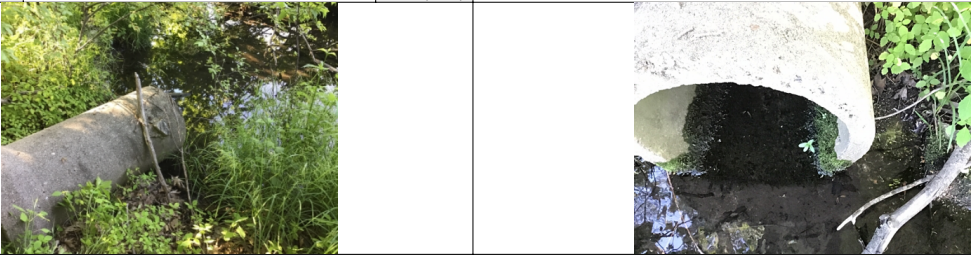
SECTION 1: BACKGROUND DATA									
ASSET ID:		BZB0847			OUTFALL ID:		BZB0847		
Date/Time:		2019-06-10 7:25:00							
Temperature: °F		62			Inspector(s):		Andres Hurtado Erin McGuire		
Street Name/Structure Location:		Cross Country							
Previous Precipitation Date/End Time:		2019-06-06 7:15:00			Amount (inches):		0.85		
Pictures

SECTION 2: OUTFALL PIPE ASSET DESCRIPTION									
Location	Upstream Asset ID	Material		Shape	Diameter/Dimension (in.)	Submerged			
Outfall Pipe	DMH-546	Reinforced Concrete		Circle	18	In Water:		No	
						With Sediment:		No	
SECTION 3: OUTFALL PIPE PHYSICAL INDICATORS									
Indicator		Indicator Present?		Indicator Description					
Asset Damage		None							
Deposits/Stains		Other		Moss/vegetation					
Pool Quality		None							
Pipe Algae/Growth		None							
*Do physical indicators suggest an illicit discharge is present (Y/N):		No							
Is Inlet Pipe No.1 Flowing?		Yes		Moderate		Estimated GPM:		10

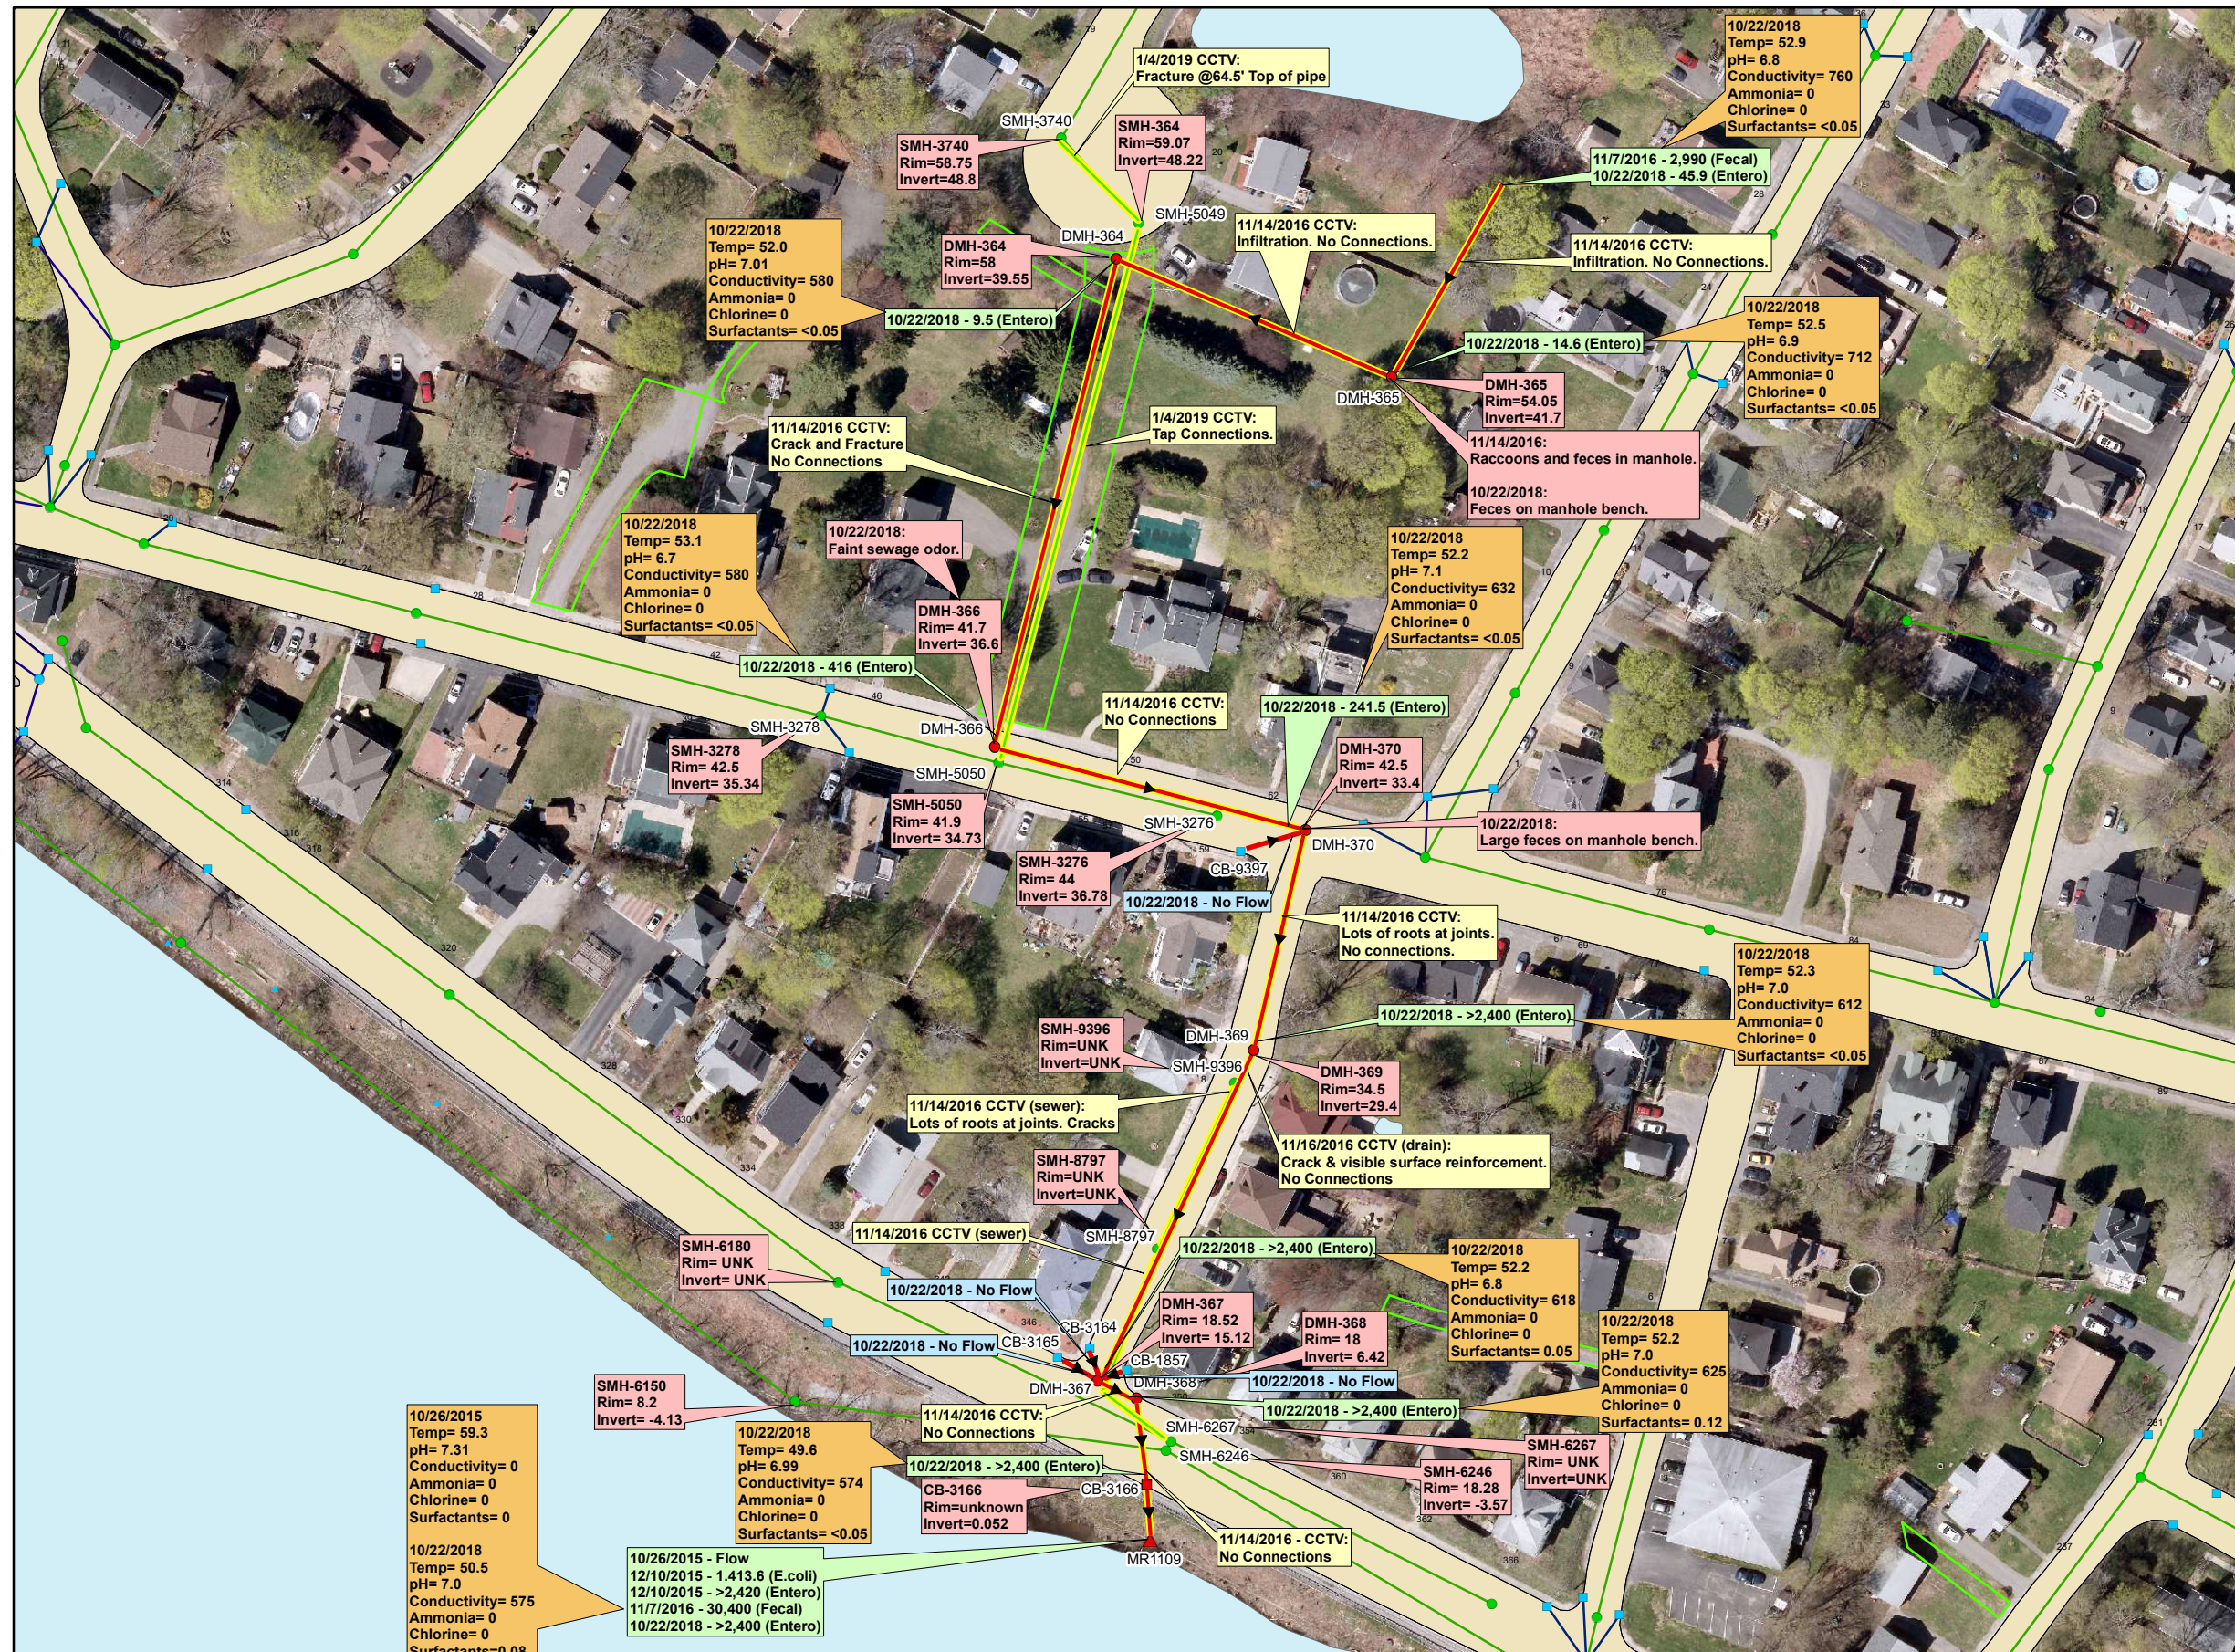
Outfall MR1109

- Outfall MR1109: The City conducted IDDE investigations on 10/22/2018. High enterococci results start in segment DMH-366:DMH-364. Raccoons and animal feces have been observed in pipes upstream of this segment. Sewer main adjacent to DMH-366:DMH-364 was CCTV'd on 1/4/2019 and has no signs of infiltration crack, or fractures. The City will seek assistance from a consultant regarding next steps. See map of progress in Appendix C.

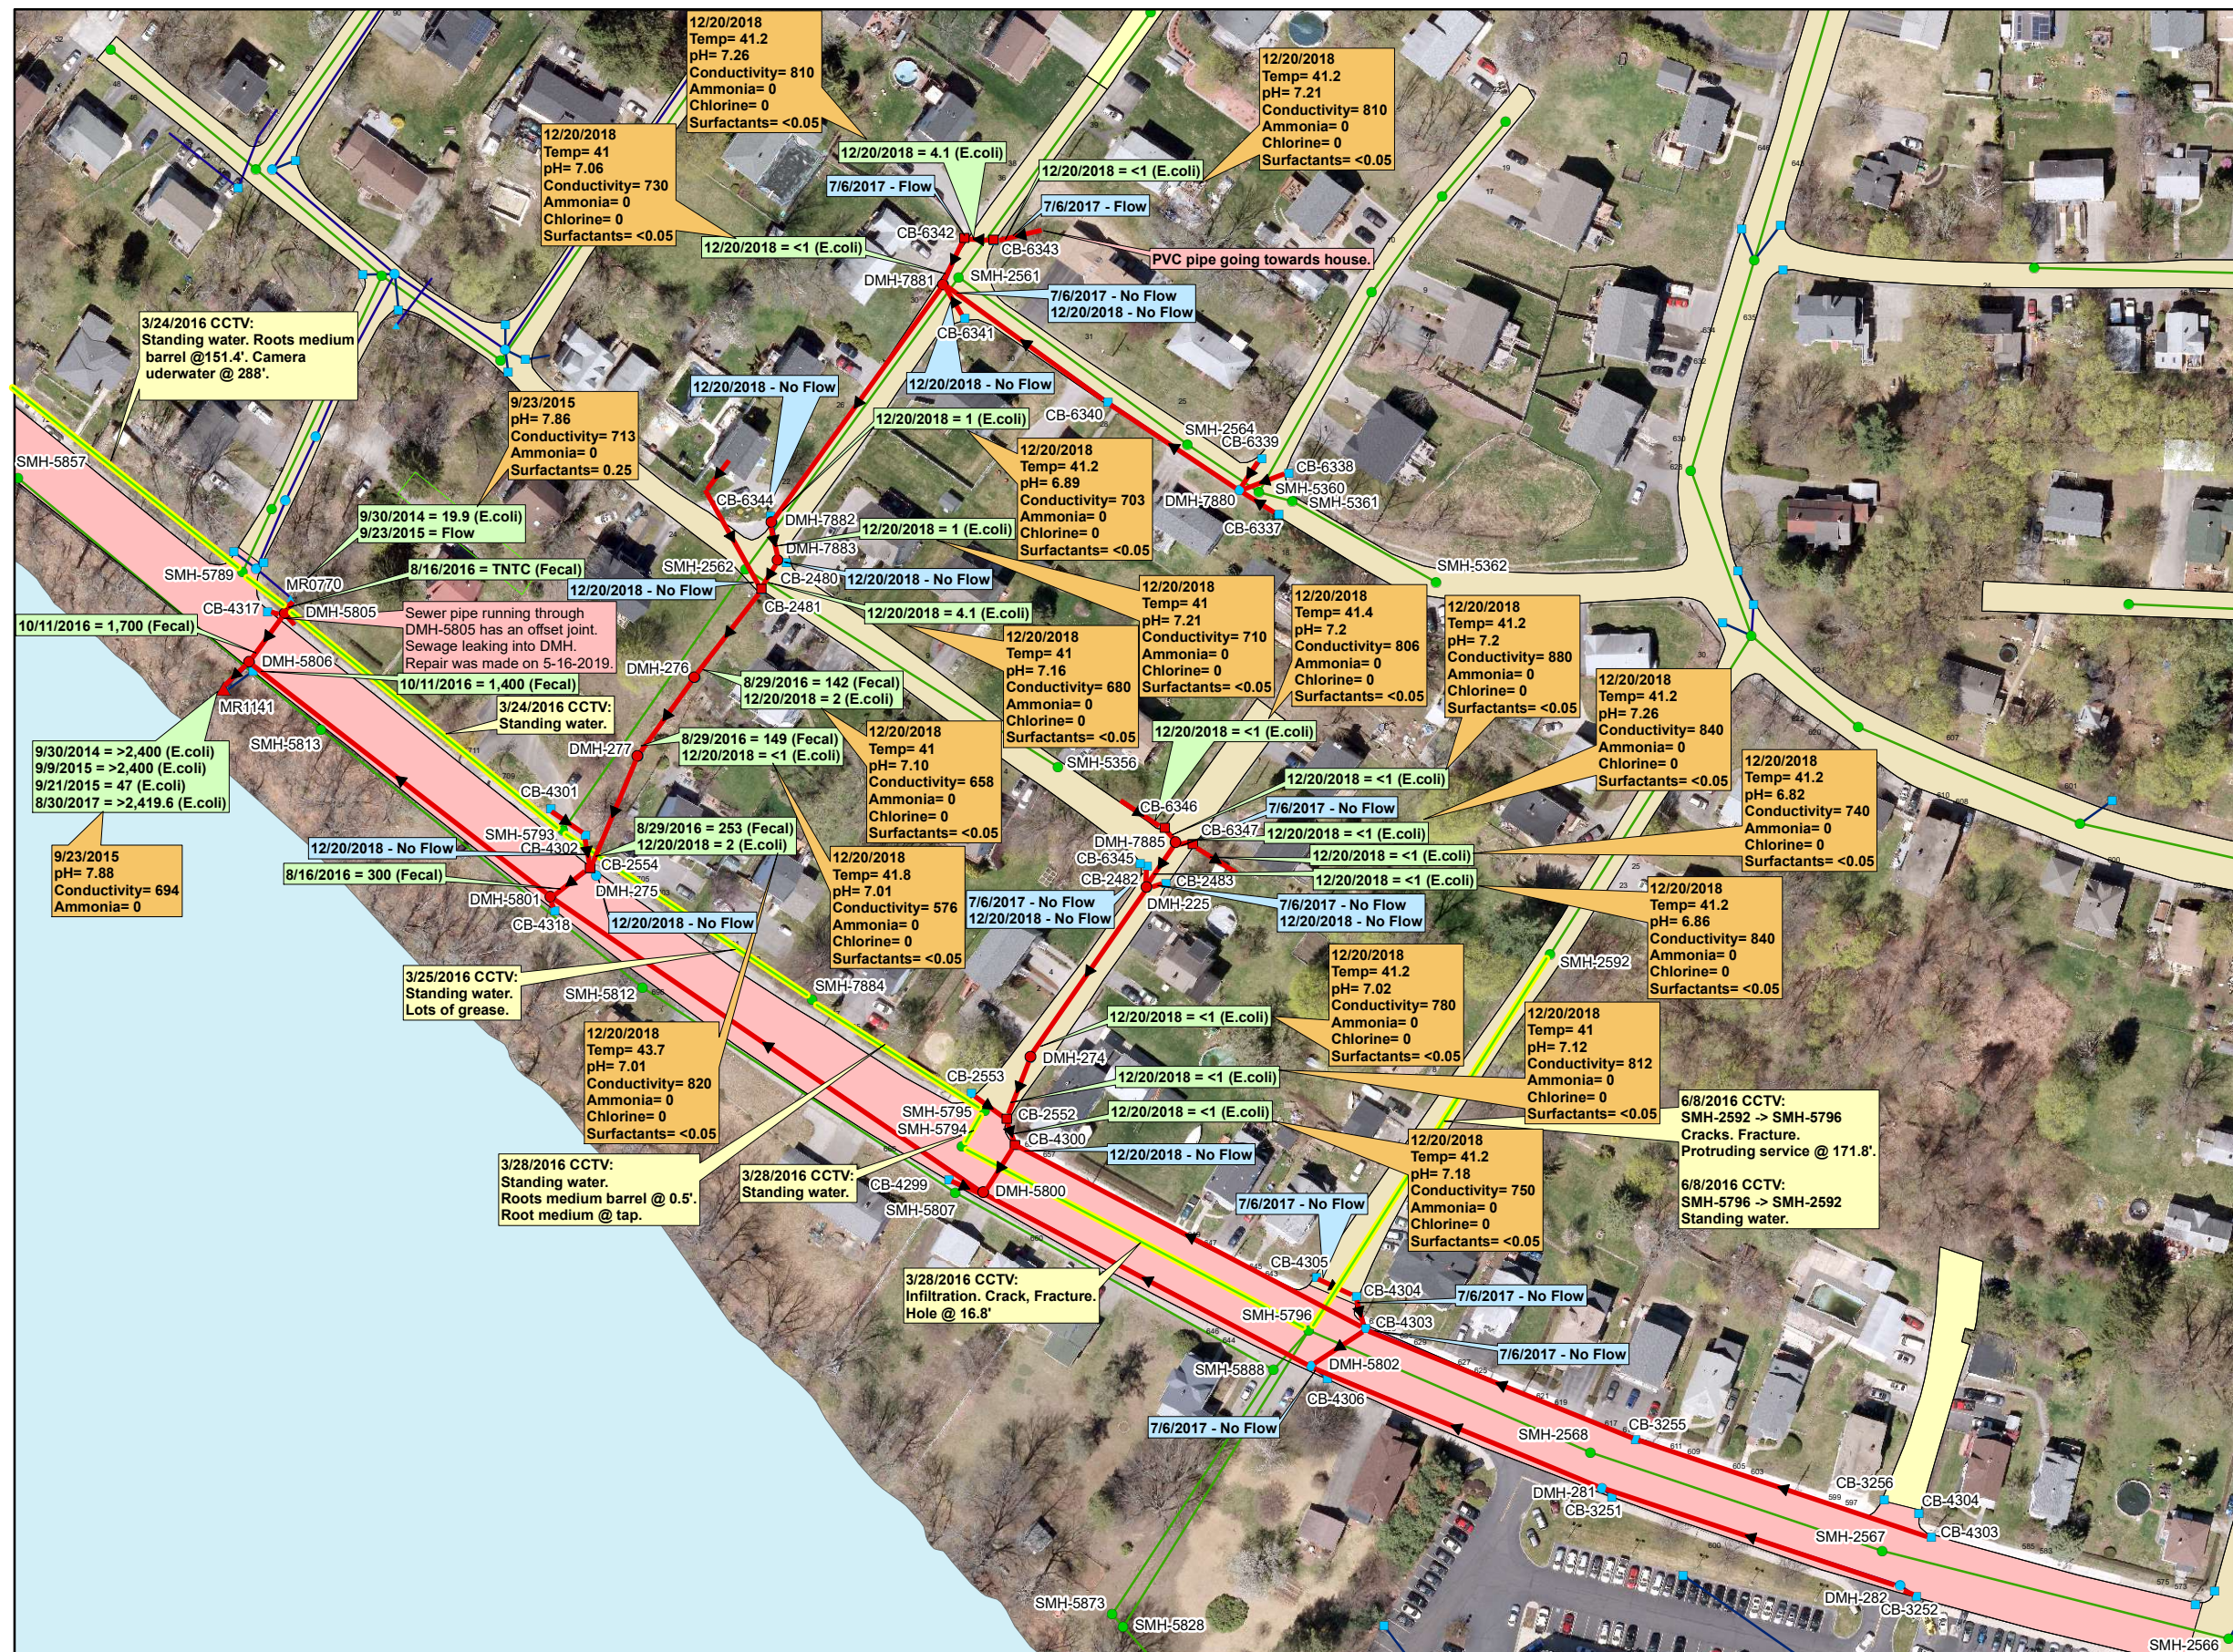
Outfall MR1141

- Merrimack River Basin
 - Outfall MR1141: The City conducted IDDE investigations on 12/20/2018. This outfall is believed to be owned by the State. The City conducted IDDE investigations on all the City owned drains that discharge to this outfall. During further investigation in DMH-5805, an offset sewer joint was found to be leaking into DMH-5805. DMH-5805 was sealed on 5/16/2019. See work order in Appendix B and map of progress in Appendix C.

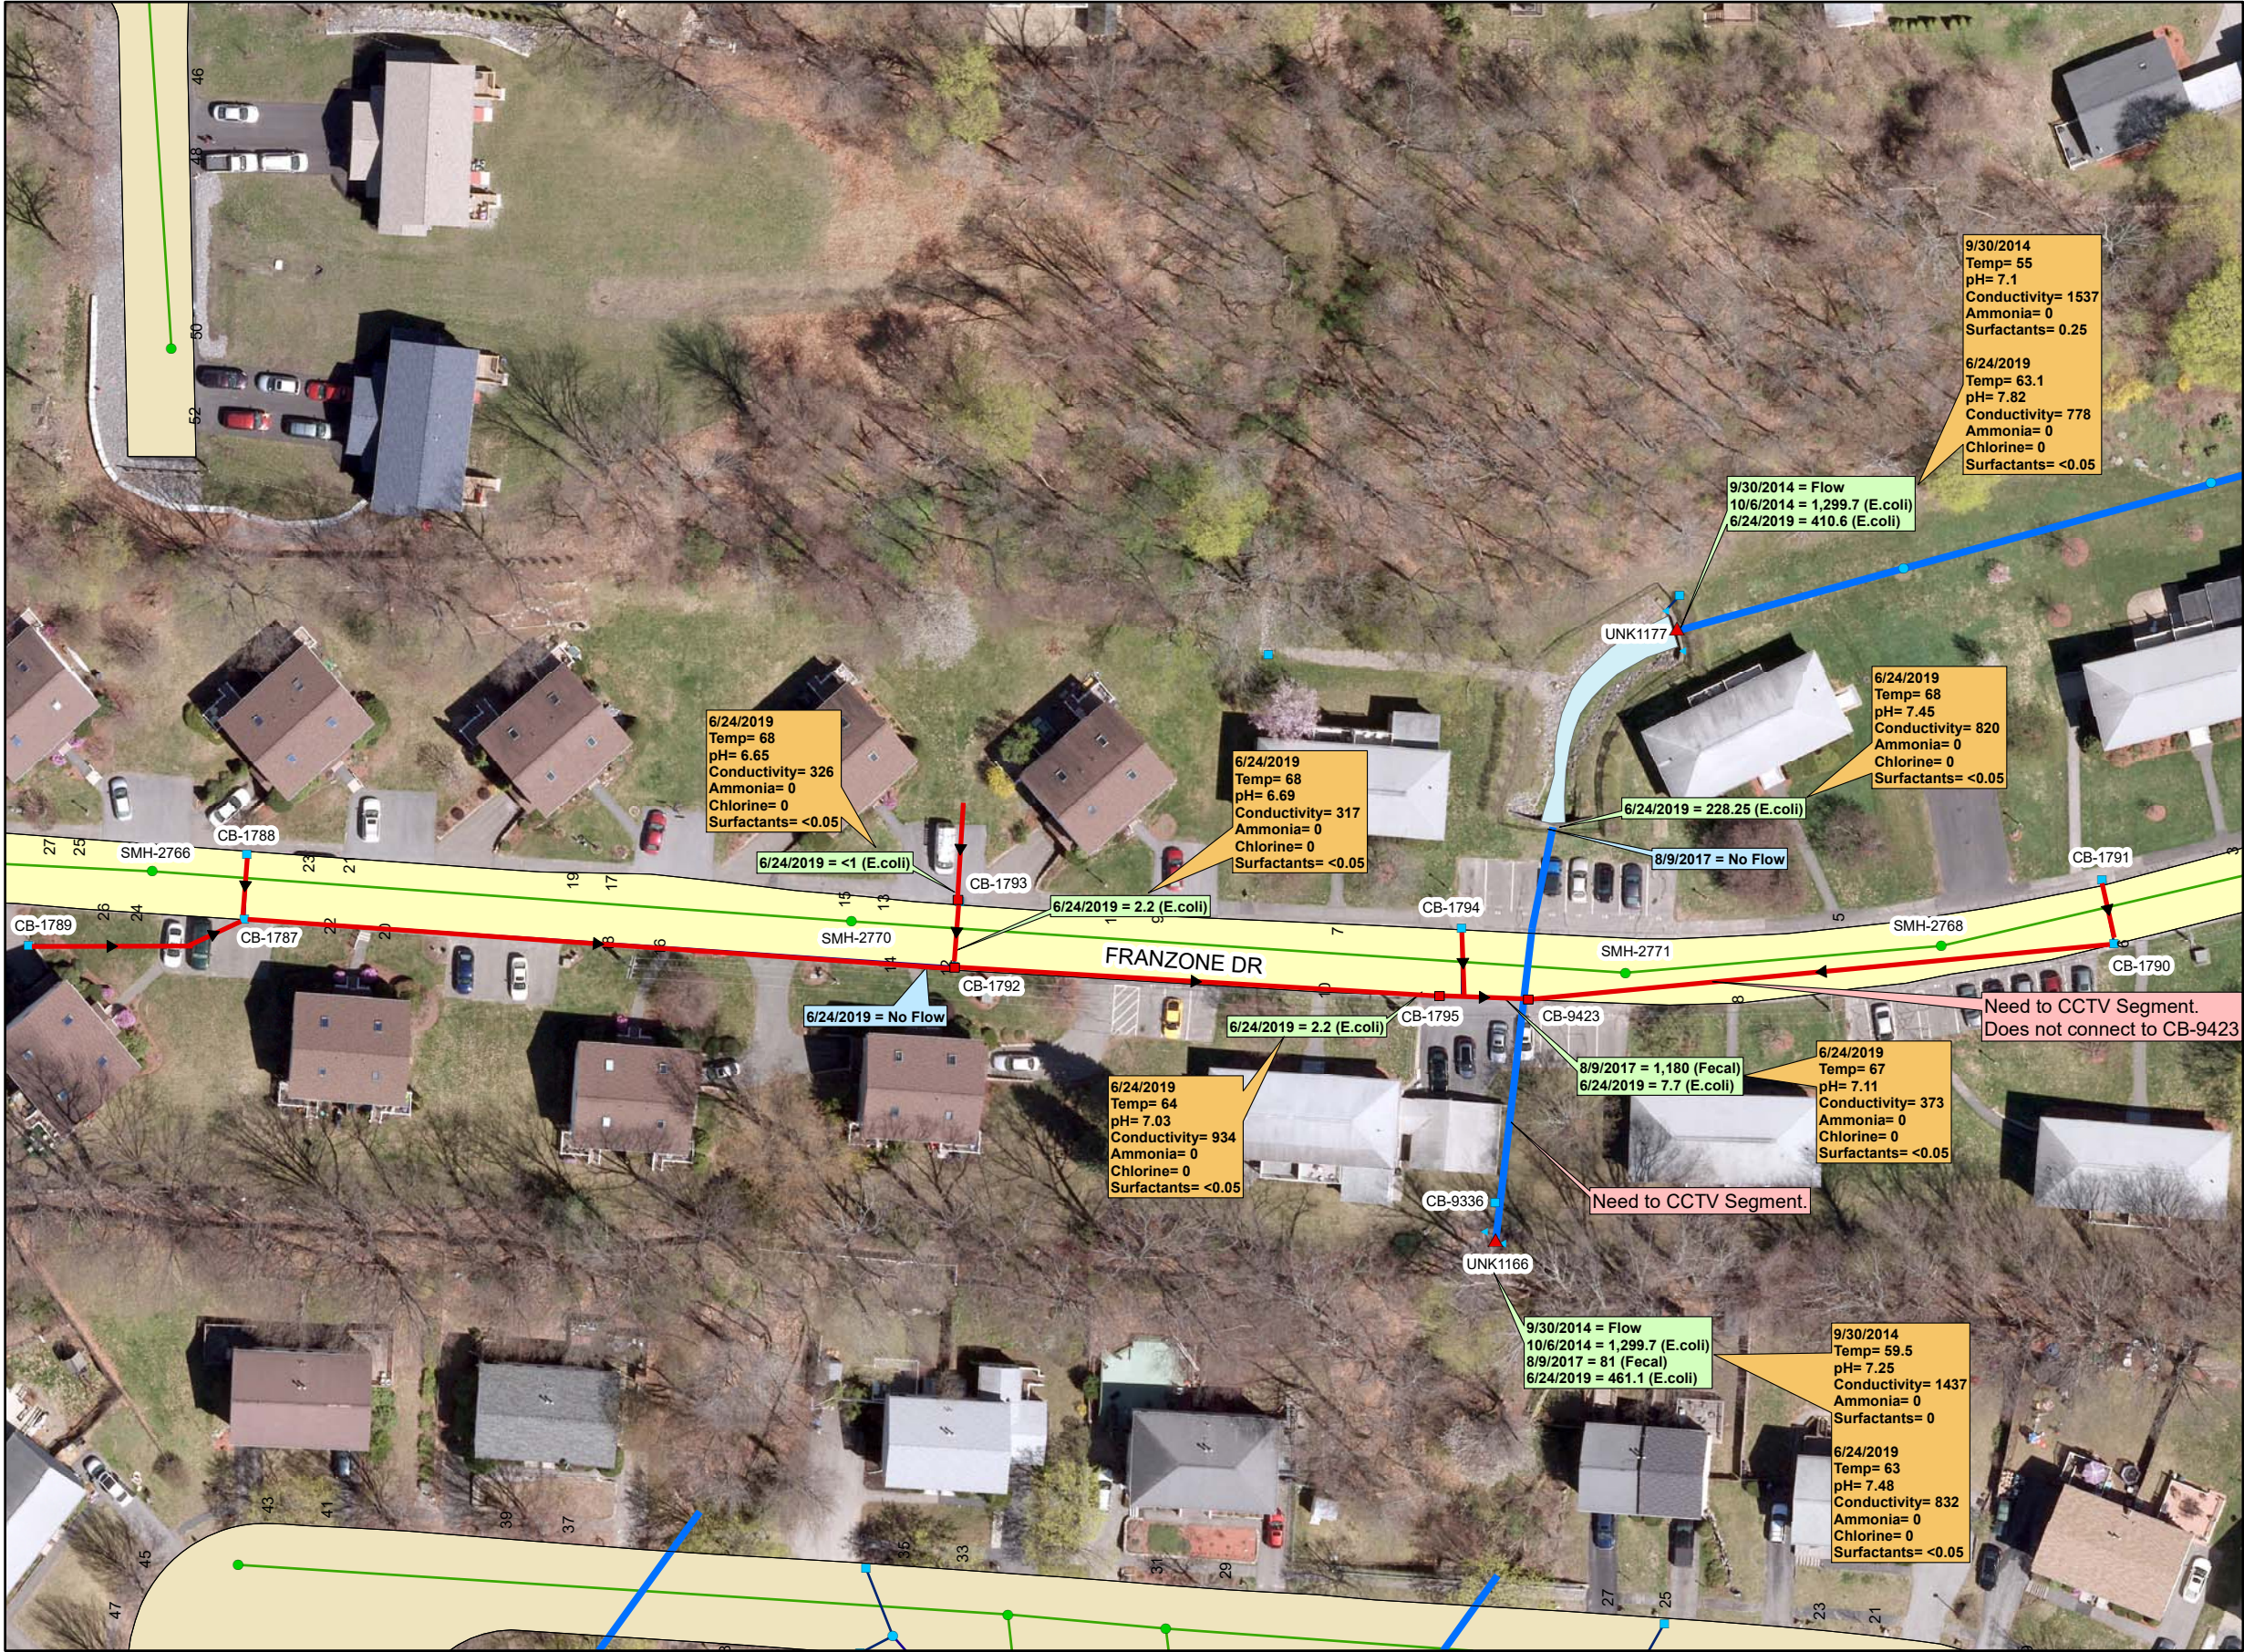
Outfall UNK1166

- Unknown or Unnamed Basins
 - Outfall UNK 1166: The City conducted IDDE investigations on 6/24/2019. High E.coli sample results occurred at UNK1166. Also on 6/24/2019, the outfall UNK1177, located just upstream of UNK1166, was sampled and high E.coli sample results were observed. It is suspected that contamination at UNK1166 is caused by UNK1177. More CCTV needs to be conducted to confirm. See inspection reports in Appendix B and map of progress in Appendix C.

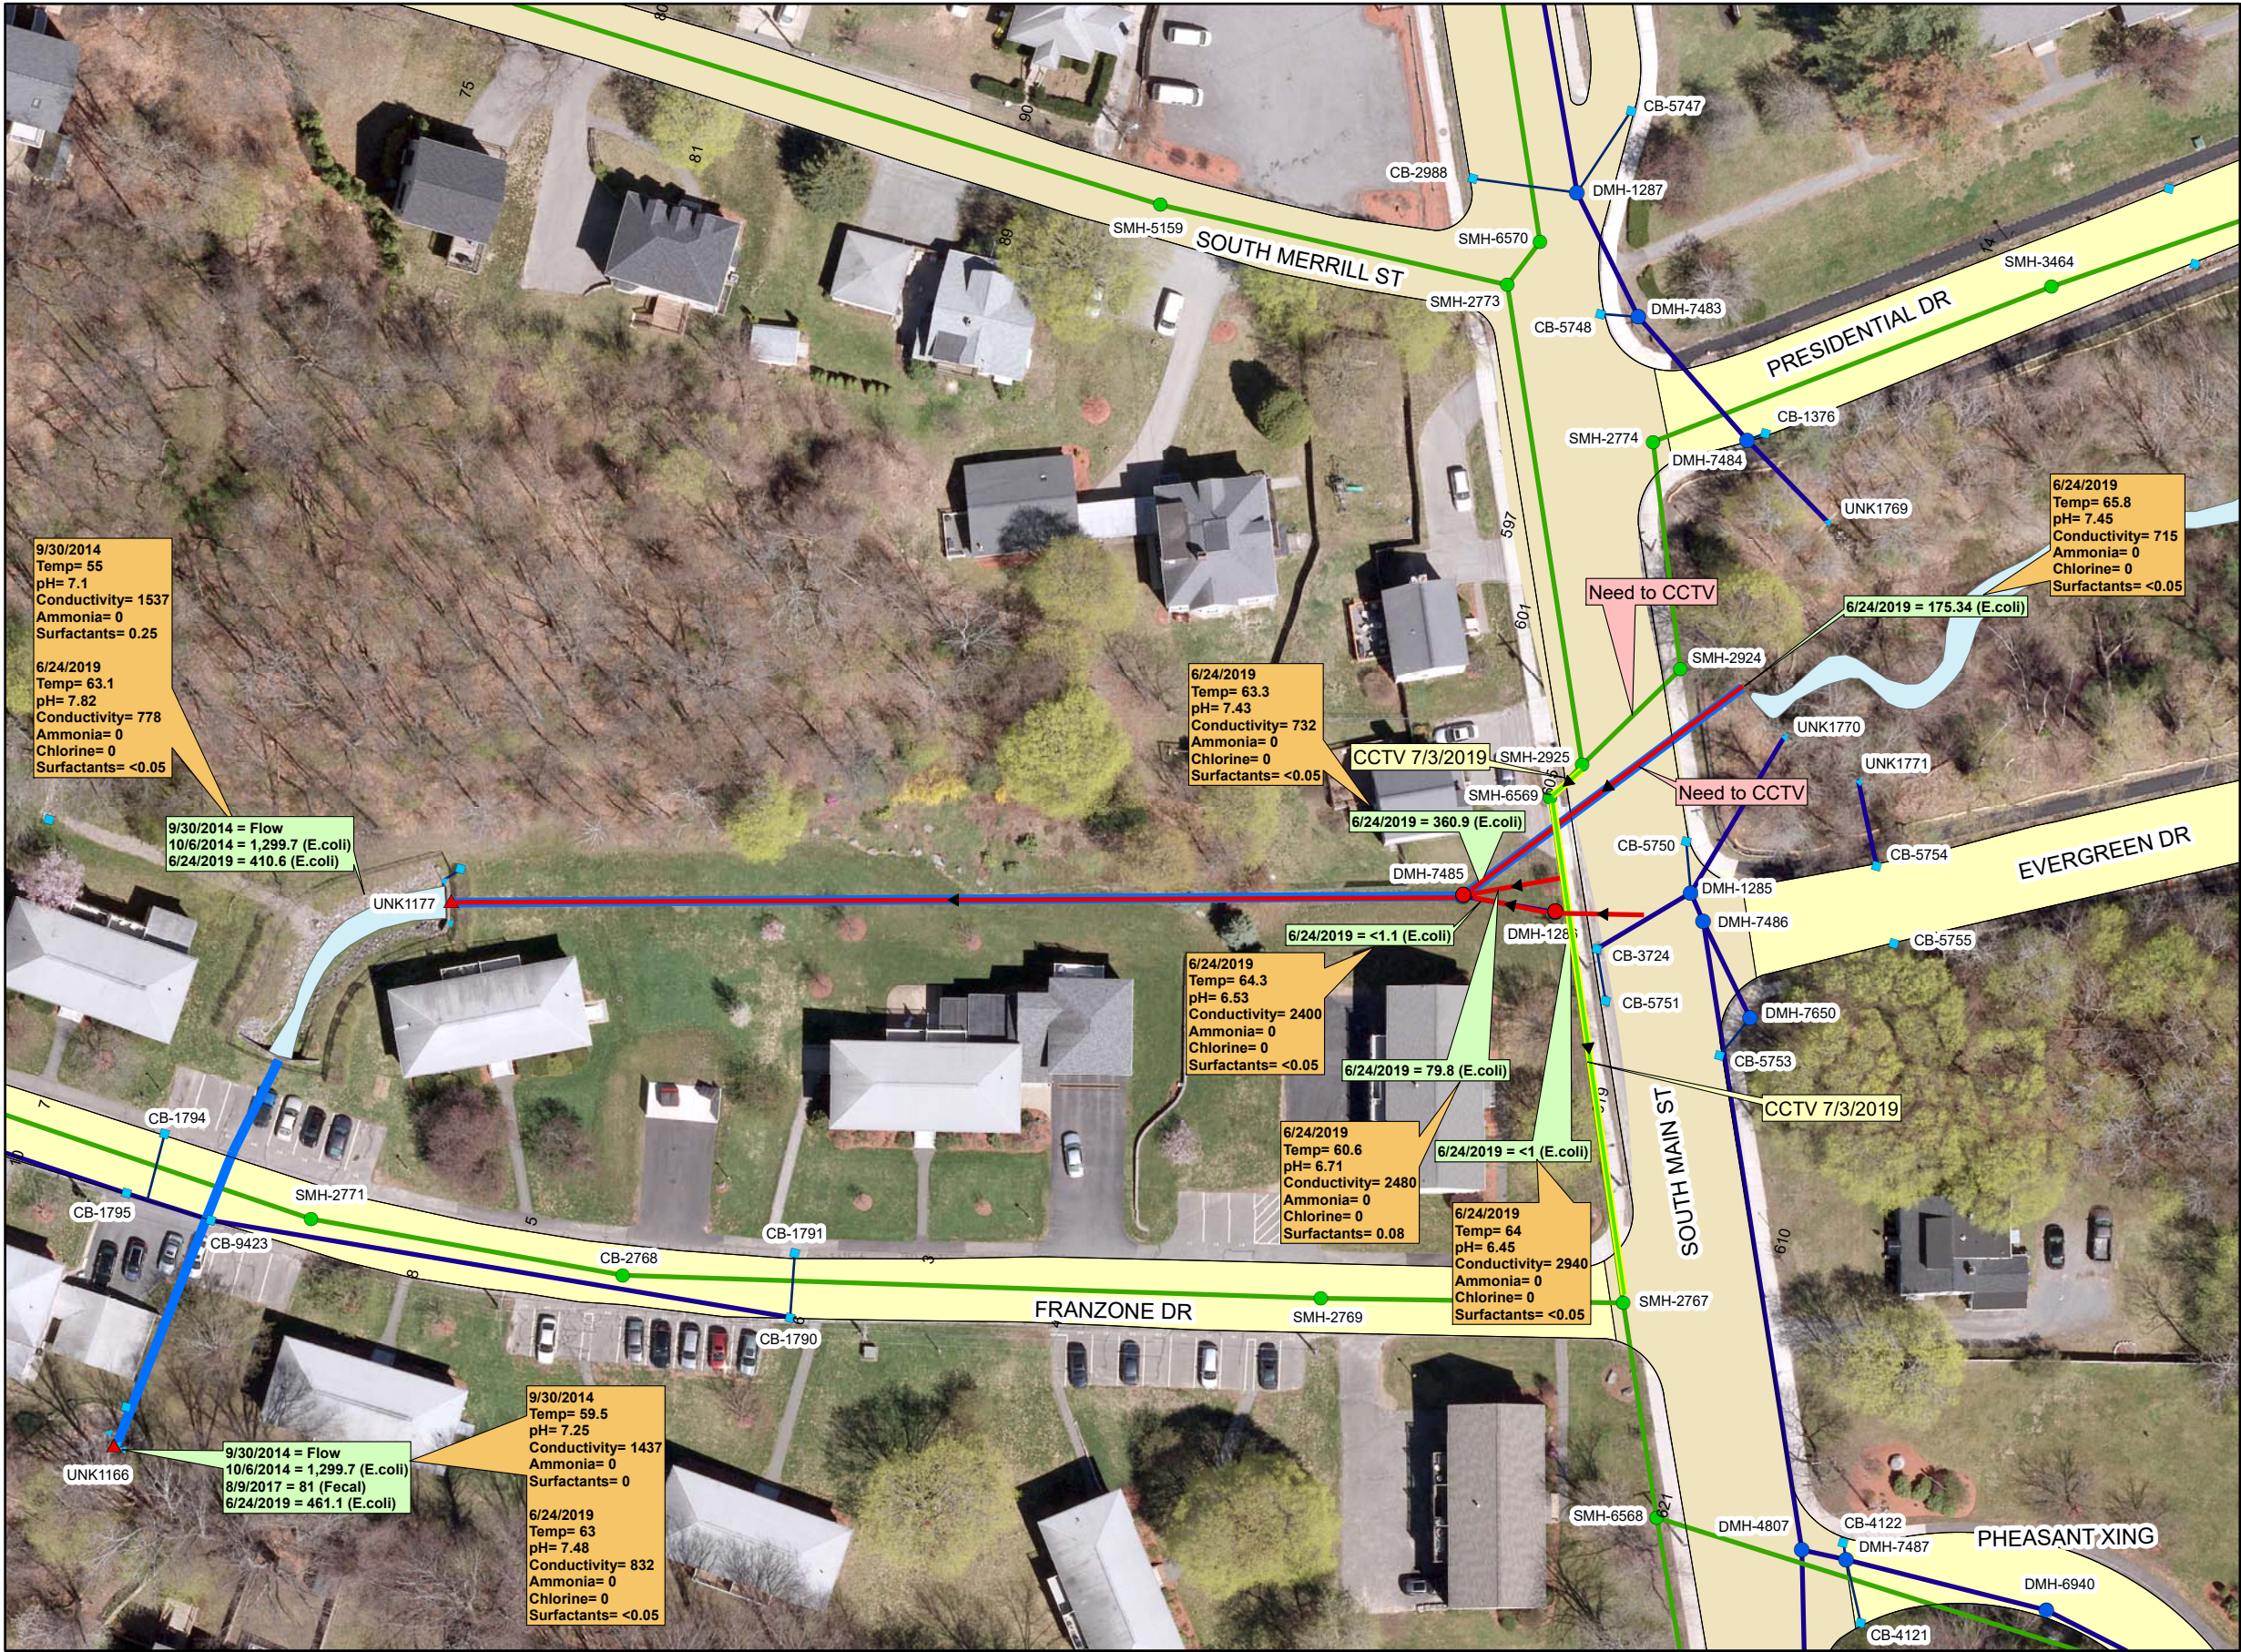
Outfall UNK1177

- Outfall UNK1177: The City conducted IDDE investigations on 6/24/2019. High E.coli sample results occurred at UNK1177 and from segment DMH-7485:Culvert Inlet. More CCTV needs to be conducted to help determine cause of contamination. See inspection reports in Appendix B and map of progress in Appendix C.

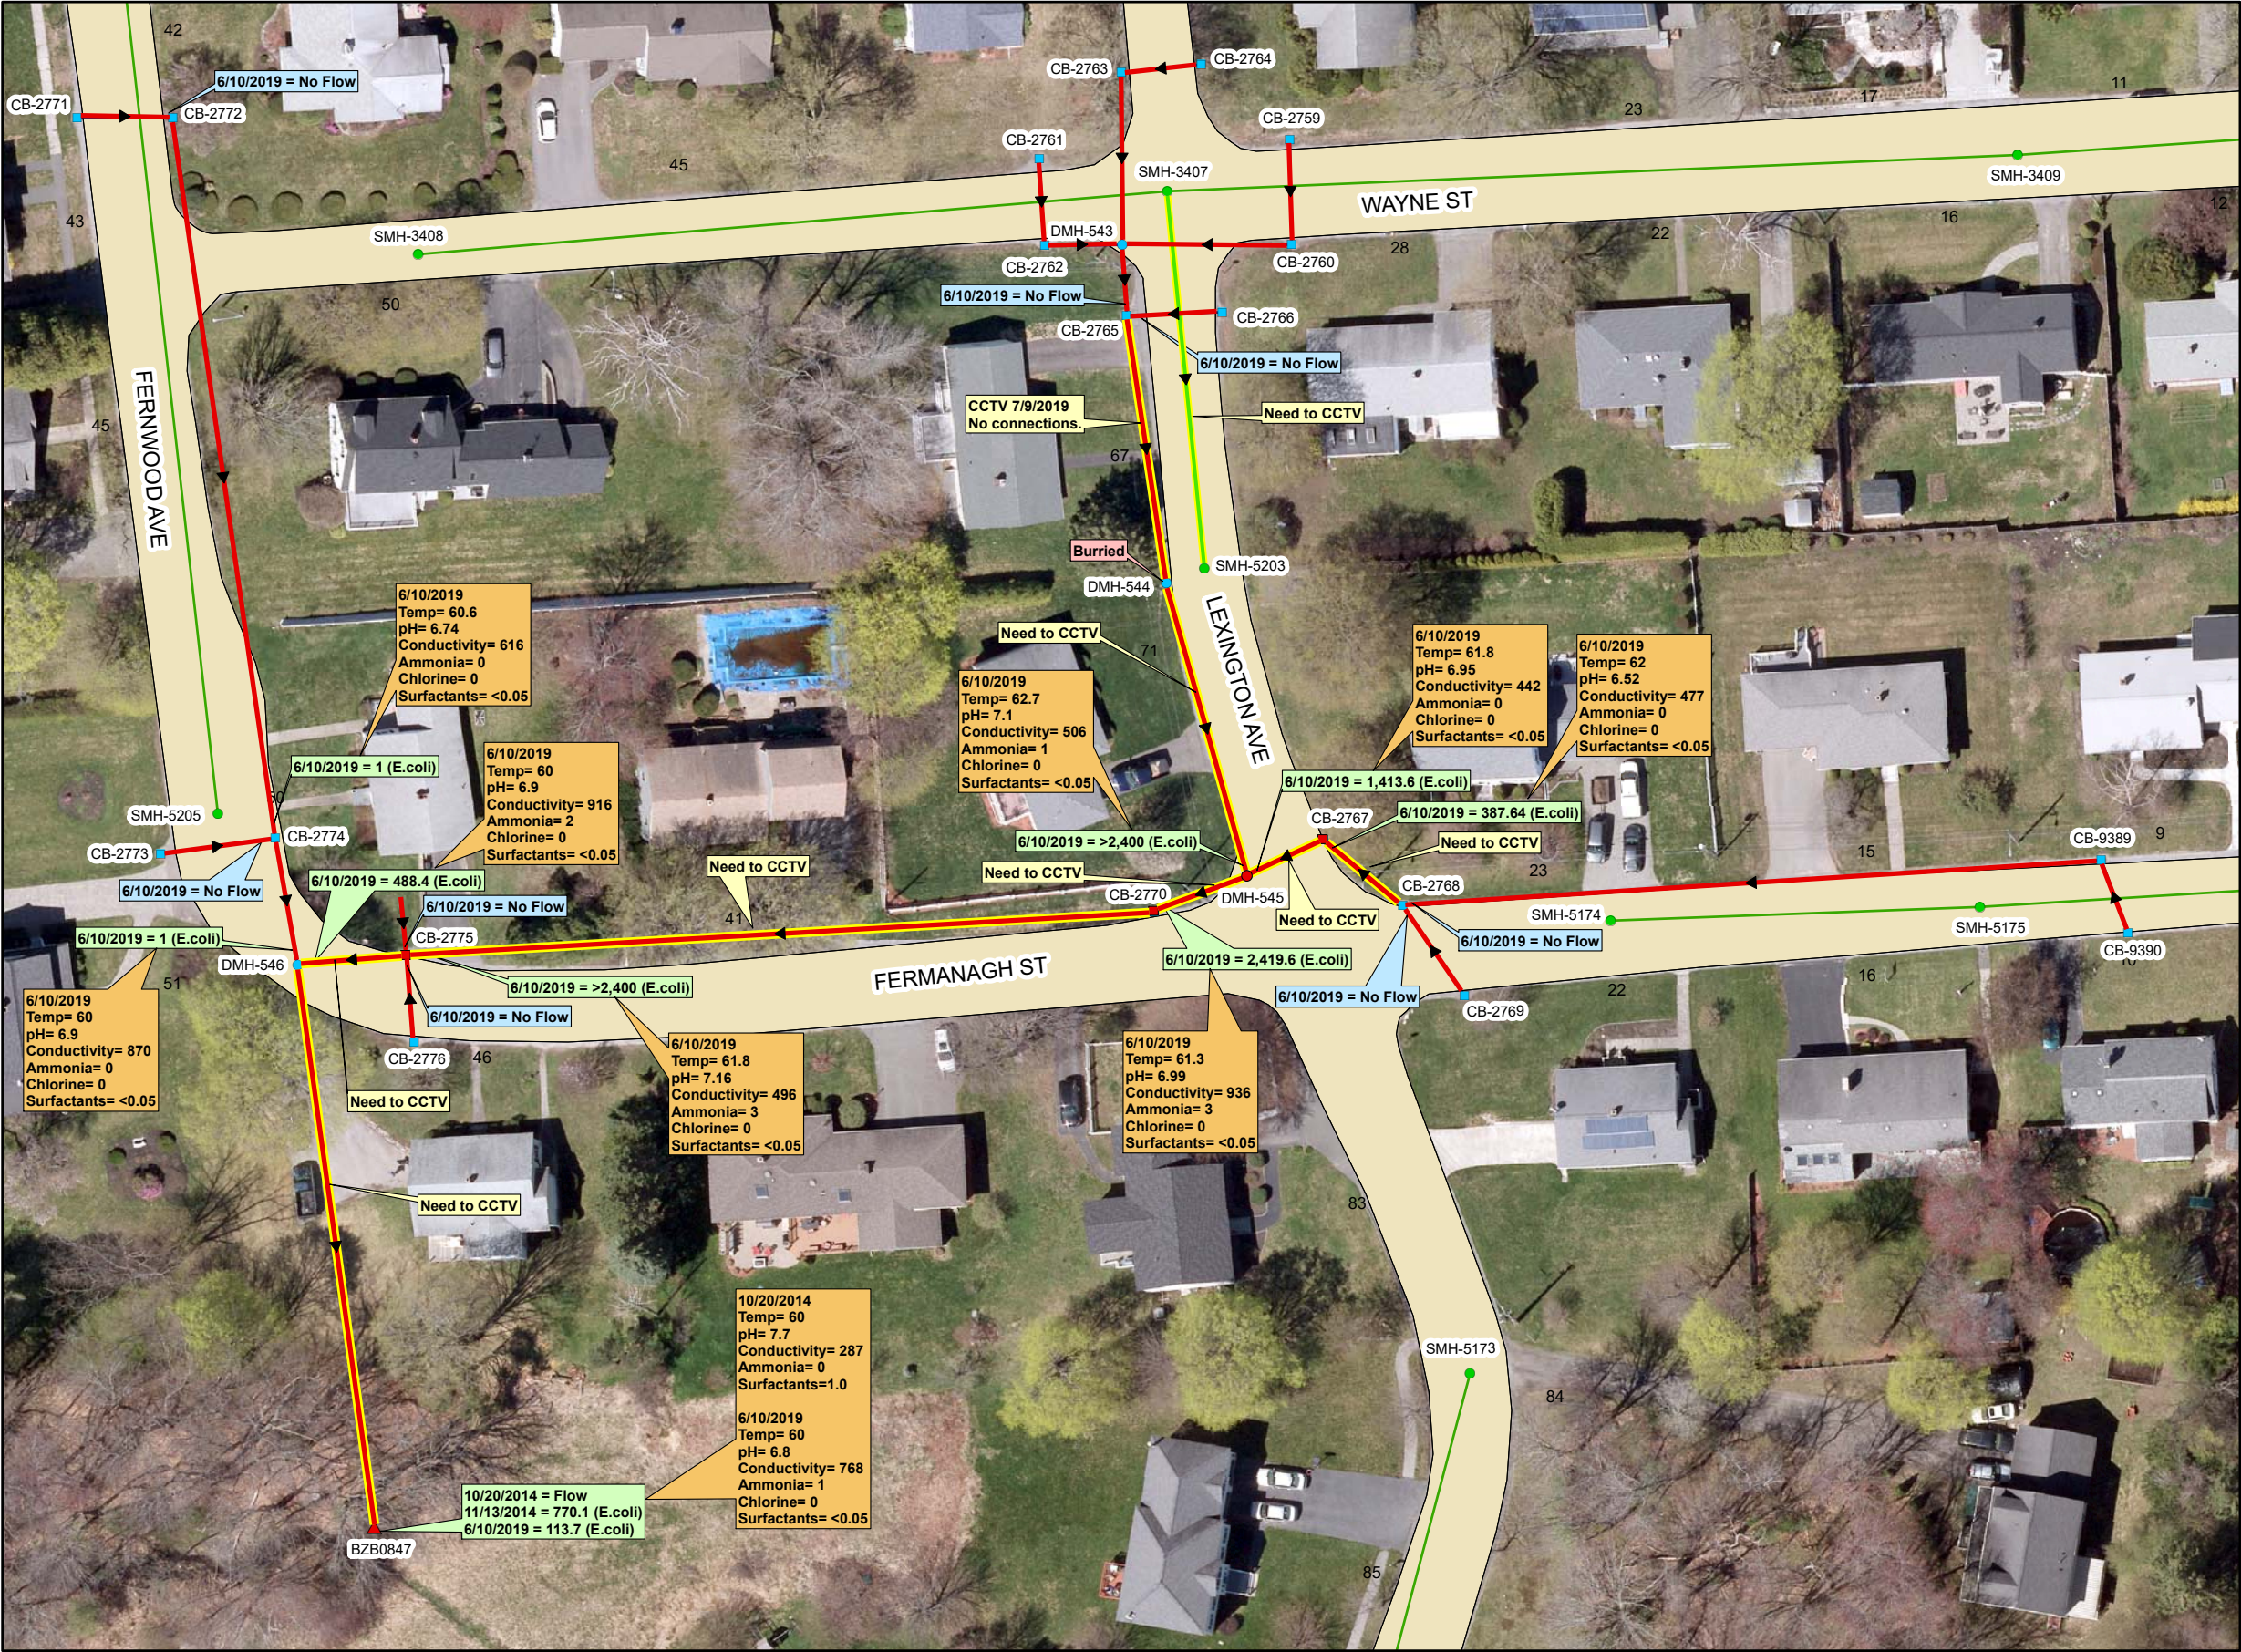
Outfall BZB0847

- Buswell Brook Basin
 - Outfall BZB0847: The City conducted IDDE investigations on 6/10/2019. High E.coli sample results occurred at segments DMH-546:CB-2775, CB-2775:CB-2770, CB-2770:DMH-545, DMH-545:CB-2767, CB-2767:CB-2768, and DMH-545:CB-2765. High ammonia sample results occurred at segments BZB0847:DMH-546, DMH-546:CB-2775, CB-2775:CB-2770, CB-2770:DMH-545, and DMH-545:CB-2765. More CCTV needs to be conducted to help determine cause of contamination. See inspection reports in Appendix B and map of progress in Appendix C.
