Haverhill

Subject: City of Haverhill, MA NPDES Permit #MA 0101621
Consent Decree Submittal (Civil Action No. 16-11698-IT)
Compliance Report Number 8 – January 1, 2020 through June 30, 2020

CITY OF HAVERHILL, MASSACHUSETTS

COMPLIANCE REPORT No. 8

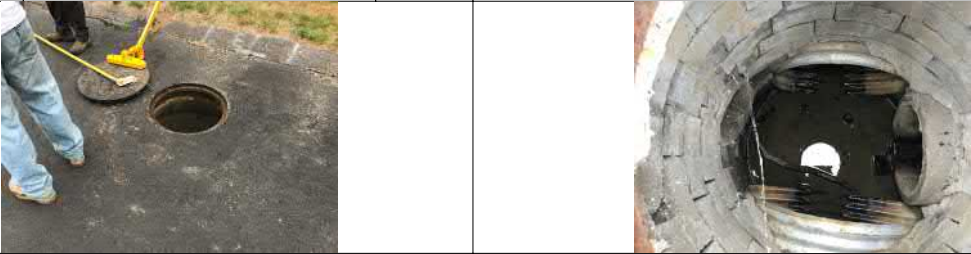
Drain Manhole

SECTION 1: BACKGROUND DATA									
ASSET ID: DMH-784					OUTFALL ID: UNK1767				
Date/Time: 2020-06-23 8:03:00									
Temperature: °F 65					Inspector(s): James Conte Jesse Middleton Samuel Martinez Zebulan Day Justin Mazzotta				
Street Name/Structure Location: TUDOR CT									
Previous Precipitation Date/End Time: 2020-06-23 12:45:00					Amount (inches): 0.2				
Pictures

SECTION 2: OUTLET PIPE ASSET DESCRIPTION						
Location	DMH Interior Condition	Material	Shape	Diameter/Dimension (in.)	Submerged	
DMH Outlet Pipe	Good	Corrugated Metal	Circle	36	In Water:	Partially
					With Sediment:	No

SECTION 3A: INLET PIPE NO. 1 PHYSICAL INDICATORS						
Indicator	Indicator Present?		Indicator Description			
Asset Damage	Chipping					
Deposits/Stains	Flow Line					
Pool Quality	None					
Pipe Algae/Growth	None					
*Do physical indicators suggest an illicit discharge is present (Y/N):			No			
Is Inlet Pipe No.1 Flowing?			No		Estimated GPM:

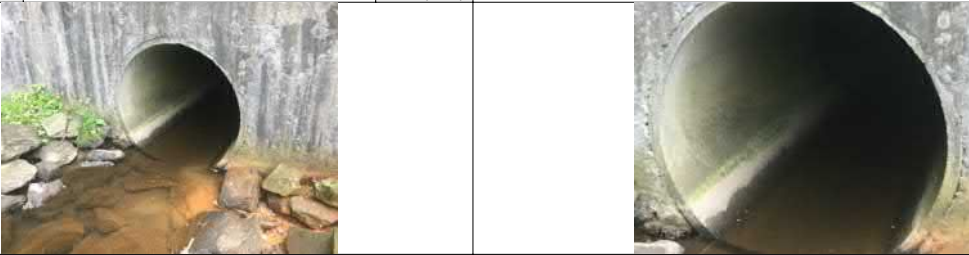
Haverhill IDDE Inspection Form Outfall

SECTION 1: BACKGROUND DATA									
ASSET ID: UNK1177					OUTFALL ID: UNK1177				
Date/Time: 2020-06-11 9:09:00									
Temperature: °F 71					Inspector(s): James Conte Jesse Middleton Zebulan Day Justin Mazzotta				
Street Name/Structure Location: Cross Country									
Previous Precipitation Date/End Time: 2020-06-11 1:20:00					Amount (inches): 0.01				
Pictures

SECTION 2: OUTFALL PIPE ASSET DESCRIPTION						
Location	Upstream Asset ID	Material	Shape	Diameter/Dimension (in.)	Submerged	
Outfall Pipe	DMH-7485	Reinforced Concrete	Circle	48	In Water:	Partially
					With Sediment:	No

SECTION 3: OUTFALL PIPE PHYSICAL INDICATORS				
Indicator	Indicator Present?	Indicator Description		
Asset Damage	None			
Deposits/Stains	Flow Line			
Pool Quality	Excessive Algae			
Pipe Algae/Growth	Brown			
*Do physical indicators suggest an illicit discharge is present (Y/N):		No		
Is Inlet Pipe No.1 Flowing?		Yes	Substantial	Estimated GPM: 10

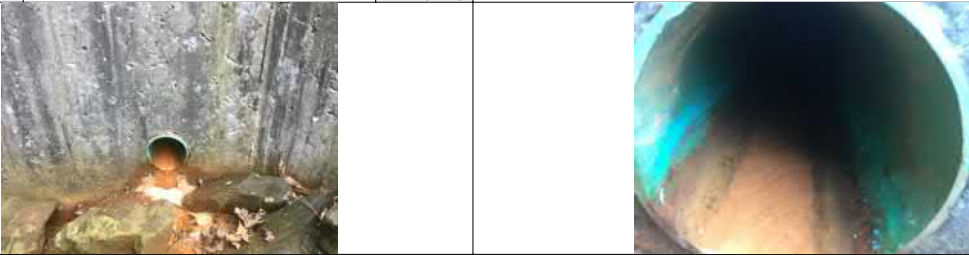
Haverhill IDDE Inspection Form Outfall

SECTION 1: BACKGROUND DATA									
ASSET ID: UNK1762					OUTFALL ID: UNK1762				
Date/Time: 2020-06-11 9:19:00									
Temperature: °F 71					Inspector(s): James Conte Jesse Middleton Zebulan Day Justin Mazzotta				
Street Name/Structure Location: Cross Country									
Previous Precipitation Date/End Time: 2020-06-11 1:20:00					Amount (inches): 0.01				
Pictures

SECTION 2: OUTFALL PIPE ASSET DESCRIPTION									
Location	Upstream Asset ID	Material		Shape	Diameter/Dimension (in.)	Submerged			
Outfall Pipe		Poly Vinyl Chloride		Circle	6	In Water:		No	
						With Sediment:		No	
SECTION 3: OUTFALL PIPE PHYSICAL INDICATORS									
Indicator		Indicator Present?		Indicator Description					
Asset Damage		None							
Deposits/Stains		Flow Line Other		Brown/orange deposit stains					
Pool Quality		None							
Pipe Algae/Growth		None							
*Do physical indicators suggest an illicit discharge is present (Y/N):		No

Is Inlet Pipe No.1 Flowing?		Yes		Trickle		Estimated GPM:		0.8	
SECTION 4: OUTFALL PIPE PHYSICAL INDICATORS (ALL FLOWING ASSETS)									
Indicator	Indicator Present (Yes/No)		Description			Severity			
Odor	No								
Color	No								
Turbidity	-		-			Slight Cloudiness			
Floatables (Does Not Include Trash)	Yes	Few/slight, origin not obvious	Suds and Foam			-			
SECTION 5: OUTFALL PIPE SAMPLING/TESTING RESULTS (ALL FLOWING ASSETS)									
Sample Date/Time:		2020-06-11 9:29:00							
Parameter	Result	Typical EPA Benchmarks		Equipment					
Temperature (degrees F)	63			Hanna portable PH and Temp meter					
pH	7			Hanna portable PH and Temp meter					
Specific Conductivity (uS)	1100			To be sent to lab or EXTECH EC500					
Salinity (ppm S)	548			EXTECH EC500					
Chlorine (ppm)	0.02	≥ Reporting Limit		Hach pocket Colorimeter					
Ammonia (mg/L)	1	≥ 0.5 mg/L		To be sent to lab					
Surfactants (mg/L)	0.08	≥ 0.25 mg/L		To be sent to Lab or Hanna Instruments HI96769C

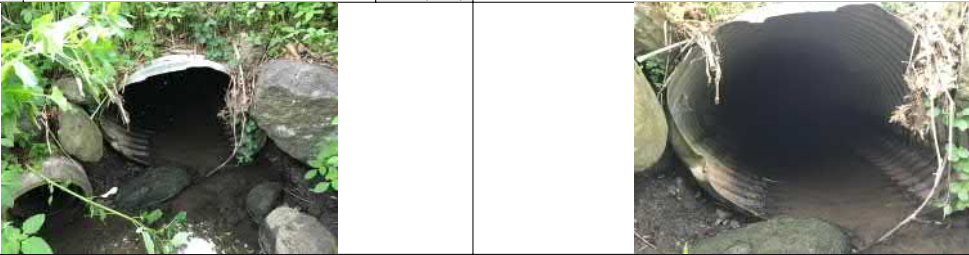
Haverhill IDDE Inspection Form Outfall

SECTION 1: BACKGROUND DATA									
ASSET ID: UNK1767					OUTFALL ID: UNK1767				
Date/Time: 2020-06-23 7:44:00									
Temperature: °F 65					Inspector(s): James Conte Jesse Middleton Samuel Martinez Zebulan Day Justin Mazzotta				
Street Name/Structure Location: Cross Country									
Previous Precipitation Date/End Time: 2020-06-11 12:45:00					Amount (inches): 0.2				
Pictures

SECTION 2: OUTFALL PIPE ASSET DESCRIPTION						
Location	Upstream Asset ID	Material	Shape	Diameter/Dimension (in.)	Submerged	
Outfall Pipe	DMH-704	Corrugated Metal	Circle	36	In Water:	Partially
					With Sediment:	No

SECTION 3: OUTFALL PIPE PHYSICAL INDICATORS				
Indicator	Indicator Present?	Indicator Description		
Asset Damage	None			
Deposits/Stains	Other	Rust		
Pool Quality	None			
Pipe Algae/Growth	None			
*Do physical indicators suggest an illicit discharge is present (Y/N):		No		
Is Inlet Pipe No.1 Flowing?		Yes	Trickle	Estimated GPM: 0.3

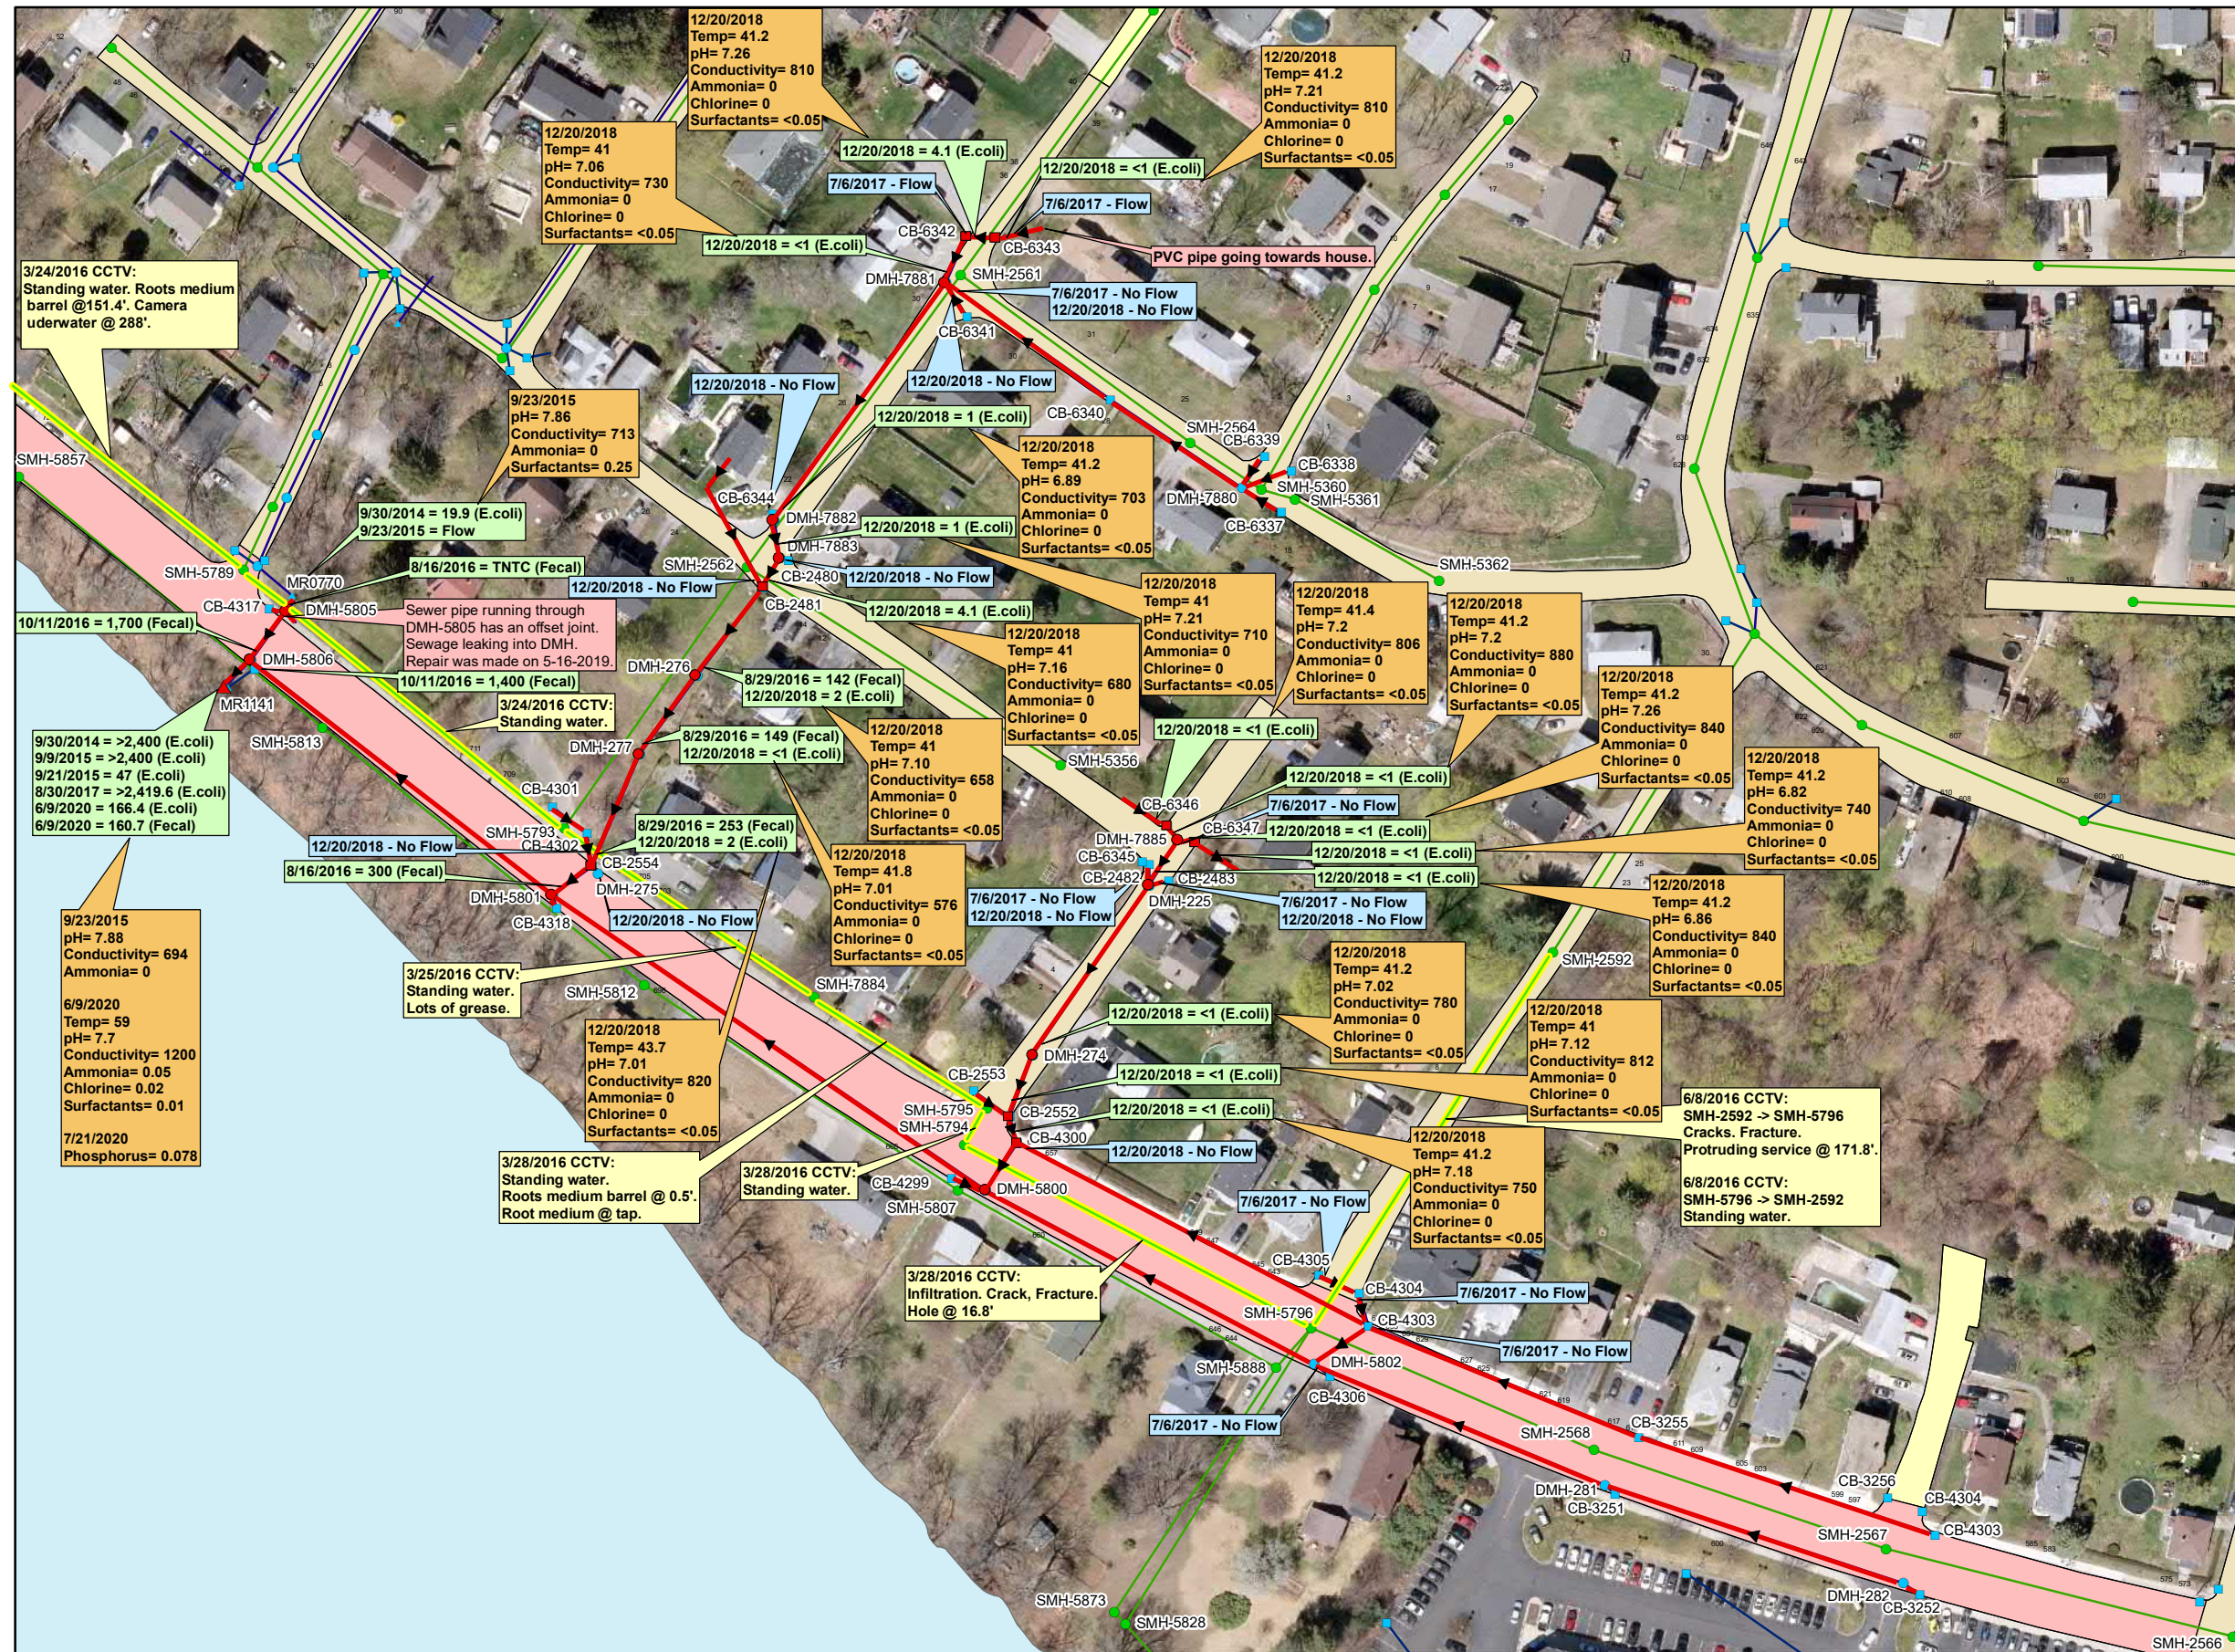
Outfall MR1141

MR1141	12/20/2018	River St	Sewer pipe joint offset leaking in DMH	Not able to estimate	Yes		Was repaired 5/16/2019			Sewer pipe joint and DMH were repaired on 5/16/2019	5/16/2019	\$500	Not able to estimate	Yes, the City is in compliance	
	MR1109		350 Water St	IDDE conducted and needs further investigation to determine the source.												
	MR1138	10/20/2017	River St	Upstream contamination from culvert inlet.												
	MR24314	7/27/2016	15 Groveland St., 19 Groveland St, 312 Water St	3 Single family	N/A		N/A	N/A	N/A		New gravity sewer installed on Nov 11, 2016 and 3 homes removed from drain system	11/4/2016	\$ 12,788	26,377	Yes, the City is in compliance	
Pentucket Lake	PL0891	10/5/2016	Marsh Avenue	leaking sewer/ exfiltration	Not able to estimate	X	Sewer replacement costs/lengths are extensive; cost exceeds discretionary funds; new fund required in next fiscal year to complete project	Fiscal Year 2019	This connection is being removed as quickly as possible and dependent on the availability of funds within the fiscal year.	N/A	10/5/18-10/10/18: SMH-2190 point repair and manhole rehabilitation complete. 10/11/18-10/16/18: Installation of CIPP main line liner on Main St 10/17/18-10/23/18: Installation of CIPP main line liner on Marsh Ave. 10/24/18: Began installing CIPP of sewer laterals. Groundwater too high causing flooding in homes. Project on hold until mid-end March. Project is complete. Post lining CCTV was reviewed and determined that more CCTV needs to be conducted and 1 defect in lining needs to be repaired.6/9/2020: illicit connection located at lateral from laundromat, owner notified to repair	-	\$446,000	-	Marsh Ave sewer repair project was bidded and awarded to National Water Main Cleaning Co. and contract had to be extended to 6/30/19 due to high groundwater. Project was completed by the end of June 2019 but after review of CCTV, it was determined that more CCTV needs to be conducted and 1 defect in lining needs to be repaired.

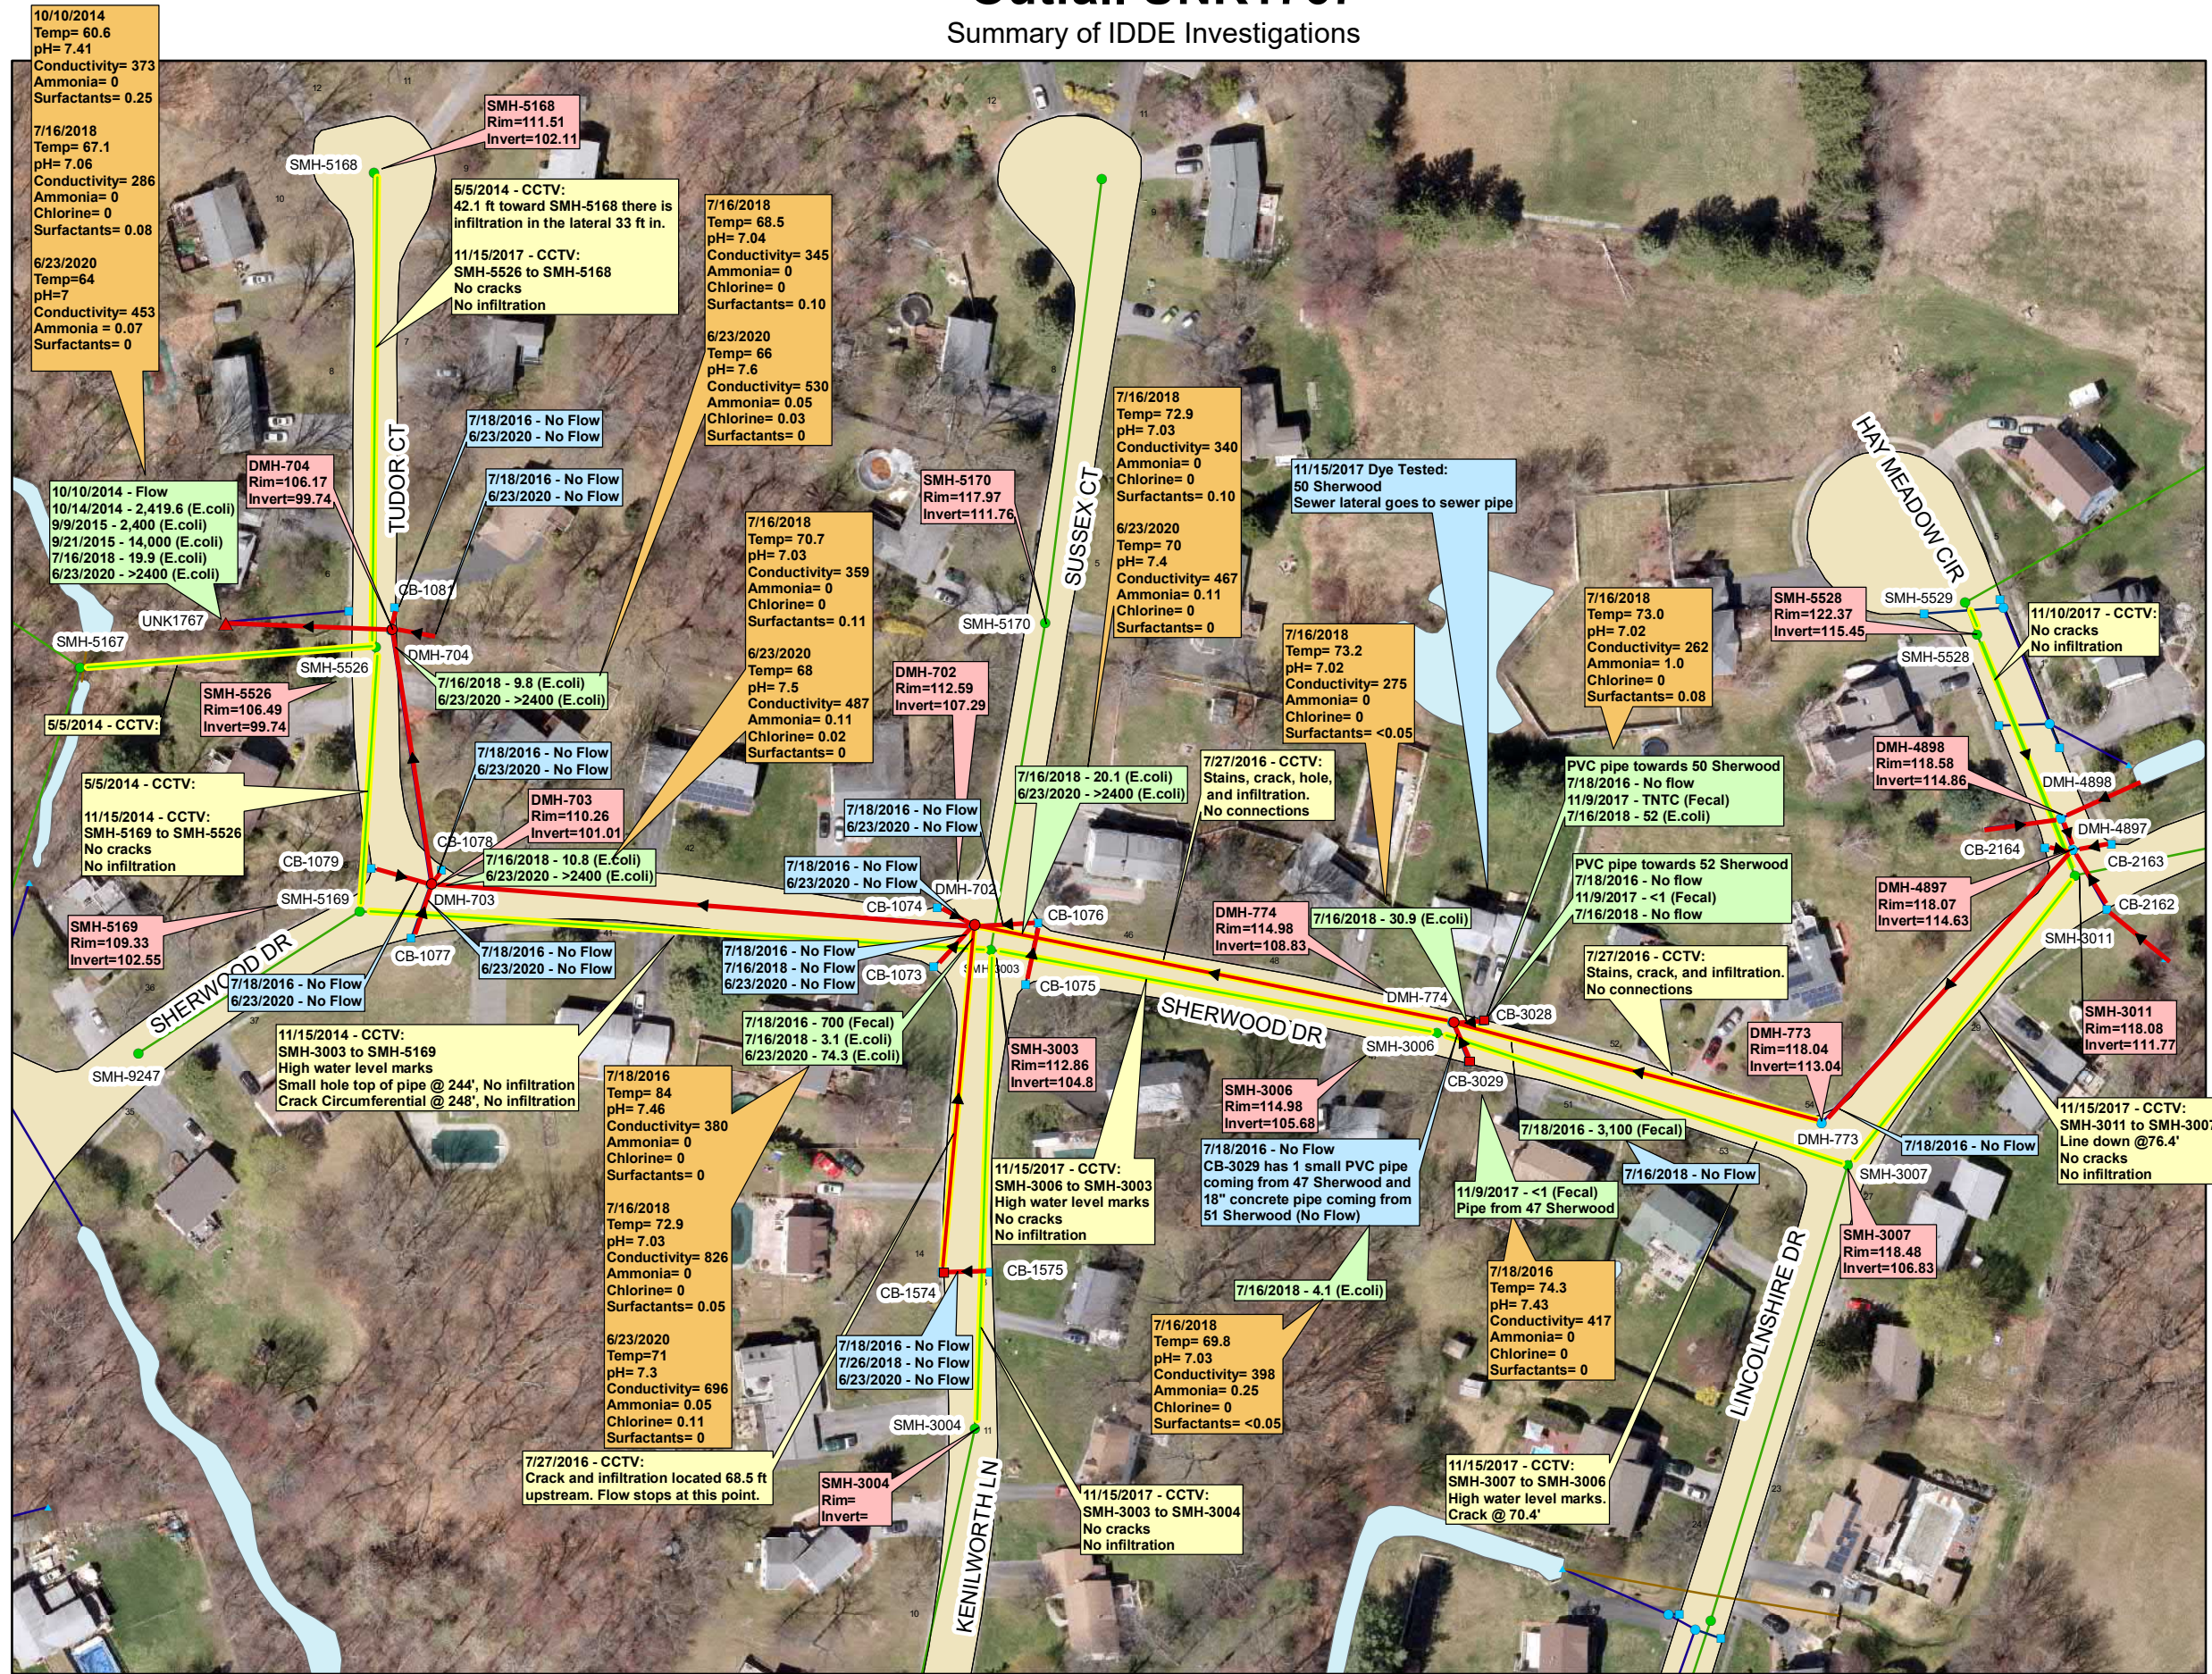
Outfall UNK1767

- Outfall UNK1767: Sampling investigation conducted on 6/23/20, as well as sampling of outfall and upstream connections DMH-702, 703, and 704 were also sampled as there was minimal flow. Additional testing will be needed further upstream as possible groundwater-only infiltration on DMH-4897 and DMH-4898. Infiltration sampled on DMH 702-3 inlet pipe, no flow at catch basin upstream on Kenilworth, infiltration source between CB1547 and DM702 will need CCTV to investigate further. See map of progress in Appendix B.
