Subject: City of Haverhill, MA NPDES Permit #MA 0101621
Consent Decree Submittal (Civil Action No. 16-11698-IT)
Compliance Report Number 10 – January 1, 2021 through June 30, 2021

CITY OF HAVERHILL, MASSACHUSETTS

COMPLIANCE REPORT No. 10

JANUARY THROUGH JUNE 2021

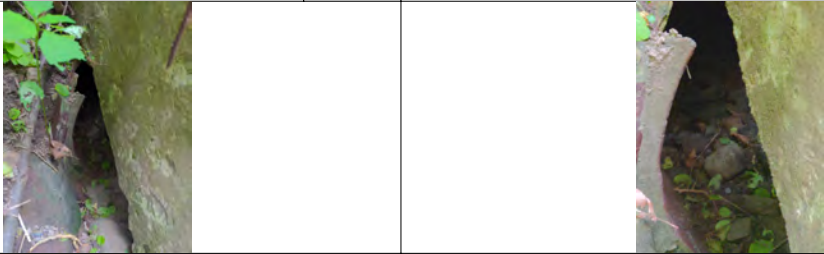
Is Inlet Pipe No.1 Flowing?									
Estimated GPM:									
Comments :	Maintenance Needed								
Signature of Inspector :
