Subject: City of Haverhill, MA NPDES Permit #MA 0101621
Consent Decree Submittal (Civil Action No. 16-11698-IT)
Compliance Report Number 12 – January 1, 2022, through June 30, 2022

COMPLIANCE REPORT No. 12
JANUARY – JUNE 2022

CITY OF HAVERHILL, MASSACHUSETTS
NPDES PERMIT No. MA0101621
CONSENT DECREE
(Civil Action No. 16-11698-IT, 11/10/16)
COMPLIANCE REPORT No. 12
JANUARY – JUNE 2022

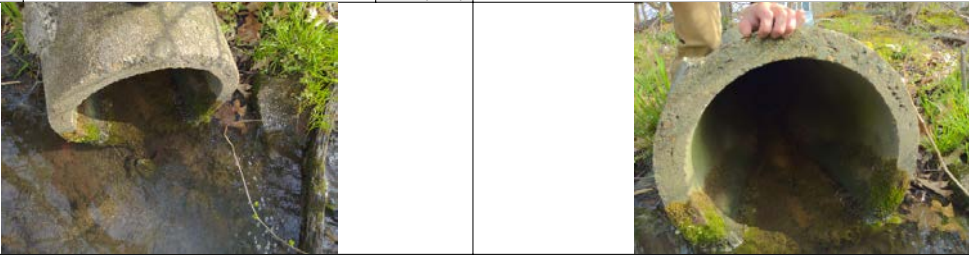
SECTION 2: OUTFALL PIPE ASSET DESCRIPTION						
Location	Upstream Asset ID	Material	Shape	Diameter/Dimension (in.)	Submerged	
Outfall Pipe		Reinforced Concrete	Circle	15	In Water:	No
					With Sediment:	No

SECTION 3: OUTFALL PIPE PHYSICAL INDICATORS				
Indicator	Indicator Present?	Indicator Description		
Asset Damage	None			
Deposits/Stains	None			
Pool Quality	None			
Pipe Algae/Growth	None			
*Do physical indicators suggest an illicit discharge is present (Y/N):		Yes	Sheen	
Is Inlet Pipe No.1 Flowing?		Yes	Trickle	Estimated GPM: 0.5

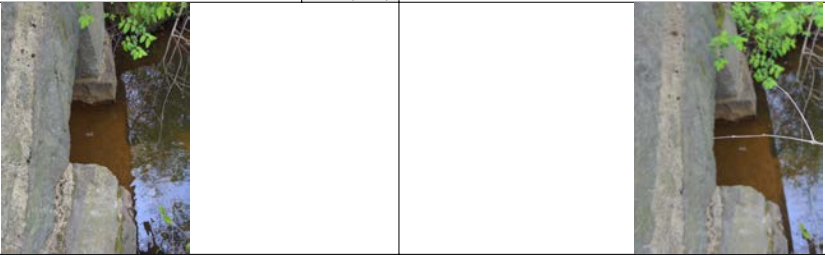
SECTION 2: OUTFALL PIPE ASSET DESCRIPTION						
Location	Upstream Asset ID	Material	Shape	Diameter/Dimension (in.)	Submerged	
Outfall Pipe		Cement Concrete	Square	40	In Water:	Partially
					With Sediment:	No

SECTION 3: OUTFALL PIPE PHYSICAL INDICATORS				
Indicator	Indicator Present?	Indicator Description		
Asset Damage	None			
Deposits/Stains	None			
Pool Quality	None			
Pipe Algae/Growth	None			
*Do physical indicators suggest an illicit discharge is present (Y/N):		No		
Is Inlet Pipe No.1 Flowing?		Yes	Trickle	Estimated GPM: 0.02

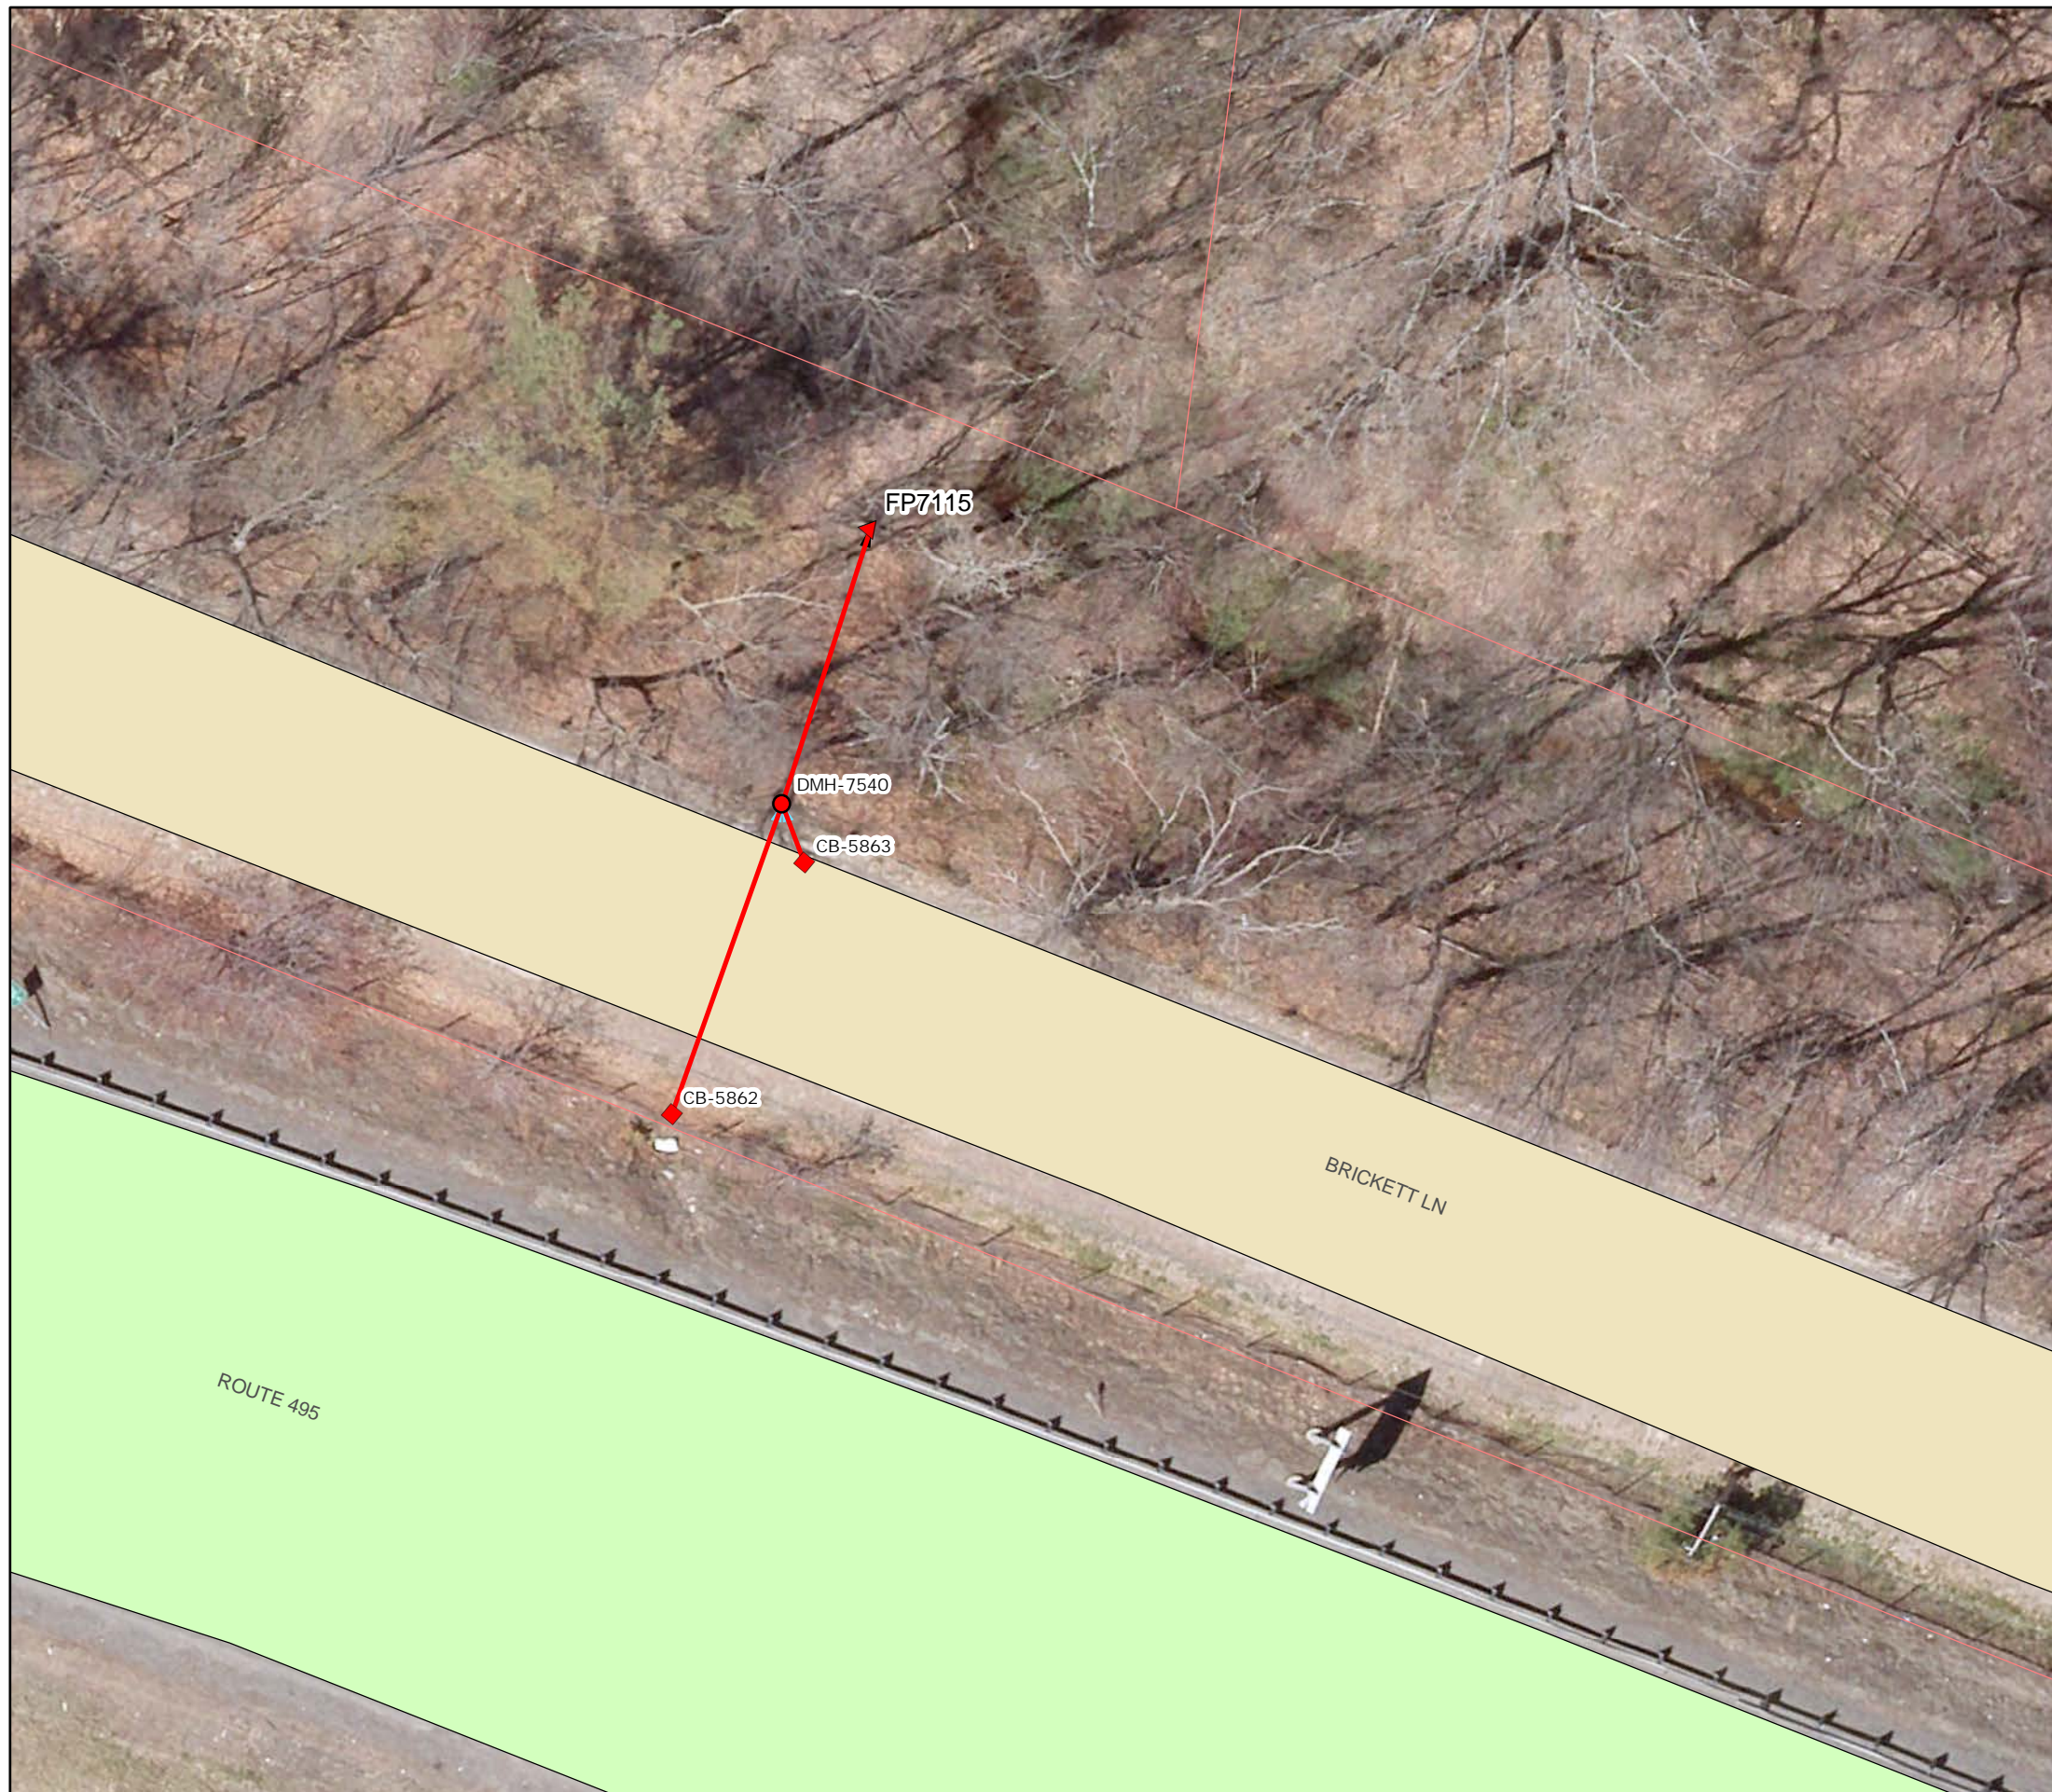
FP7115 Catchment Inspection 5/25/2022

Frye Pond Basin Outfalls – FP7115 – Catchment was investigated, and no flow was found, on additional visits flow was found with high levels of ammonia, at this time there is no source for ammonia results; it is the City's opinion the presence of wildlife is the source of ammonia. Additional sampling will be completed.
