**AN ECOLOGICAL SITE ASSESSMENT OF**

# **John's Woods**

**HVERHILL, MASSACHUSETTS**

Jeffrey Collins  
Mass Audubon Ecological Extension Service  
June 2013

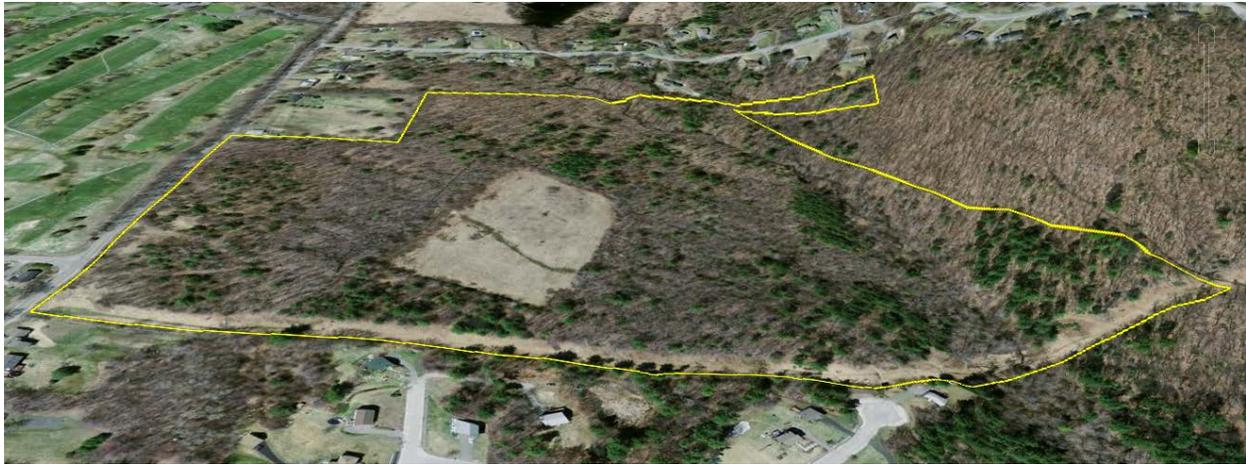
Figure 3a. View of John's Woods in Google Earth. View is looking northwest, relief is exaggerated x3.

As seen in Figure 3a and 3b, the John's Woods parcel has a northern aspect, sloping downhill as one travels northeast away from North Broadway until reaching Fishin Brook where the land begins to ascend Parsonage Hill. The slopes are gentle throughout the property, allowing for easy walking a routing of new trails if desired.

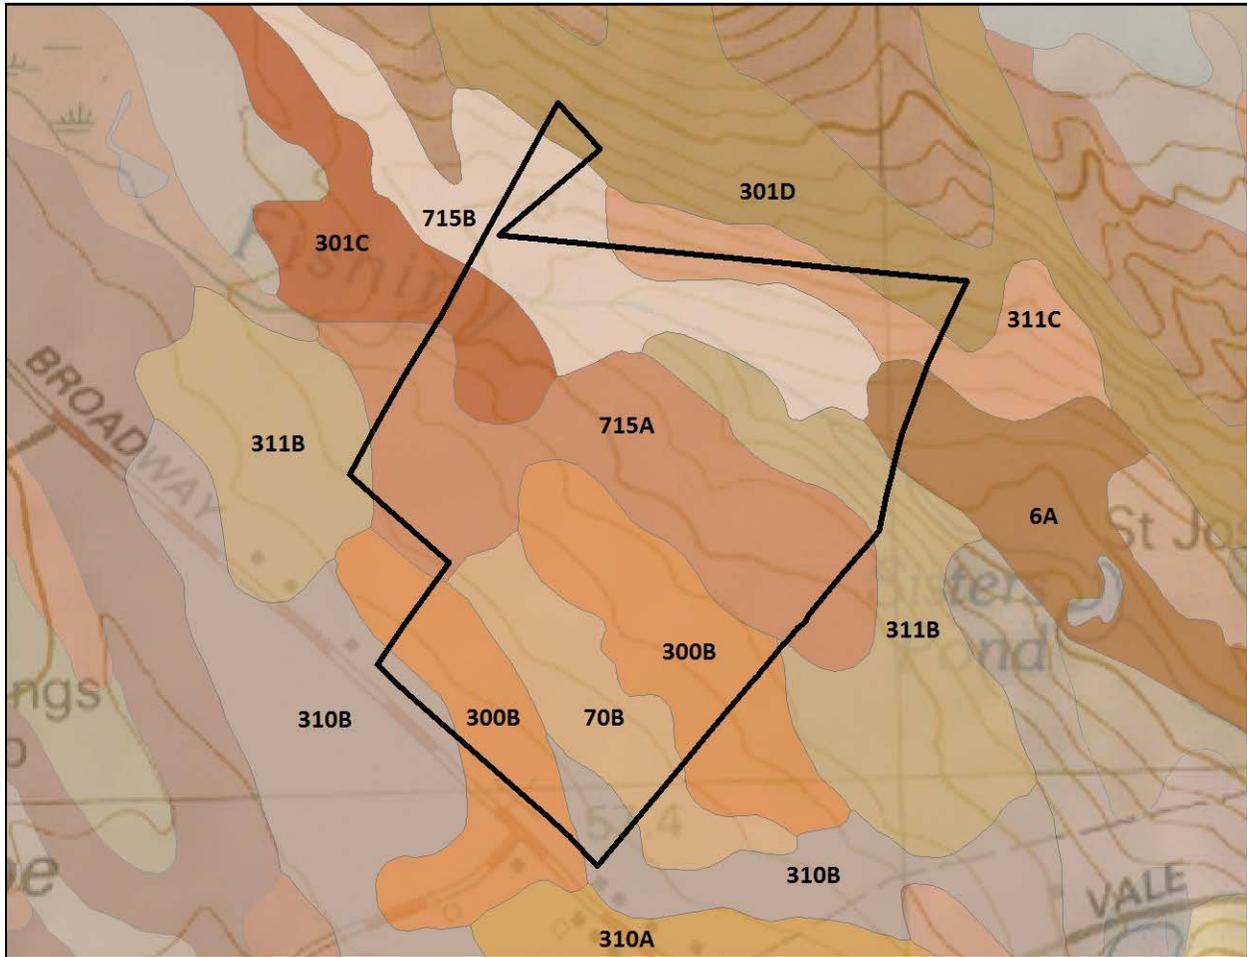
Figure 4. Soils at John's Woods

Soils on John's Woods are entirely fine sandy loams derived from glacial till (Figure 4). In soil classification, "loam" refers to a soil with a mix of sand, silt, and clay particles. The "fine sandy" prefix indicates that these loams are a bit weighted to sand and that the sand particles are small. The fine sandy loams at John's Woods range from low in stones to extremely stony, with the more stony soils found generally lower on the slope near Fishin Brook. The only variation from fine sandy loam is the small area of mucky fine sandy loam where Fishin Brook leaves John's Woods and begins to widen into Sisters Pond. Mucky soils have a higher content of partially decomposed organic material, caused here by permanent or seasonal inundation.

Fine sandy loams are generally moderately permeable to water movement, however drainage may be restricted by the presence of a dense, low permeability layer or hardpan inches to feet beneath the surface. At John's Woods, the Ridgebury and Leicester fine sandy loam and Montauk fine sandy loam cutting across the hay fields and downslope to Fishin Brook holds water close to the soil surface and creates some moist patches in the hay fields and muddy soil in the forest.

- 6A - SCARBORO MUCKY FINE SANDY LOAM, 0 TO 3 PERCENT SLOPES
- 70B - RIDGEBURY FINE SANDY LOAM, 3 TO 8 PERCENT SLOPES
- 300B - MONTAUK FINE SANDY LOAM, 3 TO 8 PERCENT SLOPES
- 301C - MONTAUK FINE SANDY LOAM, 8 TO 15 PERCENT SLOPES, VERY STONY
- 301D - MONTAUK FINE SANDY LOAM, 15 TO 25 PERCENT SLOPES, VERY STONY
- 310A - WOODBRIDGE FINE SANDY LOAM, 0 TO 3 PERCENT SLOPES
- 310B - WOODBRIDGE FINE SANDY LOAM, 3 TO 8 PERCENT SLOPES
- 311B - WOODBRIDGE FINE SANDY LOAM, 3 TO 8 PERCENT SLOPES, VERY STONY
- 311C - WOODBRIDGE FINE SANDY LOAM, 8 TO 15 PERCENT SLOPES, VERY STONY
- 715A - RIDGEBURY AND LEICESTER FINE SANDY LOAMS, 0 TO 3 PERCENT SLOPES, EXTREMELY STONY
- 715B - RIDGEBURY AND LEICESTER FINE SANDY LOAMS, 3 TO 8 PERCENT SLOPES, EXTREMELY STONY

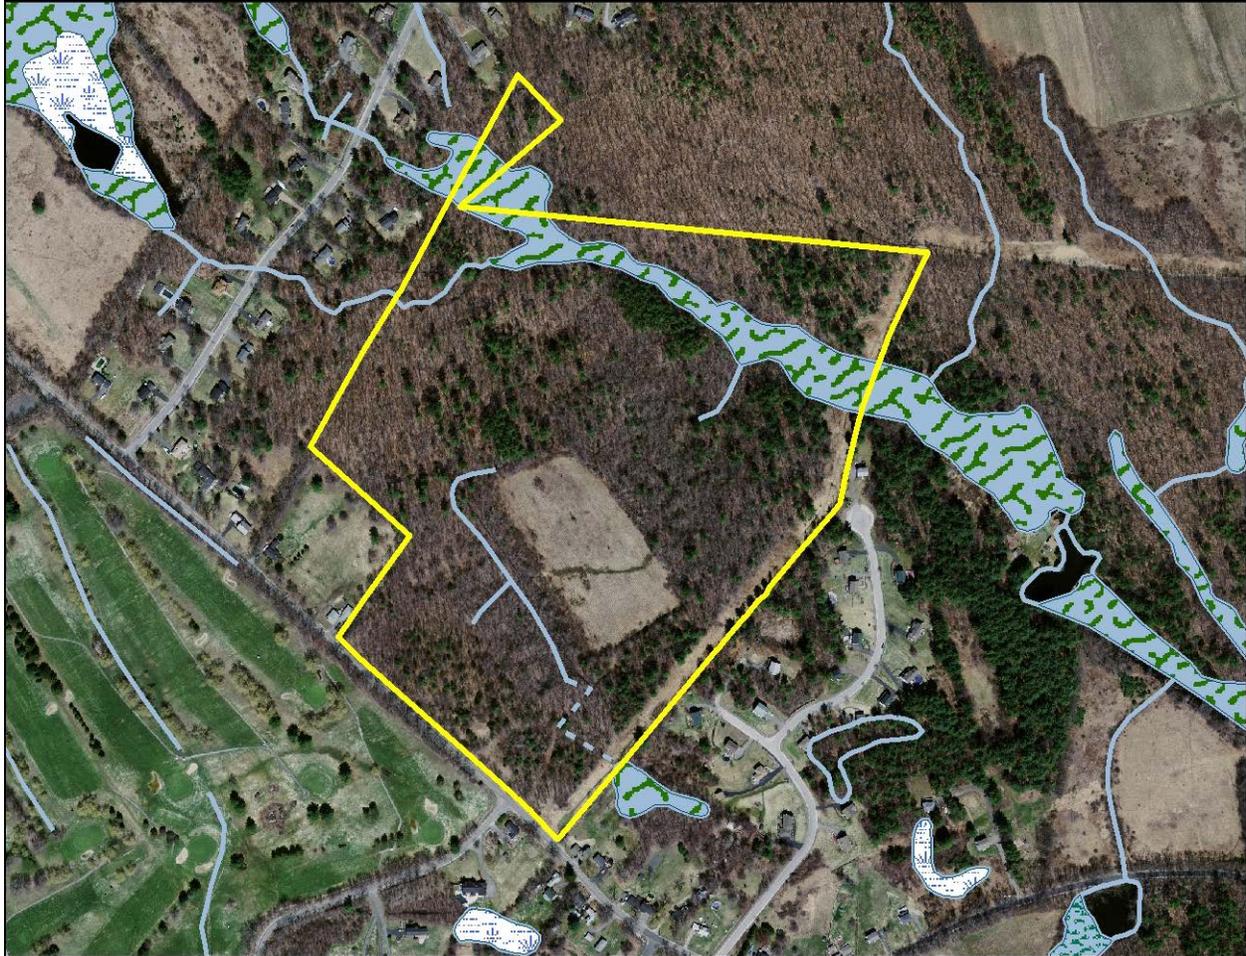
Figure 7b. John's Woods parcel.

Aerial photograph from 2008; wetlands from MassDEP; boundary approximate.

Water on the John's Woods generally flows to the north with the slope. Groundwater from the area between North Broadway and the hayfield is intercepted by what appears to be a very old manmade channel on the southern, uphill side of the hayfield and directed southeast, presumably to keep this hayfield dry. This channel is now heavily vegetated and functions as a small swampy area with some floodplain characteristics in the directly adjacent forest. Seasonal flow through this channel exits the property at the southeast corner, entering a swampy area adjacent to Diana Drive. Water to the north of the hayfield flows downslope to the north through areas of seepy forest characterized by red maples

and muddy ground, eventually reaching Fishin Brook. The brook flows off of the property near the northeast corner. Fishin Brook continues east another mile to its confluence with the Little River in the Rosemont section of Haverhill. The Little River flows south to downtown Haverhill, last seen near Haffners Service Station before flowing in culverts to the Merrimack River.

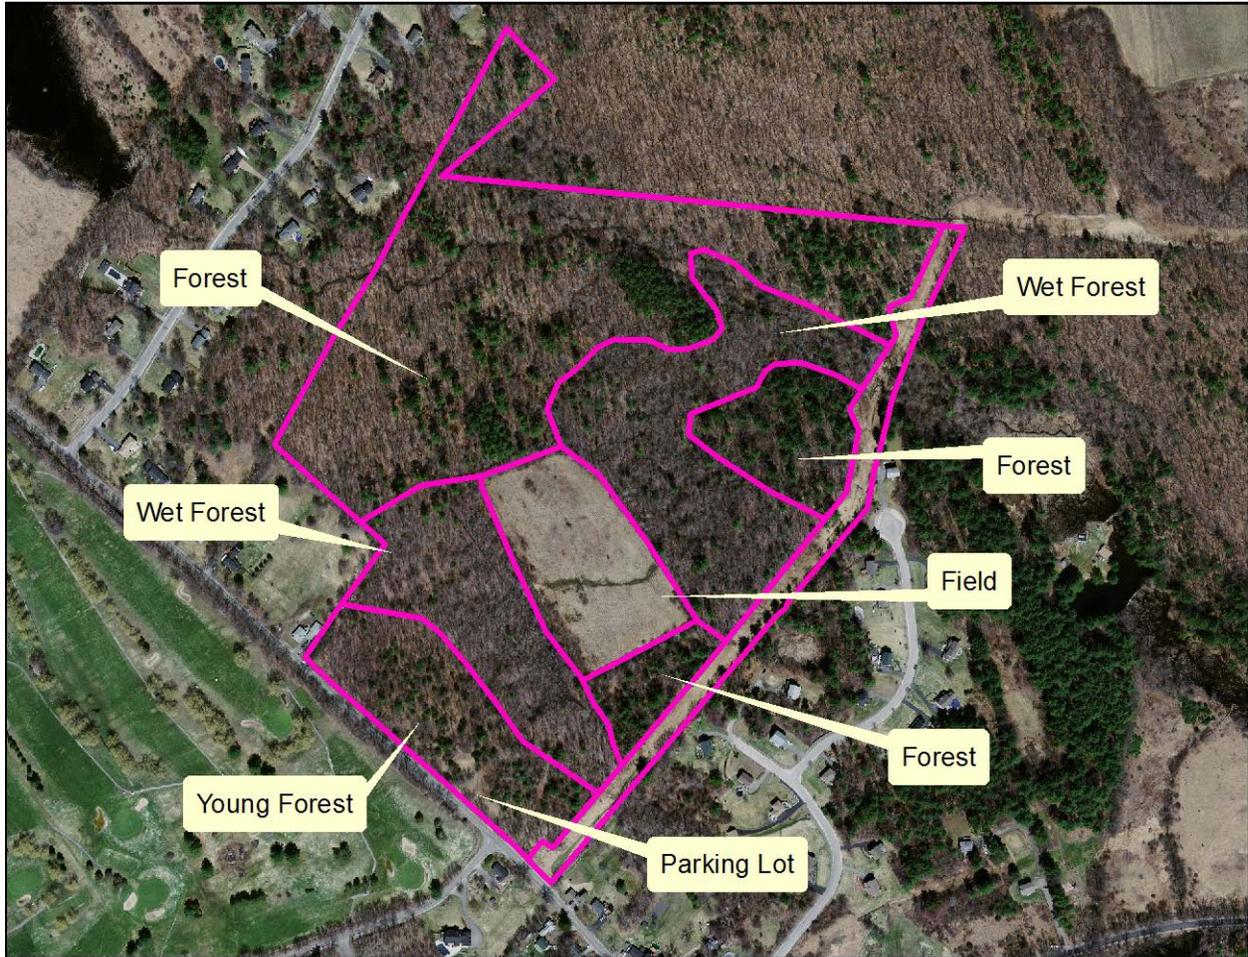
Figure 8. Natural Communities of John's Woods

Forest covers 57 acres of John's Woods and ranges from young, even-aged red maple forest on moist soils to mature, uneven-aged, mixed hardwood-white pine forest on dry, rocky soils.

- Dry Forest – These 31 acres are dominated by a stately canopy of black oaks with white pine, black birch, white ash, black cherry, sugar maple, and shagbark hickory. Beech and yellow birch, two species with a more northerly range, are present lower on the slope, near Fishin Brook, suggesting that cool air drains down the Fishin Brook 'valley'. American chestnut is present at very low density, including at least one medium-sized individual that appears quite healthy and

- Wet Forest – Red maple dominates in the 25- to 35-foot tall canopy of these 19 acres with white ash also common. Silver maple, American elm, river birch, and musclewood, while present at much lower density, indicate persistent wet soil conditions that almost suggest floodplain conditions. Highbush blueberry and winterberry are the most common shrubs with witch hazel and American hazelnut also present. The invasives common buckthorn and Japanese barberry are quite common in places. The ground layer is characterized by a dense cover of ferns including cinnamon fern, New York fern, royal fern, and sensitive fern along with tall rue and jack-in-the-pulpit. The banks of Fishin Brook are dense in places with winged euonymus, a non-native invasive shrub.

- Young Forest – The 6.5 acres nearest North Broadway is characterized by a young forest reflecting abandonment of open fields 20 to 30 years ago. The canopy here is generally shorter than in the more mature forested areas and is composed of white pine, white birch, cherries, and red maple, with red cedar reaching the canopy in places. The shrub layer includes the invasive multiflora rose, honeysuckles, and glossy buckthorn. More open areas, closer to the parking area, have no canopy and include small patches of goldenrod meadow (west of the parking area) and thickets of staghorn sumac overgrown with oriental bittersweet (north of the parking area). Several red cedars have been overtopped by taller growing species and shaded to the point that they are dead or nearly dead while a few large red cedars persist in the canopy. The red cedars (and the extent of invasives here) indicate that this area was used as pasture or was otherwise maintained in an open state that allowed the red cedars to grow while other woody vegetation was not allowed to grow. When the field was abandoned, other, faster-growing woody vegetation took over.

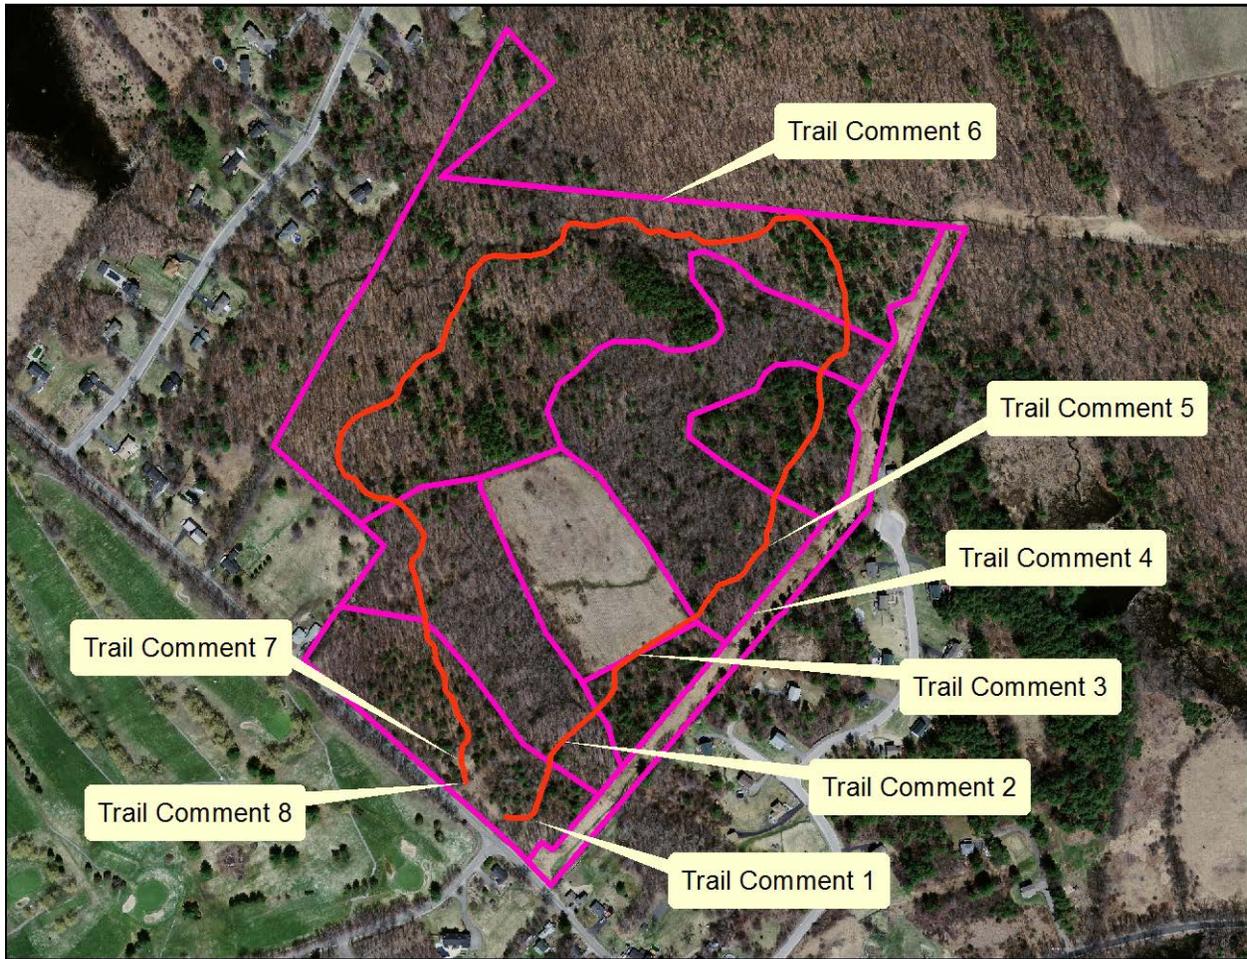
Figure 9. Comments on Trails at John's Woods

The existing one-mile loop trail at John's Woods allows the visitor to experience the full range of habitat types on the property. Very nice wooden bridges have been installed to cross Fishin Brook in two places and the forested sections of the trail appear to be well-maintained. Sections of the trail are outlined below, with comments keyed to Figure 9:

- 1) The trail leading out of the east side of the existing parking area is overgrown with herbaceous vegetation and has quite a bit of poison ivy in the path itself. The length of trail leading from the parking area through the section of open-canopy vegetation, approximately 200 feet to a stone wall, should be surfaced or continually mown to suppress vegetation. Poison ivy should be regularly treated with a broadleaf herbicide to eliminate it from the trail itself.

- 2) The trail running through this section of wet forest is seepy and appears to hold water at some times of year. This section may need bog bridging or trail work to direct water to a low point on the trail where it can cross to the southeast. Approximately 150 feet of trail appears at least seasonally wet.

- 3) The trail through the field is not well-delineated when the grass is not mown, during winter or early spring when field vegetation is the same height as trail vegetation, or soon after mowing. The trail should be better marked on the side of the field, should be surfaced, or the grass trail should be mown weekly from April to October.

- 4) ATVs and dirt bikes access the property from the gasline easement and a small spur trail meeting the main trail near the eastern corner of the field. This trail should be blocked with gates and signage placed at the north and south end of the easement to indicate that motorized vehicles are not permitted.

- 5) The trail through the Wet Forest includes some areas of seepy and muddy soil along the trail bed. Bog bridging has been installed in places, but is needed to cross this entire area in the wettest conditions. Trustees and trail volunteers should inventory the site more precisely to establish the amount of bog bridging required.

- 6) ATVs and dirt bikes access John's Woods from the property to the north, crossing a stone wall and using the northern-most section of the trail. Riders appear to stay north of Fishin Brook. ATVs have been used to create new trails by plowing over existing vegetation and tearing up soil. Boulders could be replaced in the stone wall to dissuade access at this point, although they will likely be removed again. Signage should be installed to indicate that motorized vehicles are not permitted on the property.

- 7) The trail on the west side of the parking area is overgrown with grasses and goldenrods. The trail should be widened and regularly mown or surfaced so that it is visible and appealing.

- 8) A foundation hole on the west side of the parking lot, labeled the "Chase House Foundation" on the online John's Woods trail map, is quite close to the trail as it meets the parking lot, yet is overgrown and presents a hazard should anyone take a step or two off of the main trail. The

foundation should be revealed by clearing vegetation, or the trail should meet the parking lot further to the north so that trail users do not risk stepping into the foundation.
