Massachusetts Inland Resource Area Delineation Report

Project number: 20171390.U30

Site Address/Location: Little River, between Essex Street and Greenhill Farm Road
42.782623706 N, 71.09047162 W

Inspection Date: September 27, 2021 and April 29, 2022

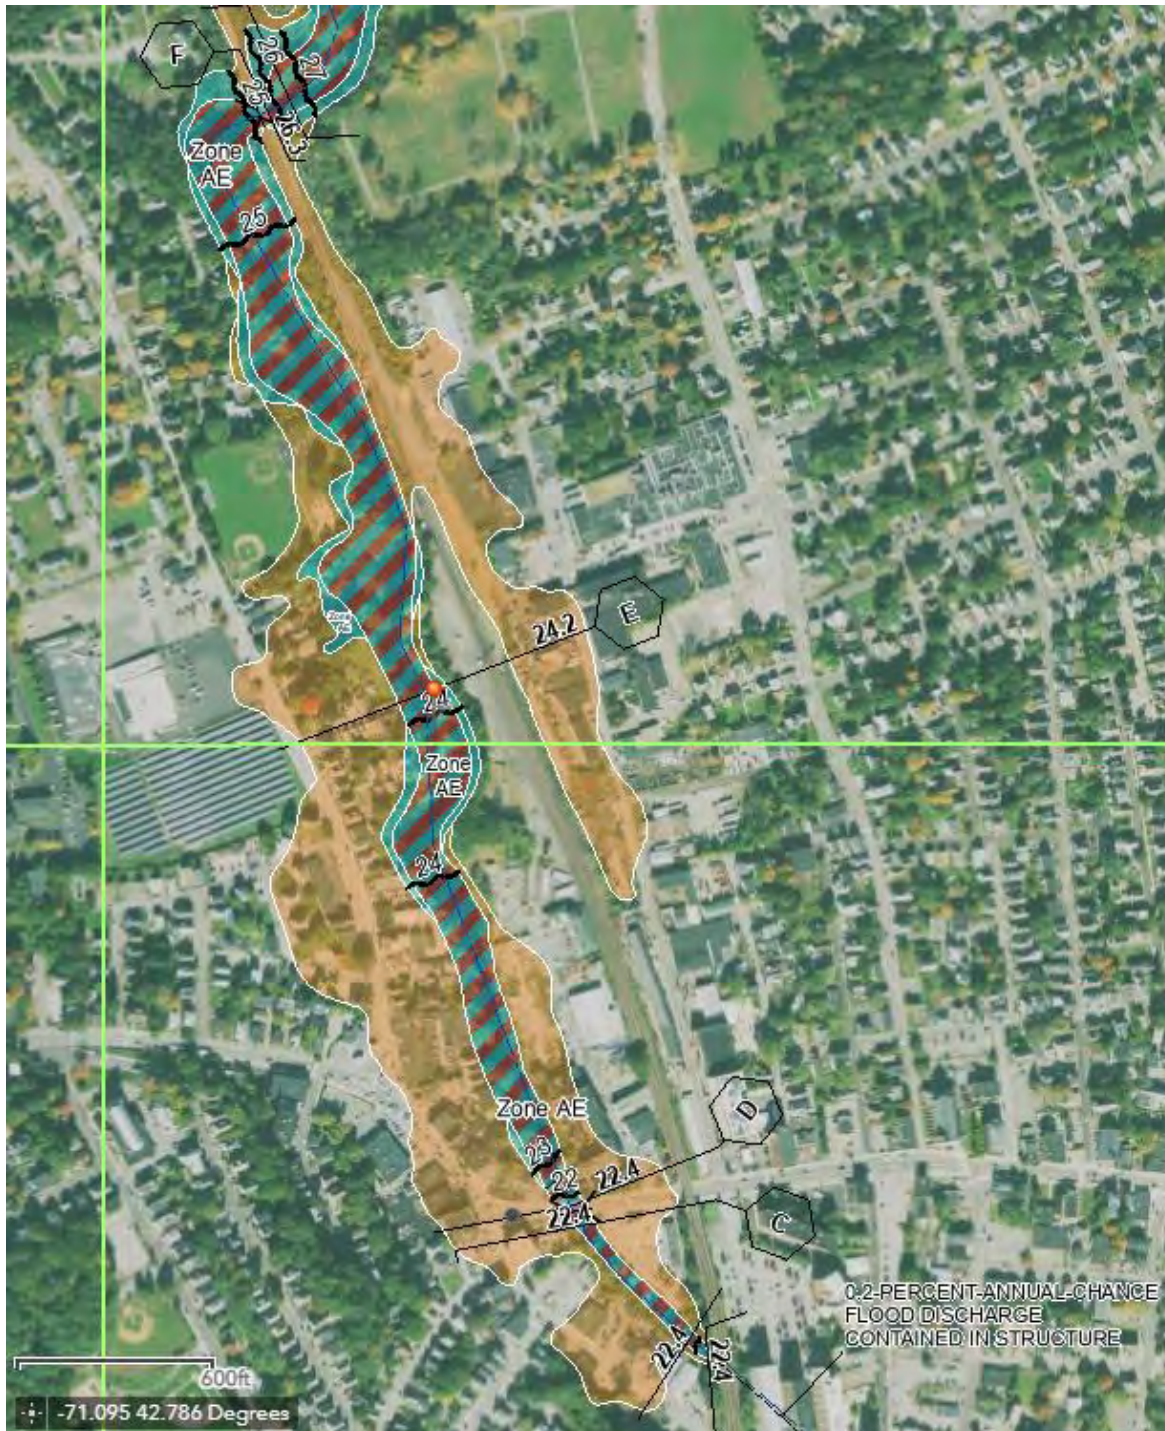
FEMA National Flood Hazard Layer

The National Flood Hazard Layer, provided by FEMA, dated July 3, 2012 depicts areas at the Site within Flood Zones AE and A, which designate areas likely to experience flooding in 100-year storm events (see attached *FEMA National flood Hazard Layer*). This area likely coincides with the historical lateral extent of floodplains and bordering wetlands at the Site; however, urban development now comprises much of these areas, and the physical characteristics that define BLSF in 310 CMR 10.57(2)(a)1 are absent. To determine the extent BLSF at the Site, Fuss & O’Neill conducted hydraulic modeling.

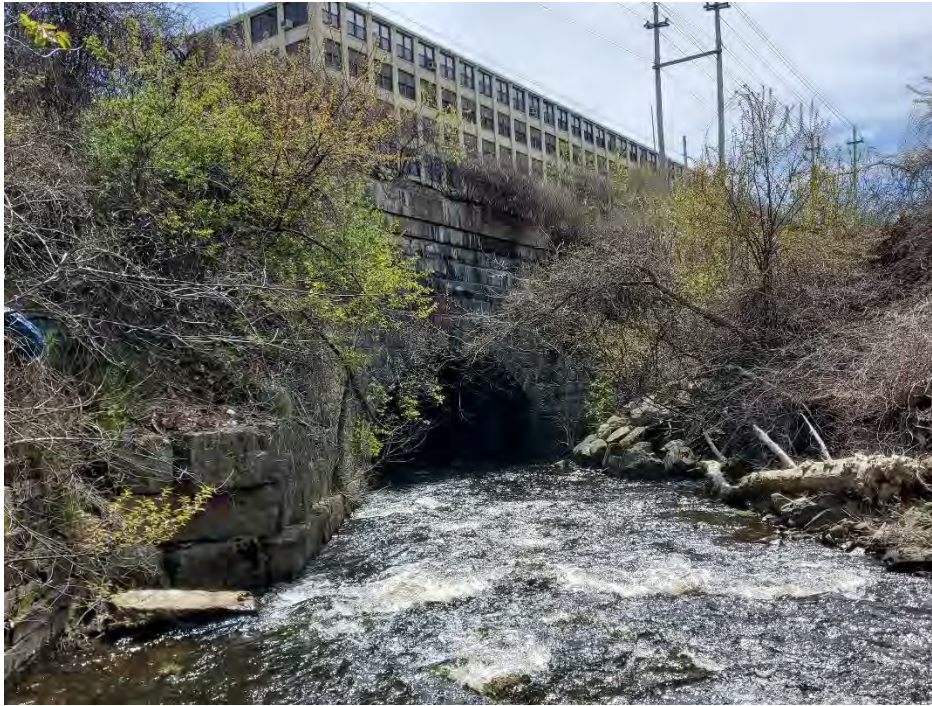
Figure 1. Little River at the southern (downstream) terminus of project area. Looking southeast from flag G700, toward the culvert which conveys the river to the Merrimack River.

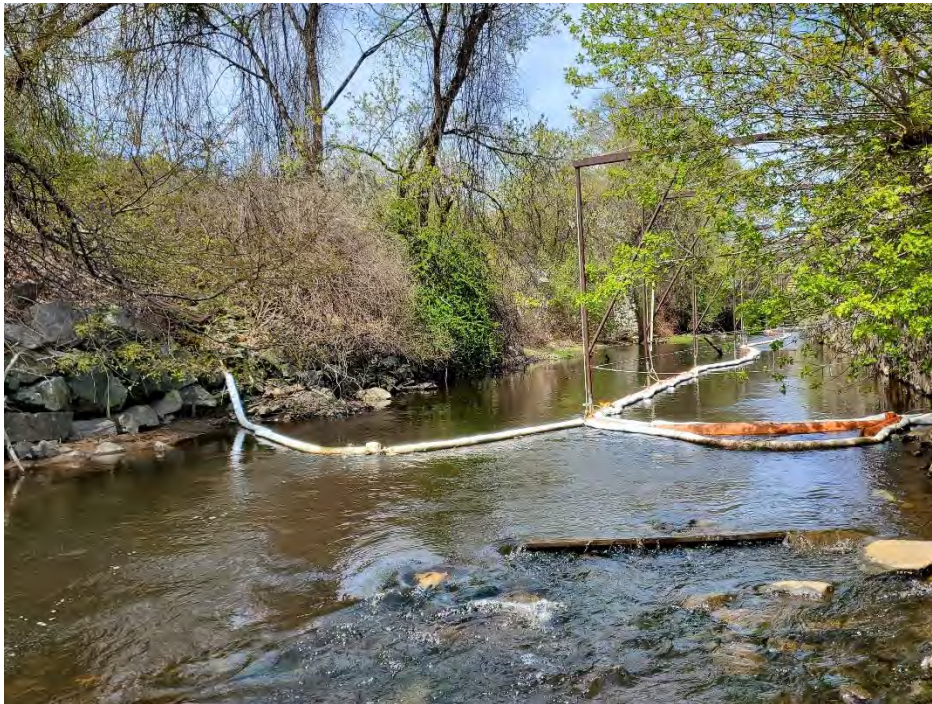
Figure 2. Western bank of Little River. Looking northwest (upstream) from flag G700.

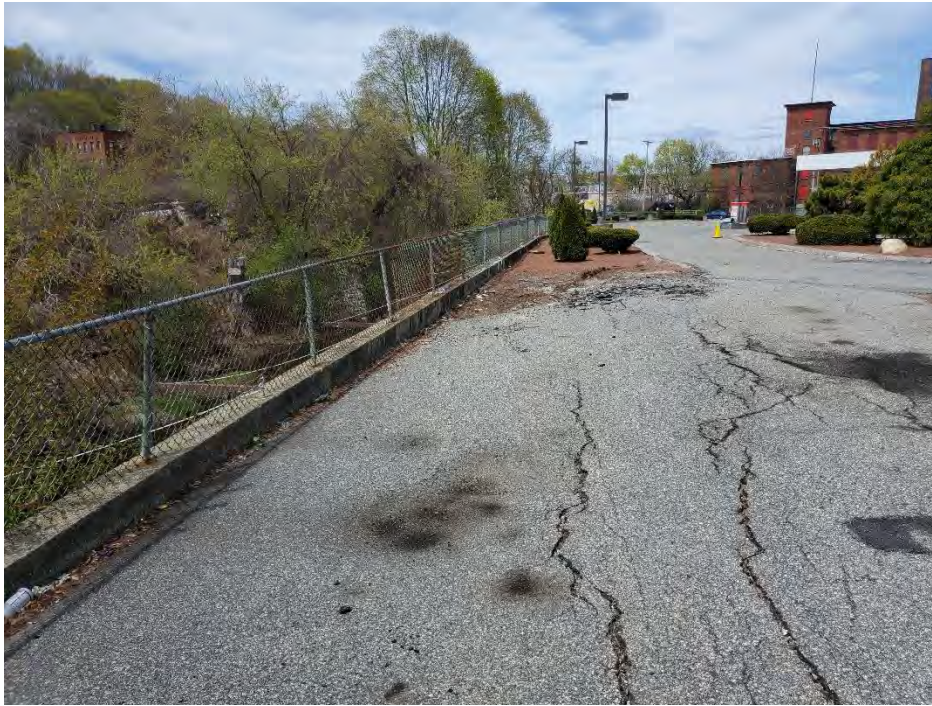
Figure 3. Urban development immediately east of Little River south of Winter Street. Looking northwest (upstream) near flag G701.

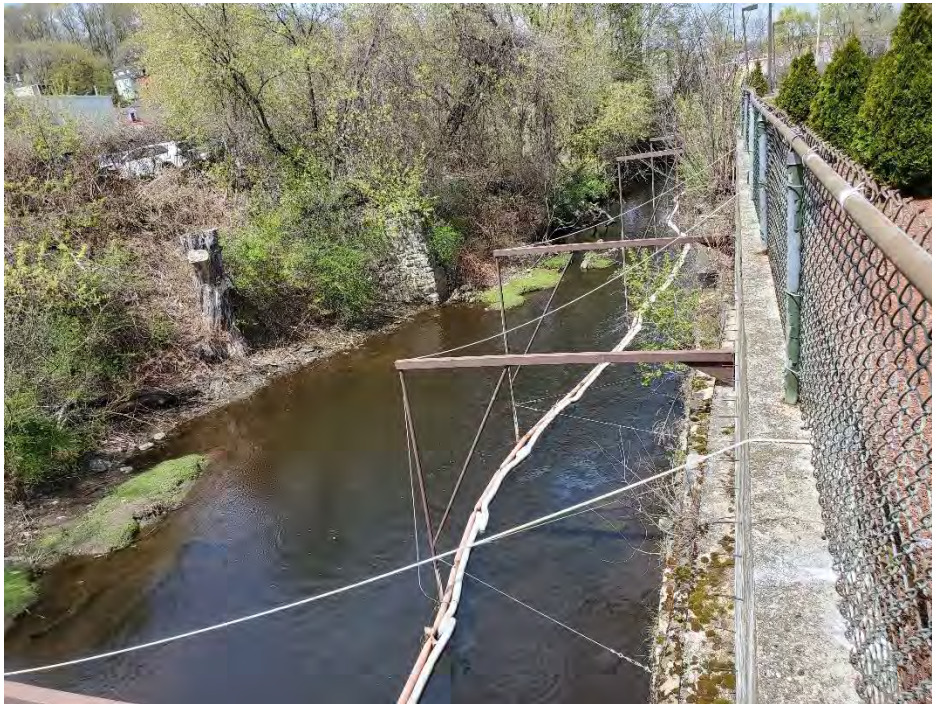
Figure 4. Little River and banks south of Winter Street. Looking northwest (upstream) near flag G702.

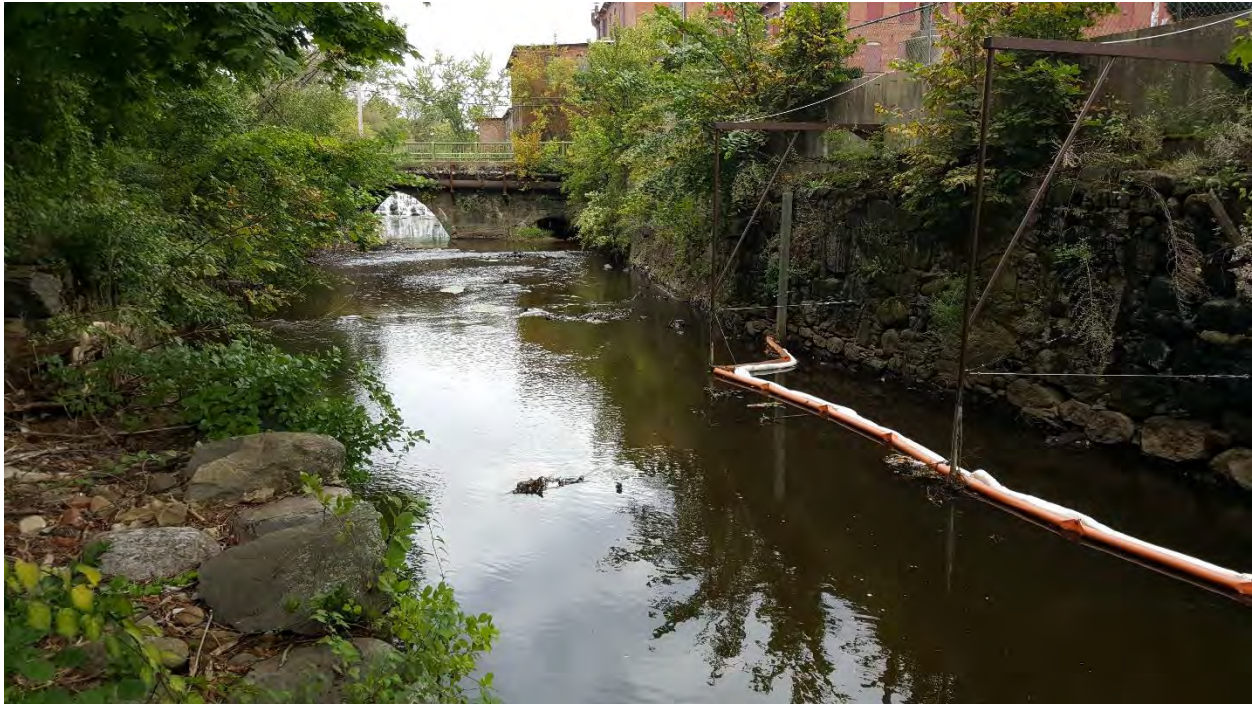
Figure 5. Little River and banks south of Winter Street, with the Winter Street bridge in background. Looking northwest (upstream) near flag A102.

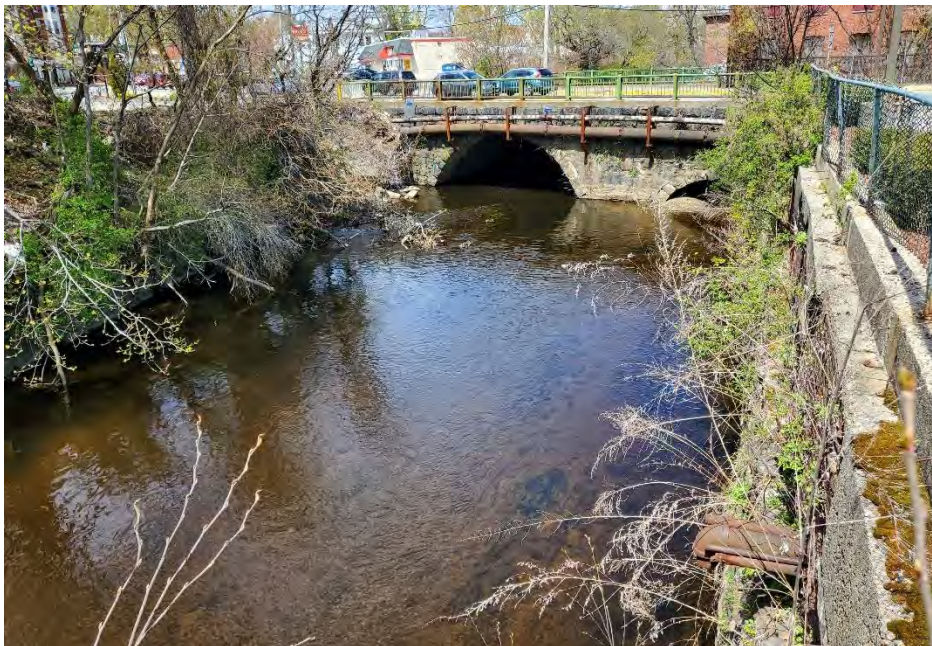
Figure 6. Little River and banks south of Winter Street, with the Winter Street bridge in background. Looking northwest (upstream) near flag G707.

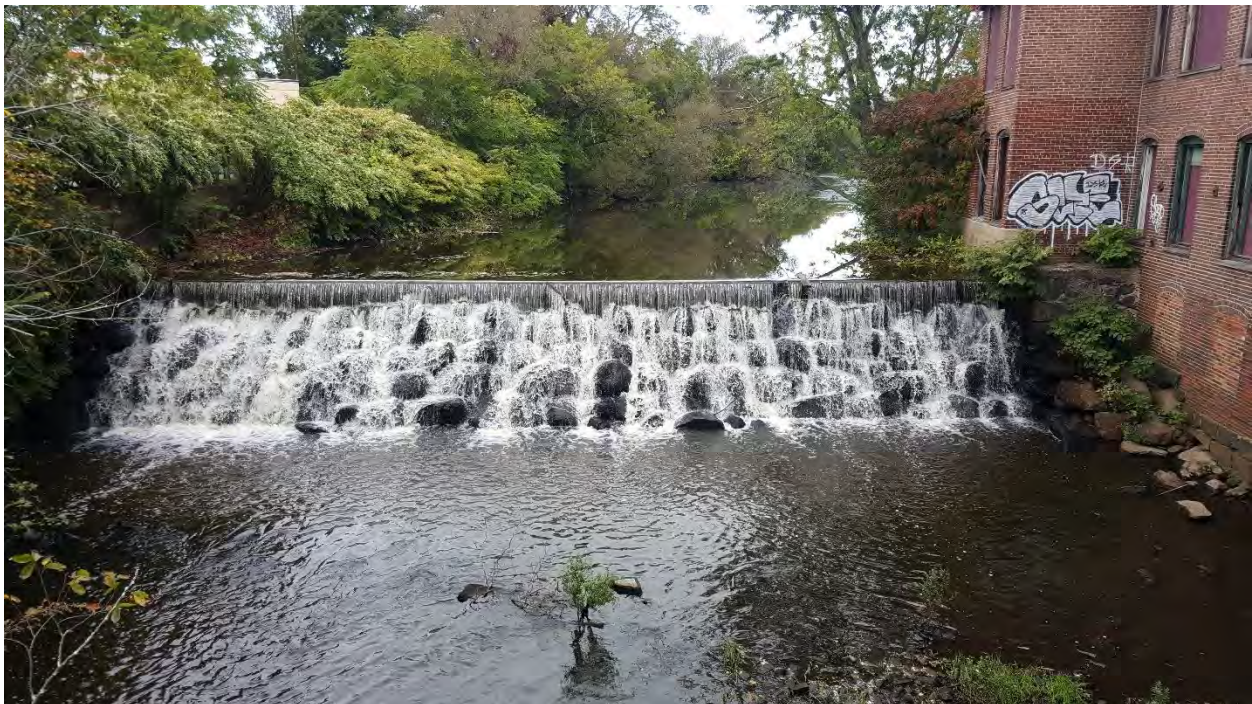
Figure 8. Spillway dam just upstream of Winter Street. Looking northwest (upstream) from the Winter Street bridge.

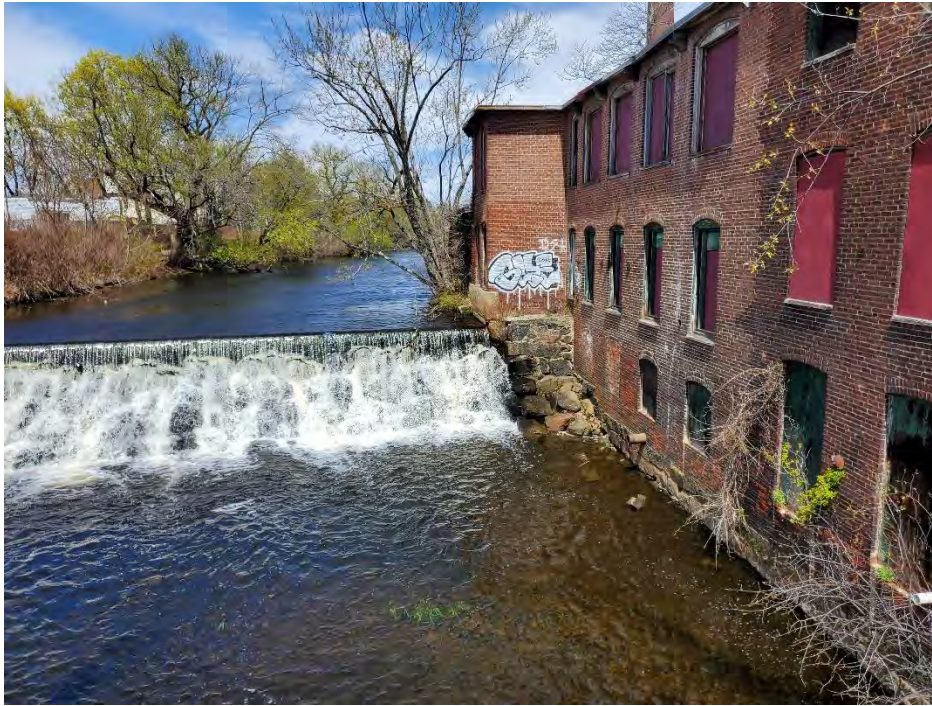
Figure 9. Spillway dam and eastern bank. Looking north (upstream) from the Winter Street bridge.

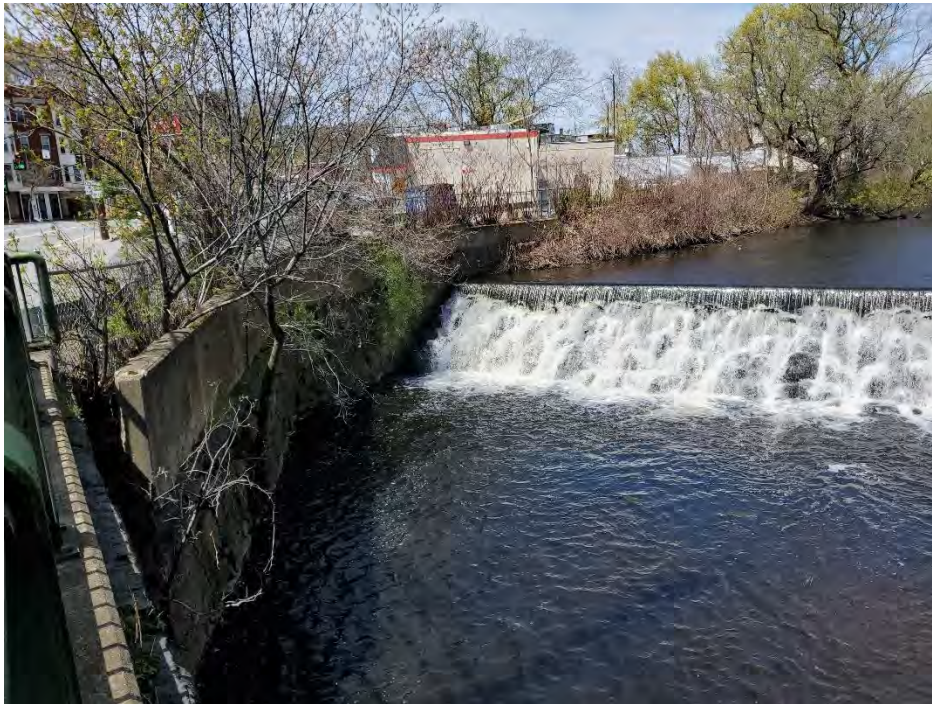
Figure 10. Spillway dam and western bank. Looking northwest (upstream) from the Winter Street bridge.

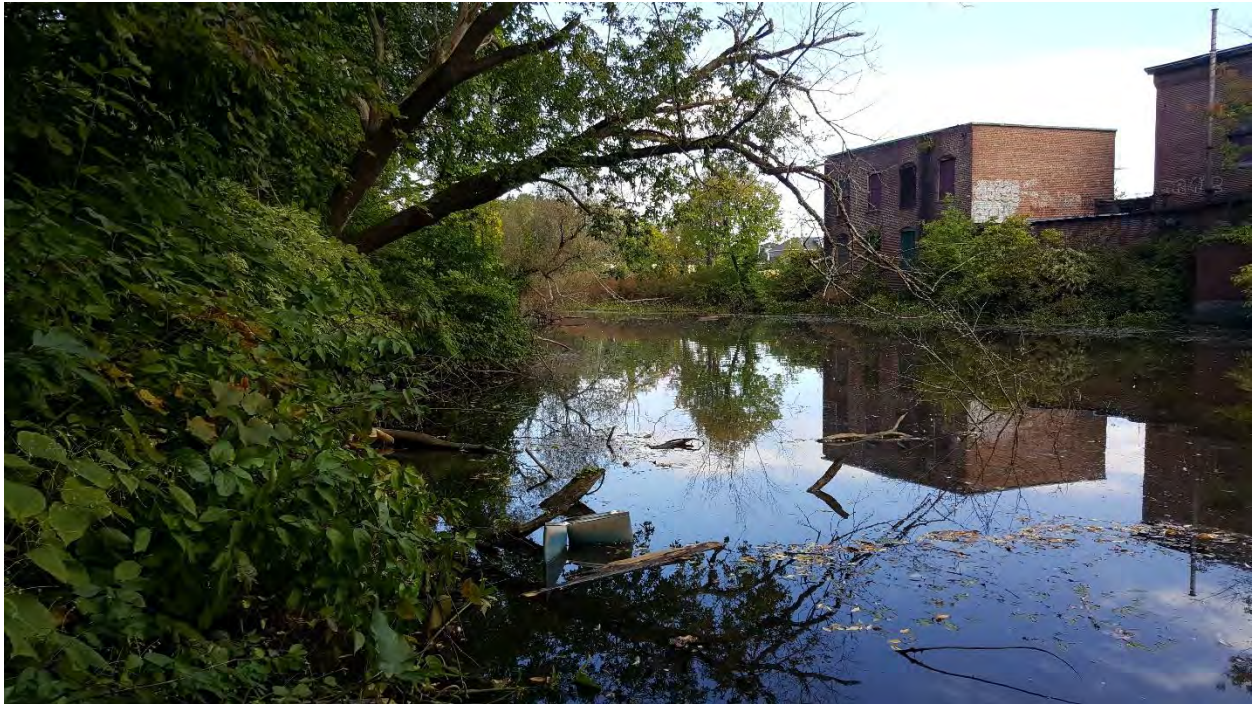
Figure 11. Little River, with old mill on eastern bank in the background. Looking north (upstream) near flag A113.

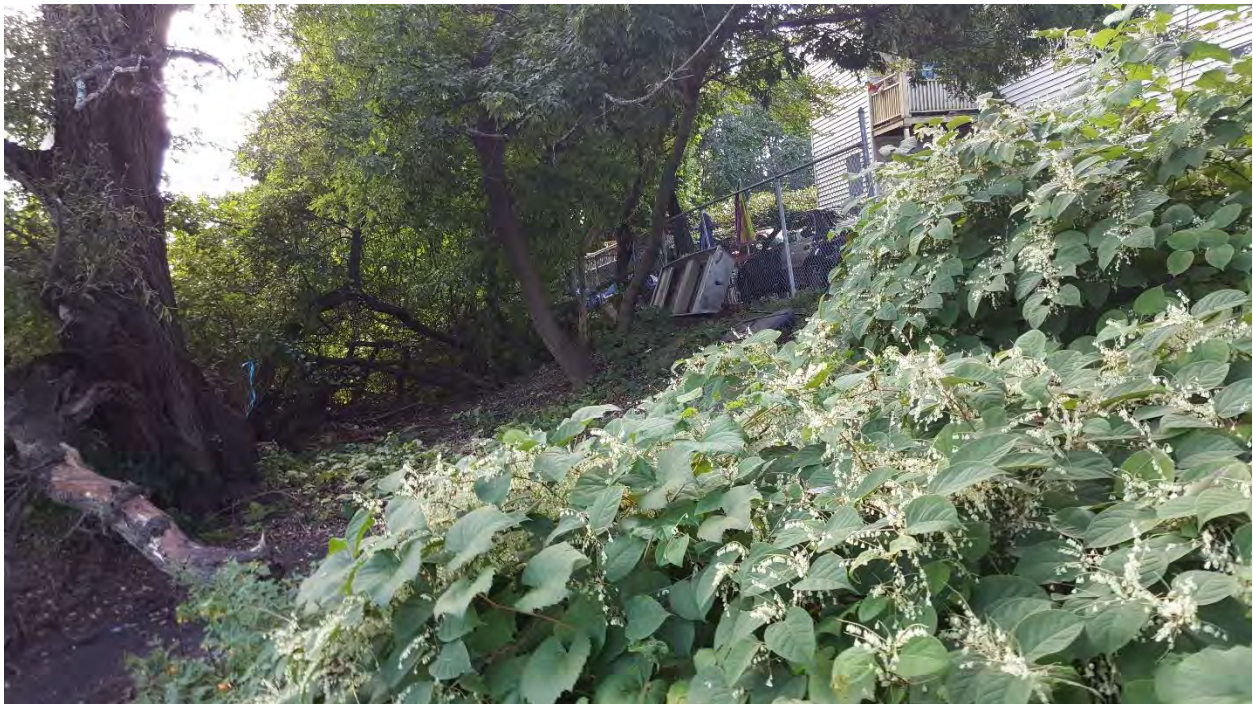
Figure 12. Typical conditions of the western bank and adjacent uplands. Looking south near flag A113.

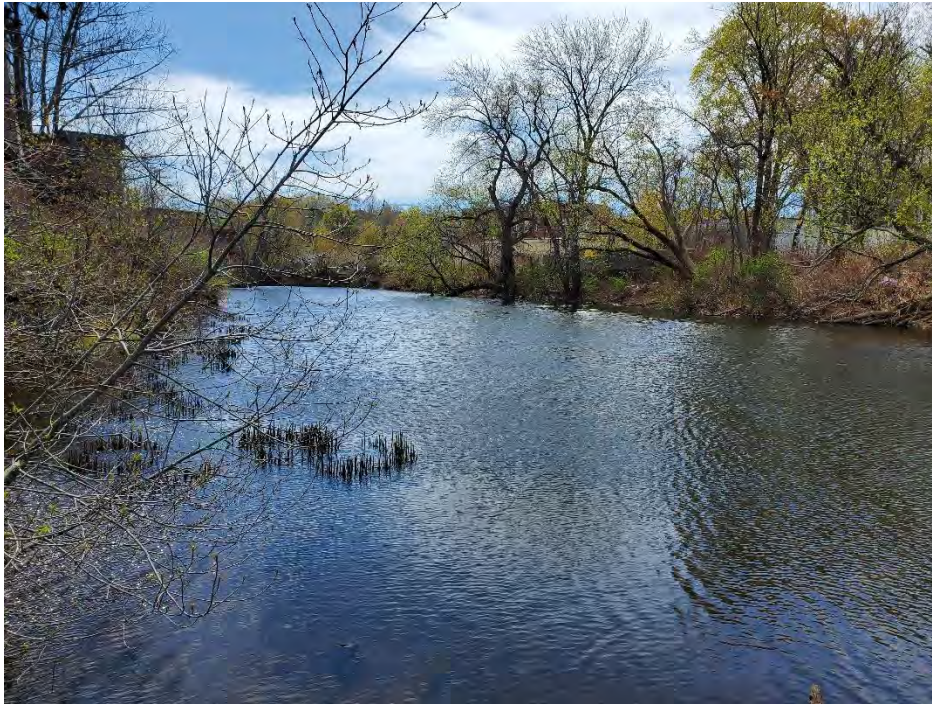
Figure 13. Little River and its western bank. The building visible at left is a portion of the old mill. Looking south (downstream) near flag G712.

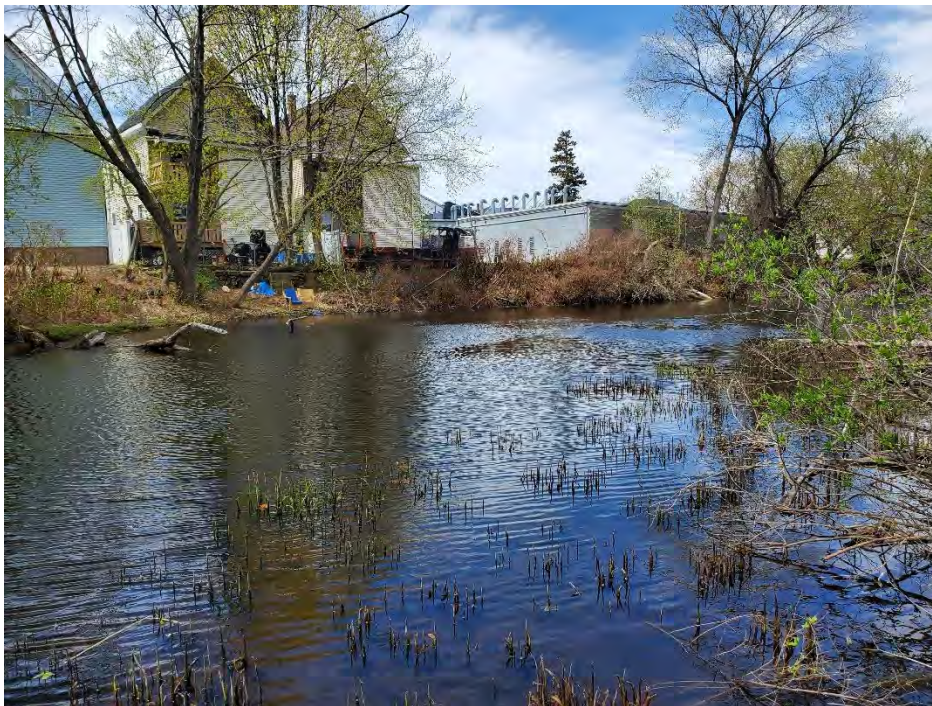
Figure 14. Little River and its western bank. Looking northwest (upstream) near flag G712.

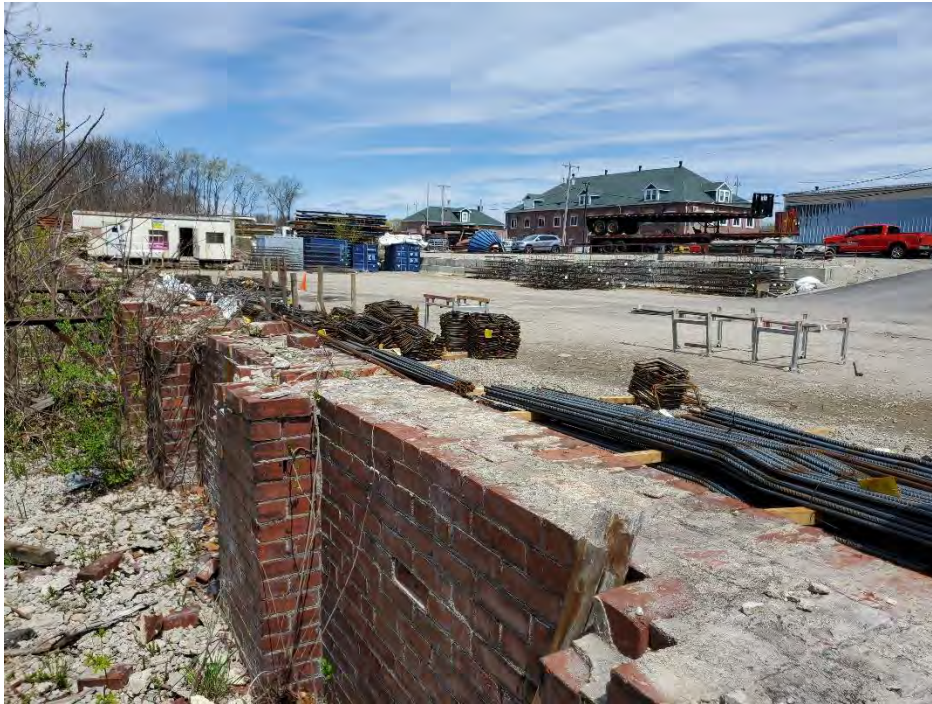
Figure 15. Urban development immediately east of Little River eastern bank, located north of the old mill off Stevens St. Looking north near flag G 714.

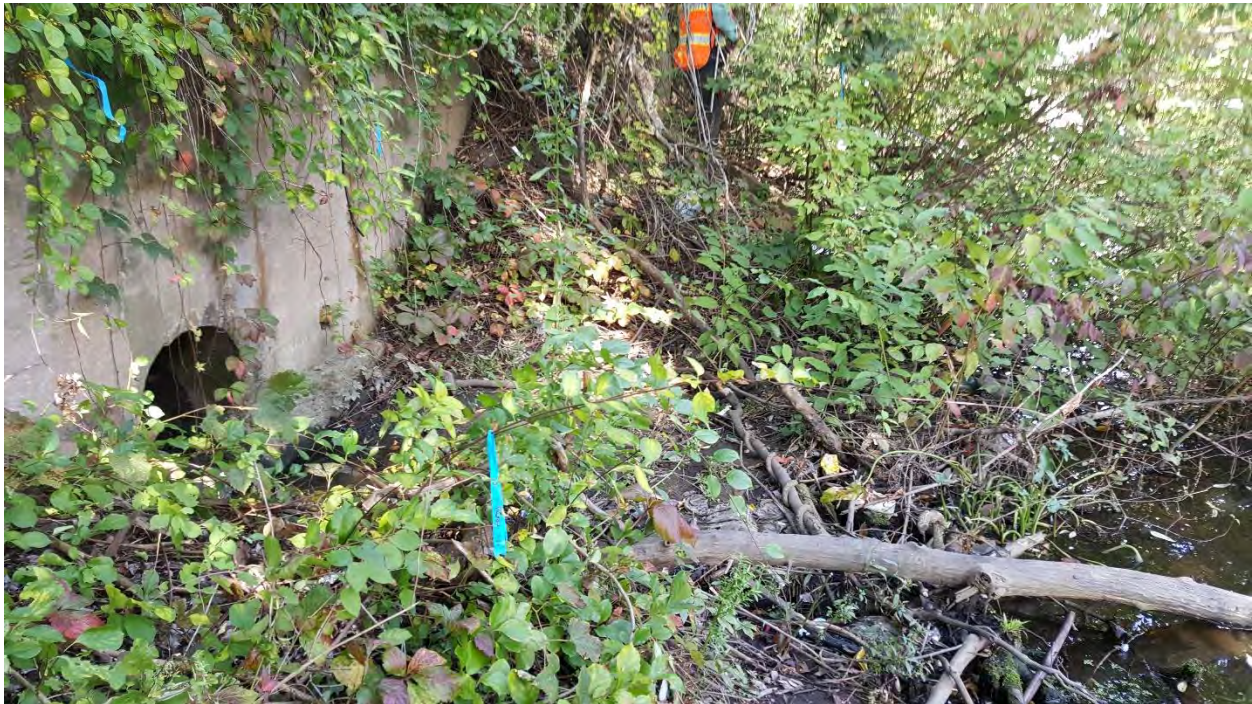
Figure 17. Stormwater outfall on the western bank. Looking northwest near flag A130.

The Site is located within the local drainage basin of Little River, a perennial stream that joins the Merrimack River approximately 1,800 feet downstream (to the southeast). Upstream of the site, the drainage area of Little River is nearly 27 square miles of land area (according to the USGS website StreamStats, <https://streamstats.usgs.gov/ss/>). Within the reach investigated, no tributaries to the Little River were observed or are mapped by Mass DEP. Stormwater outfalls were found along the east and west banks.

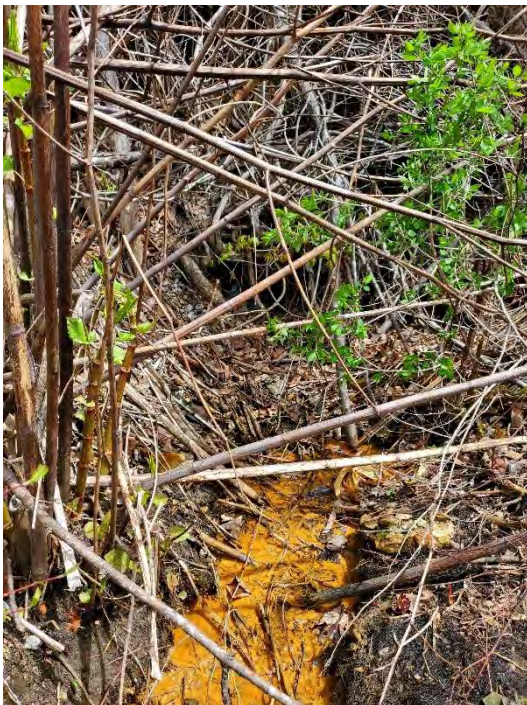
Figure 18. Stormwater outfall on the eastern bank.
Looking east near flag G728.

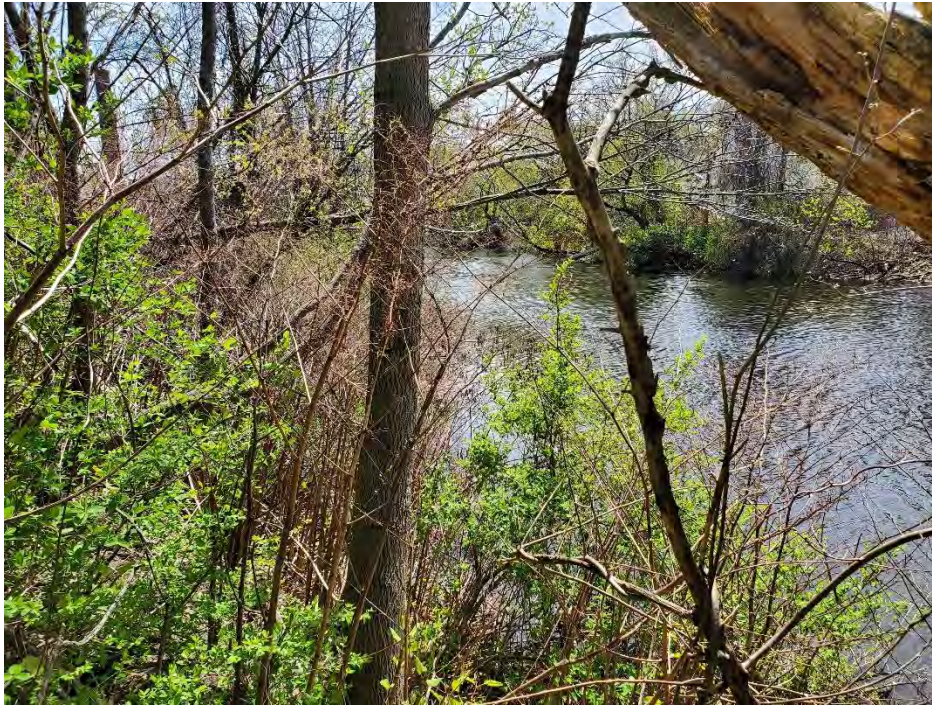
Figure 19. Little River and its western bank in the background. Looking southwest (downstream) near flag G731.

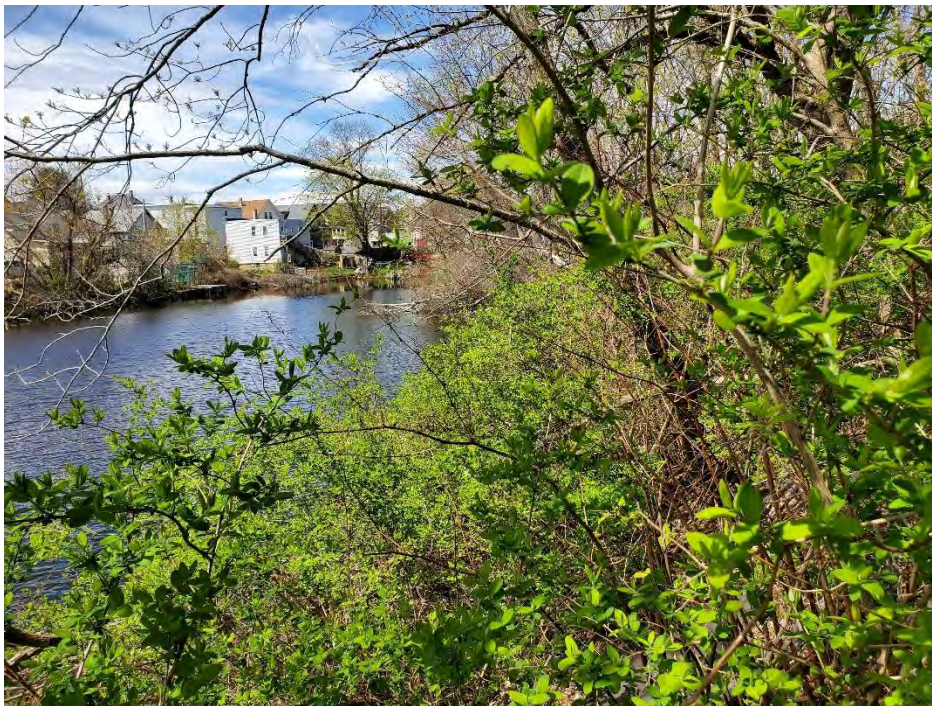
Figure 20. Little River and its western bank in the background. Looking northwest (upstream) near flag G731.

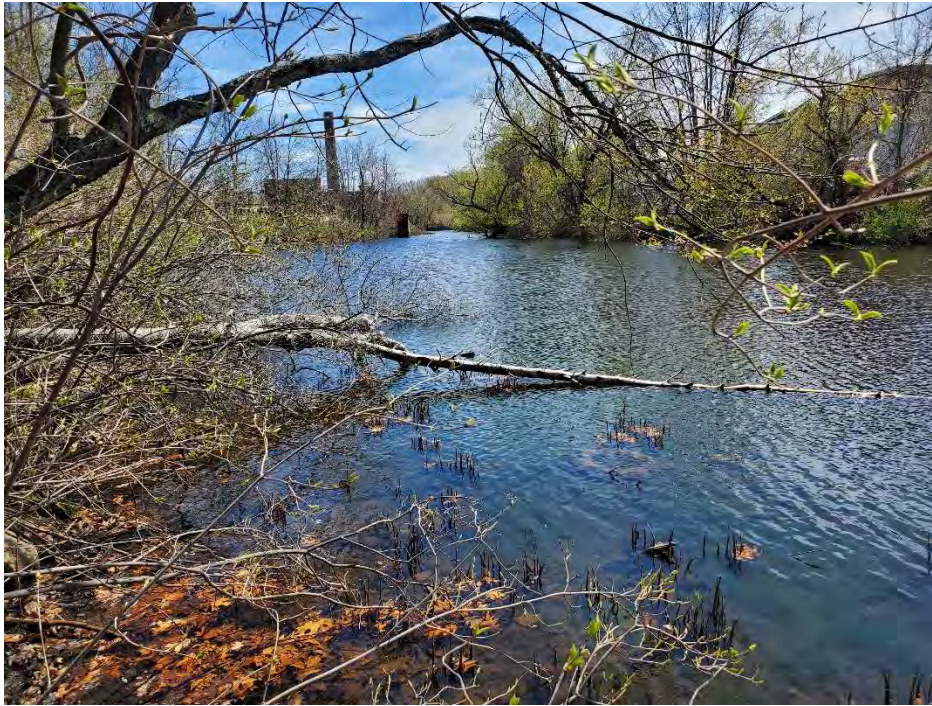
Figure 21. Little River and its eastern and western banks (left and right, respectively). Looking south (downstream) near flag G735.

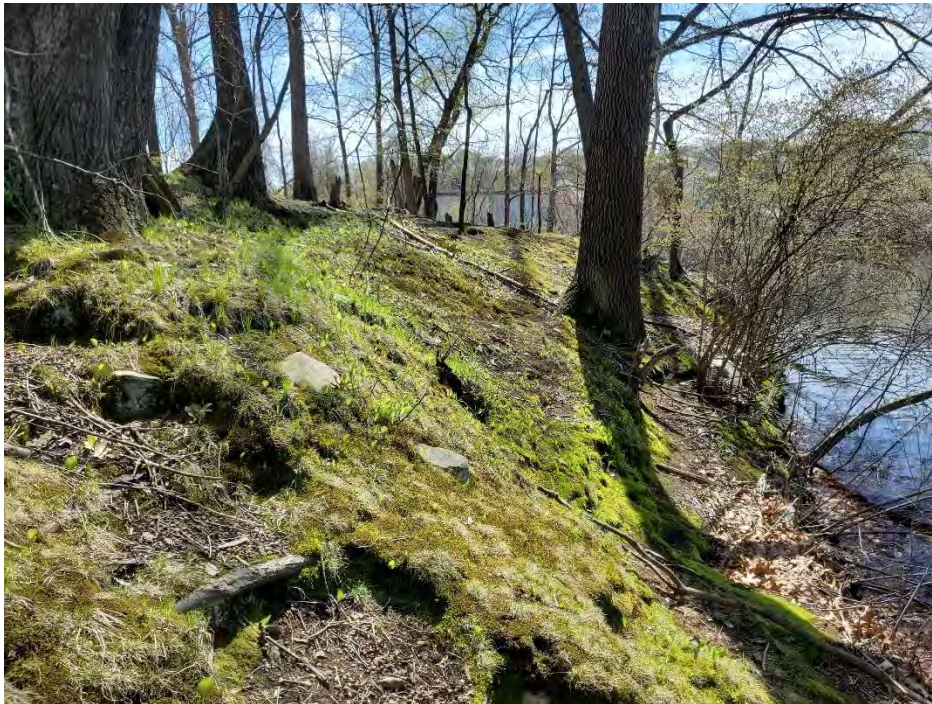
Figure 22. Little River and its western bank. Looking west-southwest (downstream) near flag G740.

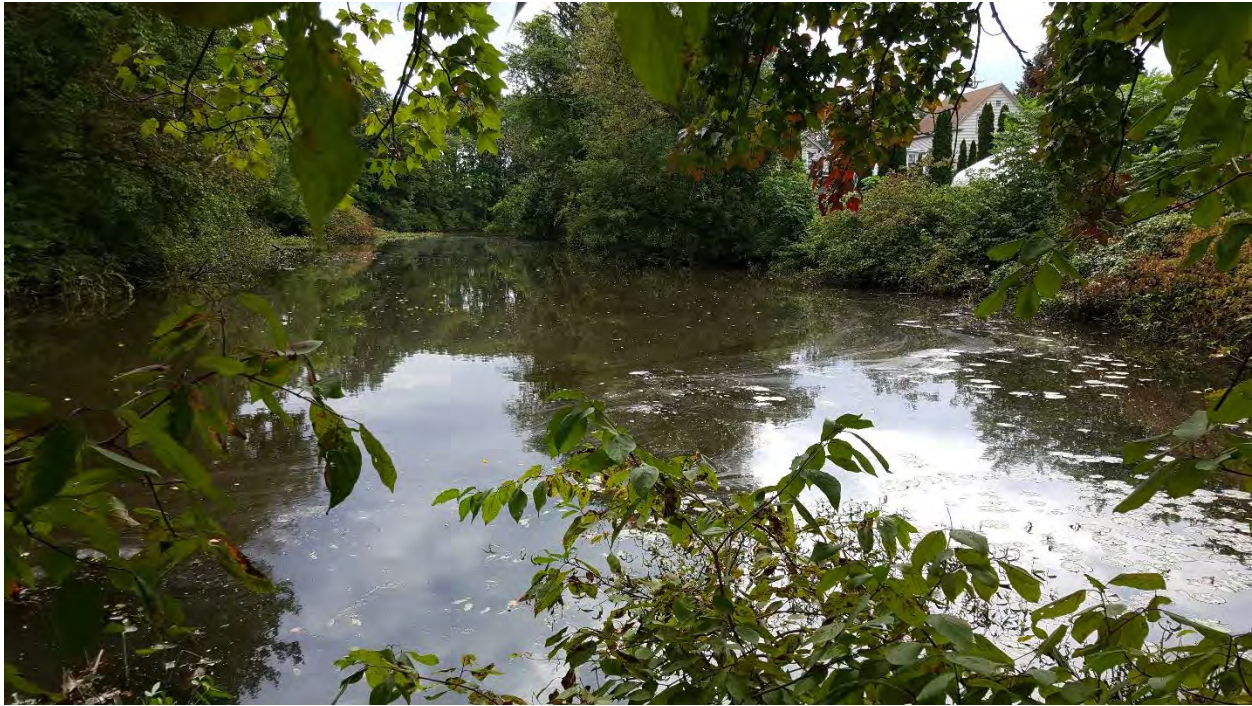
Figure 23. Little River and its eastern and western banks (left and right, respectively). Looking south (downstream) near flag A146.

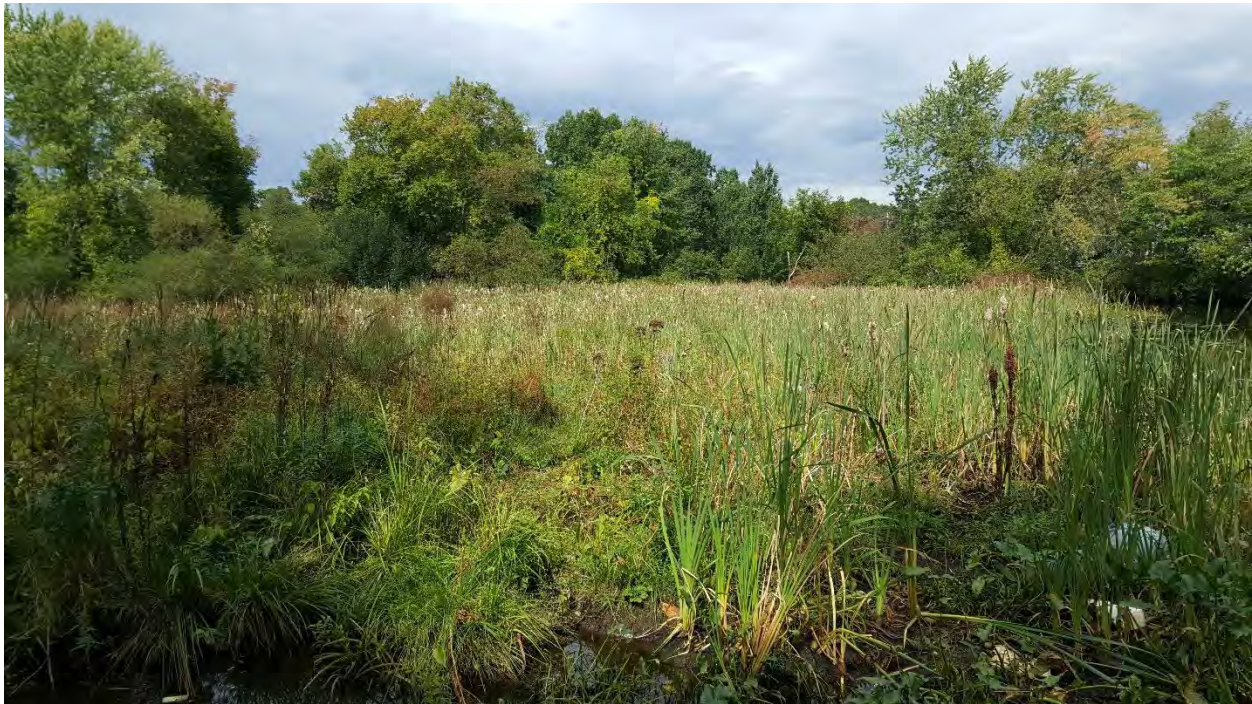
Figure 24. Emergent BVW along the western bank. Looking north-northwest near flag A149.

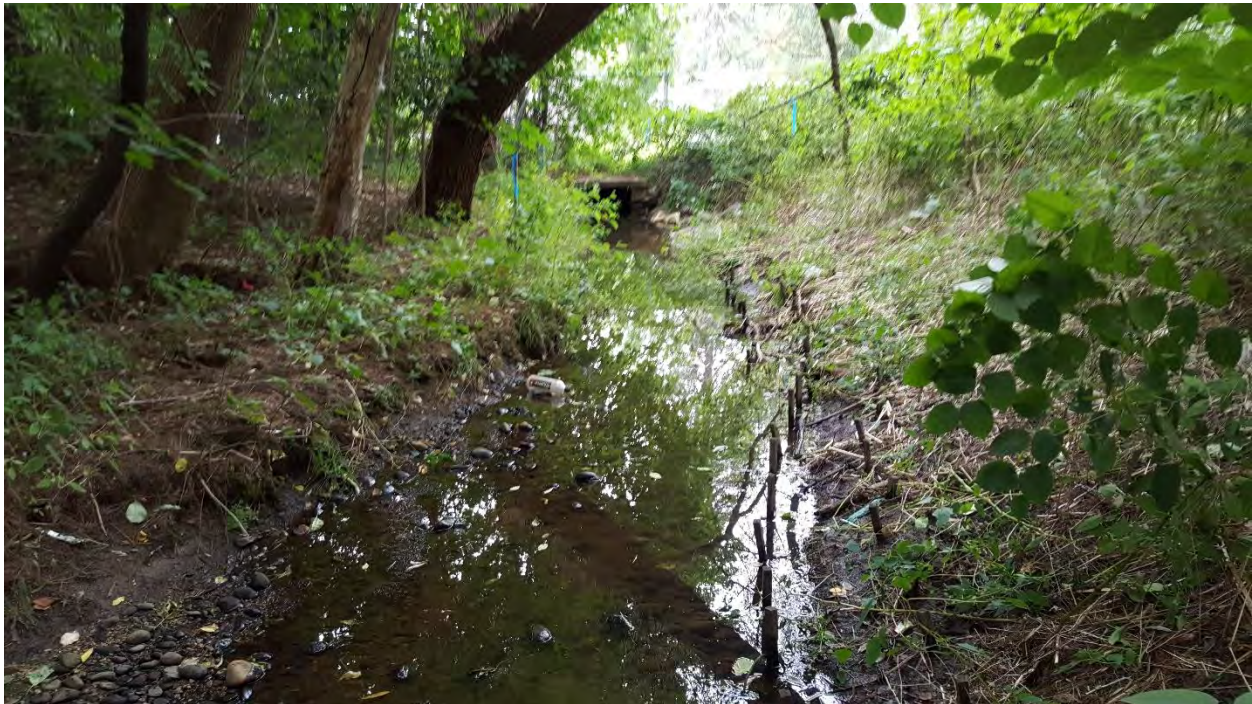
Figure 25. Drainage channel and culvert outlet (in background, flags A156 and A157) just south of undeveloped parcel (125 Hilldale Ave). Looking west-southwest near flag A159.

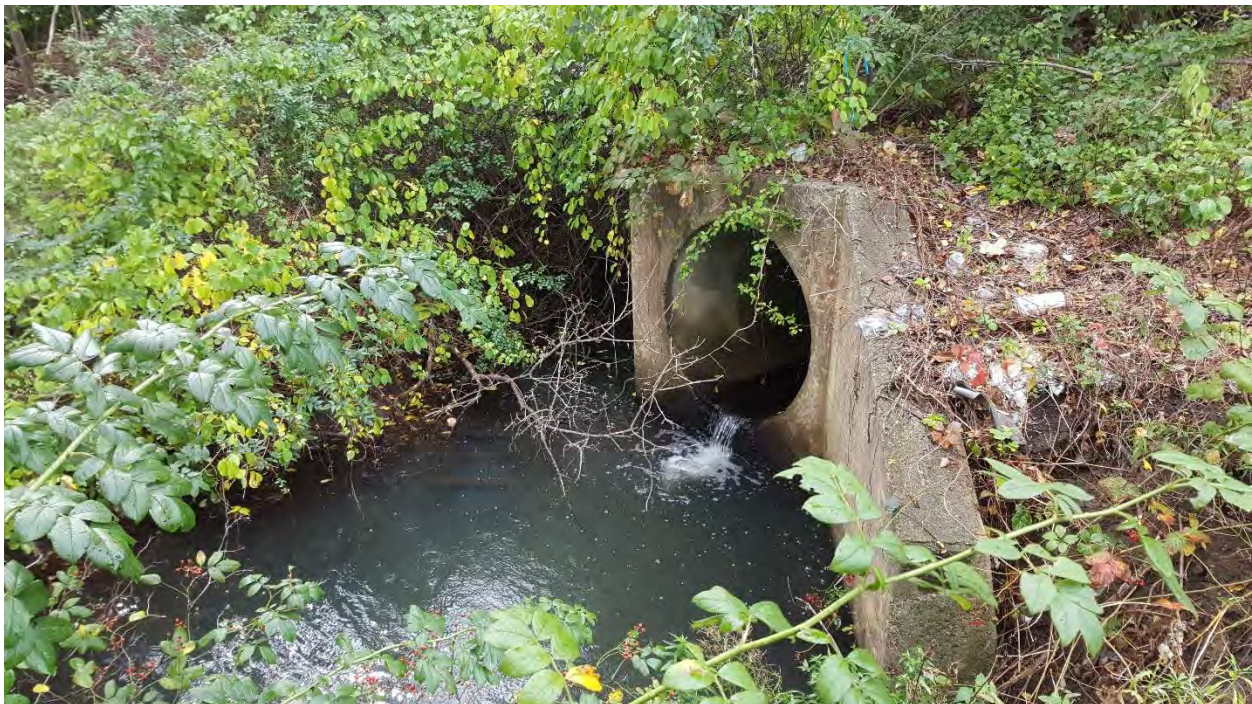
Figure 26. Outfall (flags A183 and A184) on the western bank just south of Cashmans Park. Looking southwest near flag A186.

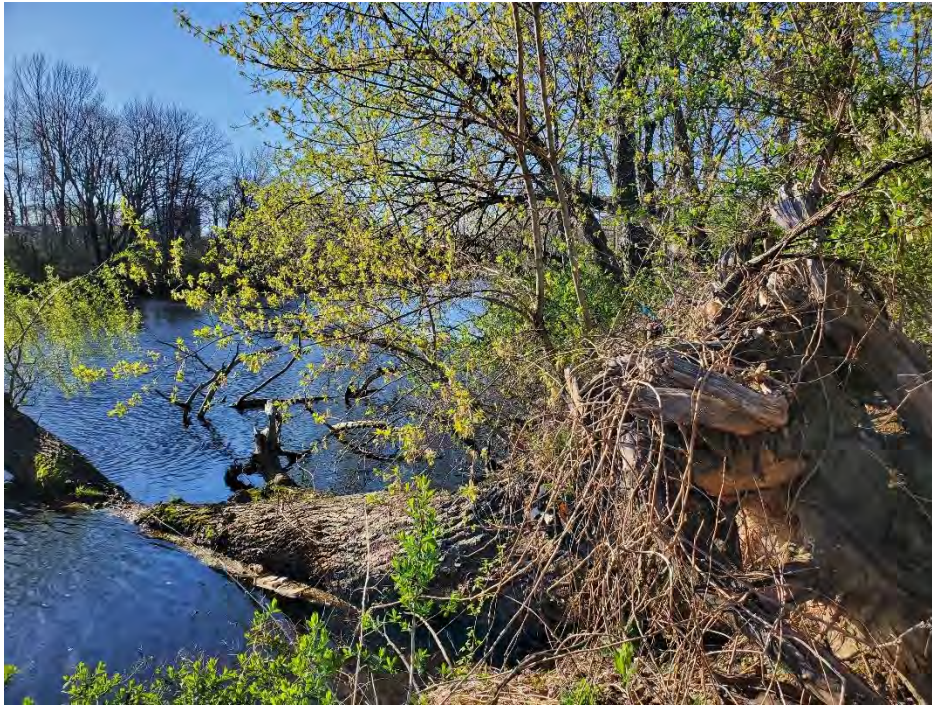
Figure 27. Little River from its western bank. Looking southeast (downstream) near flag A225.

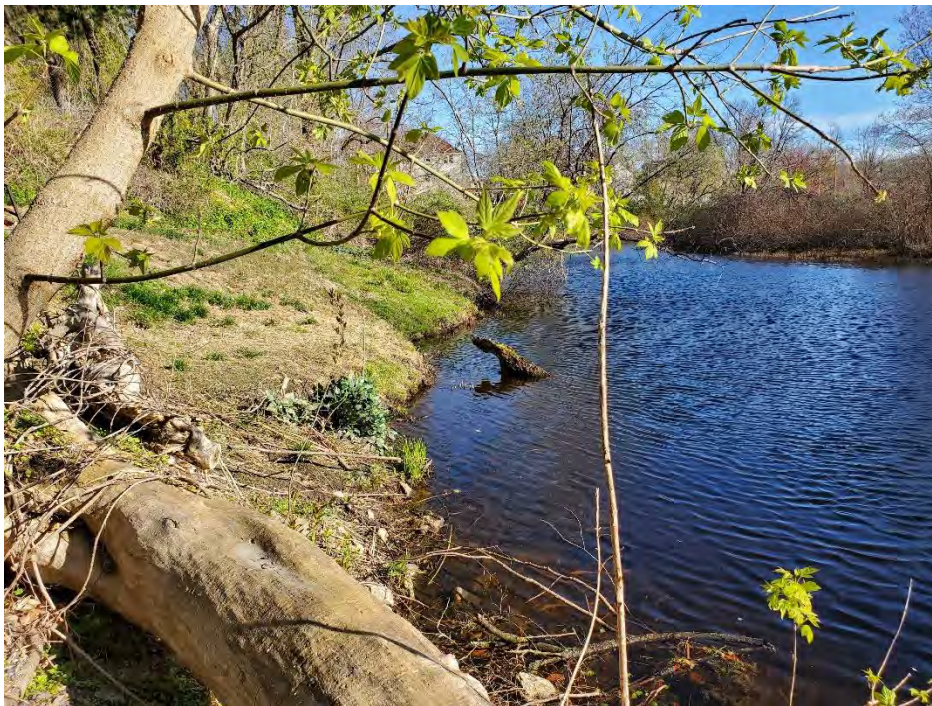
Figure 28. Little River, with its western bank at left and eastern bank in background at upper right. Looking north (upstream) near flag A227.

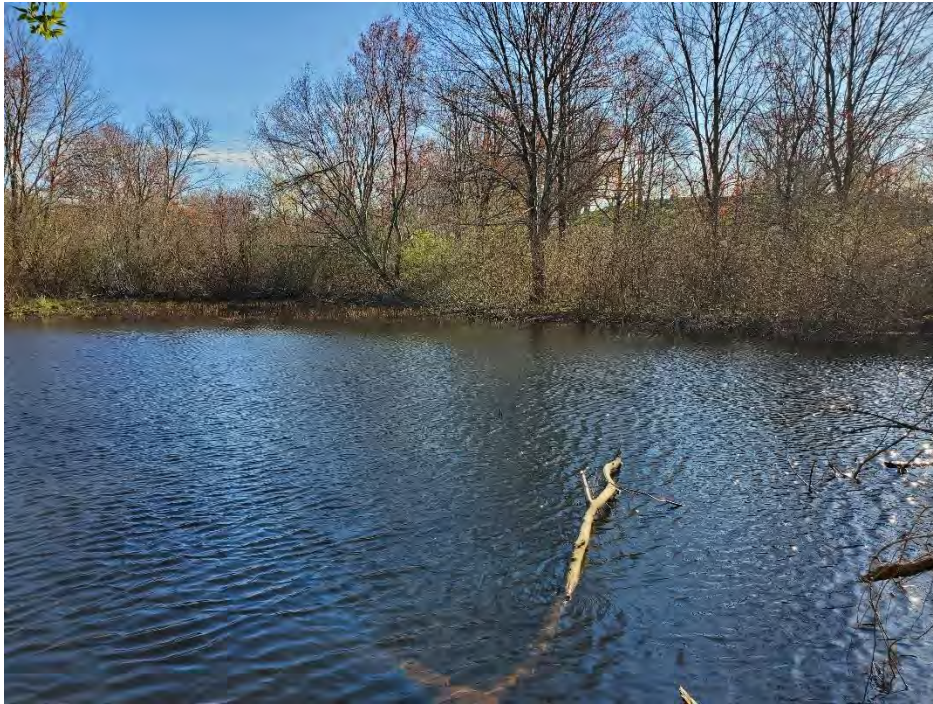
Figure 29. Little River from its eastern bank. Looking northeast toward the scrub-shrub BVW of 0.6± acres just south of the railroad bridge.

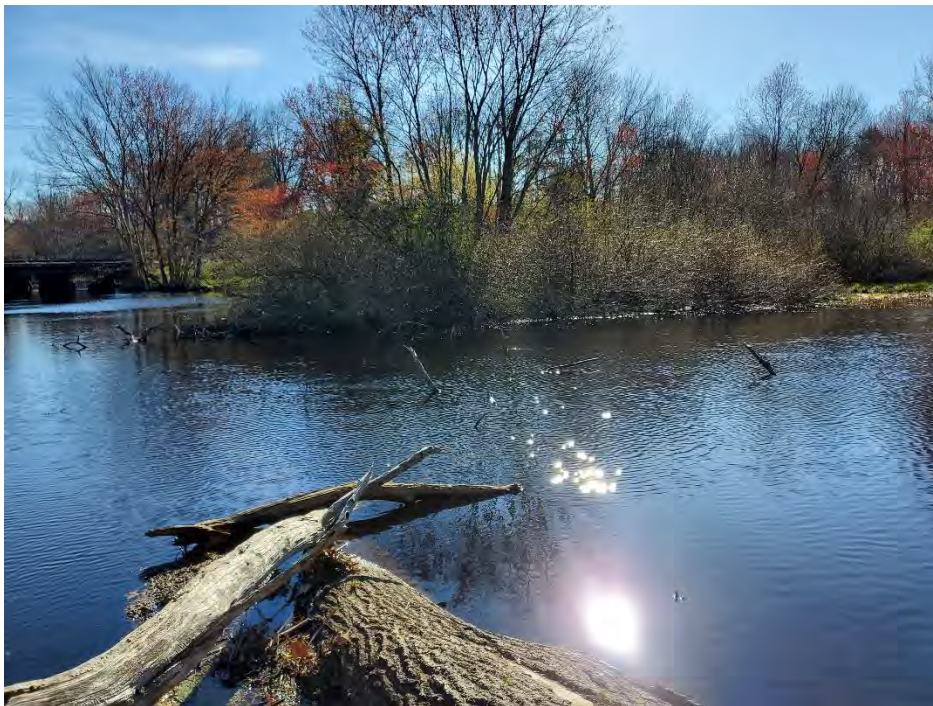
Figure 30. Little River from its eastern bank. Looking east toward the scrub-shrub BVW of 0.6± acres just south of the railroad bridge (at left).
