Massachusetts Inland Resource Area Delineation Report

Project number: 20171390.U30

Site Address/Location: Little River, between Essex Street and Greenhill Farm Road
42.782623706 N, 71.09047162 W

Inspection Date: September 27, 2021 and April 29, 2022

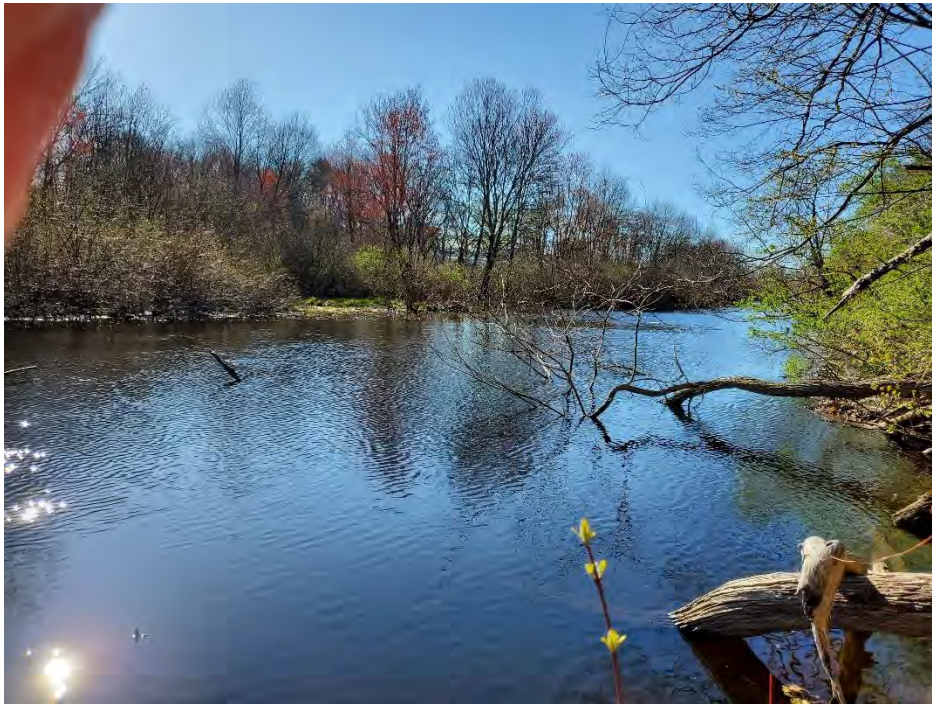
Figure 32. Little River and its eastern and western banks (left and right, respectively) downstream of the railroad bridge. Looking south (downstream) near flag A235.

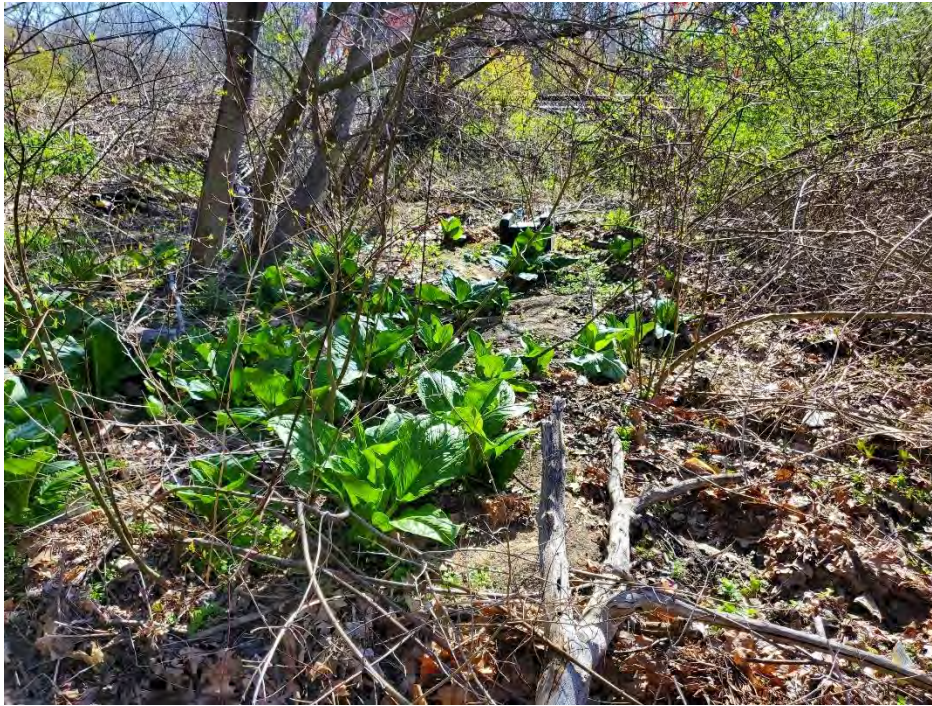
Figure 33. Scrub-shrub BVW (flag series F600-F607) on the western bank, just downstream of the railroad bridge. Looking east near flag F605.

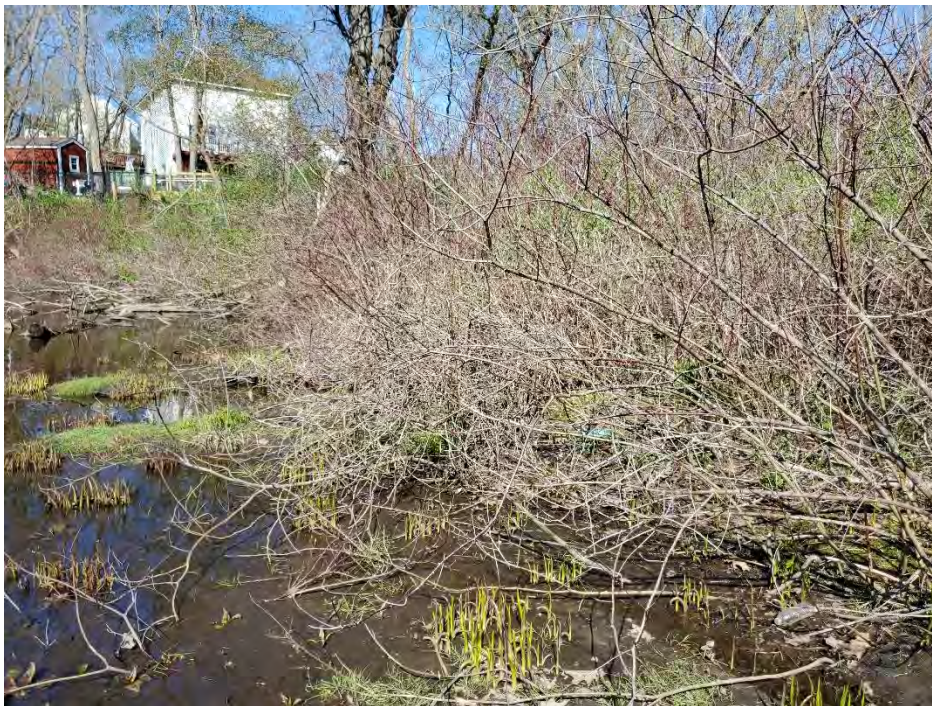
Figure 34. Scrub-shrub BVW (flag series F600-F607) on the western bank, just downstream of the railroad bridge. Looking west near flag A242, with Little River at left.

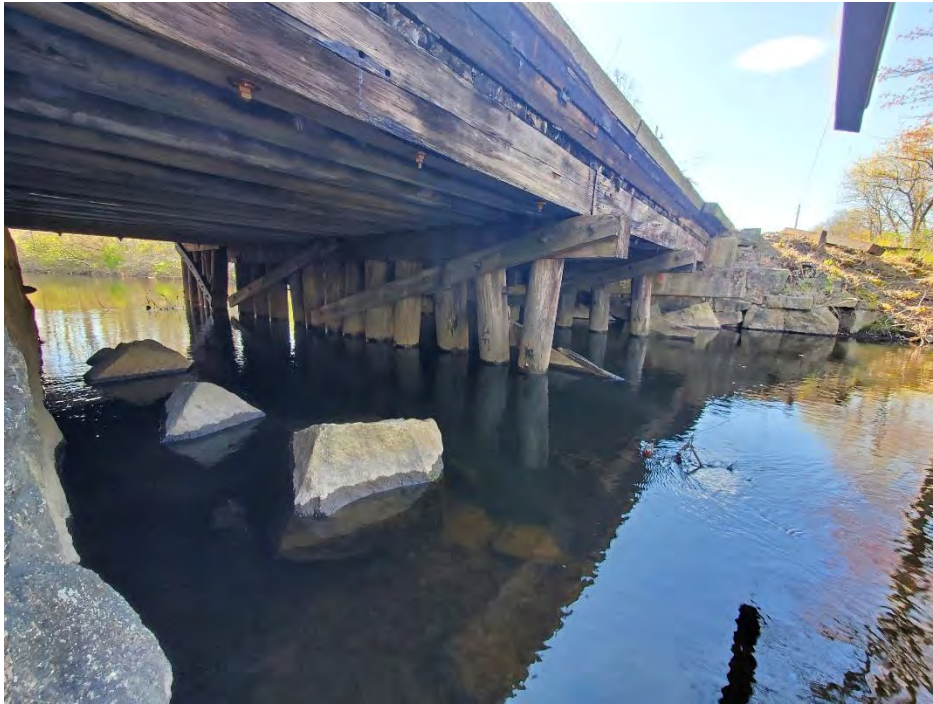
Figure 35. Little River at the railroad bridge. Looking southeast near flag A246.

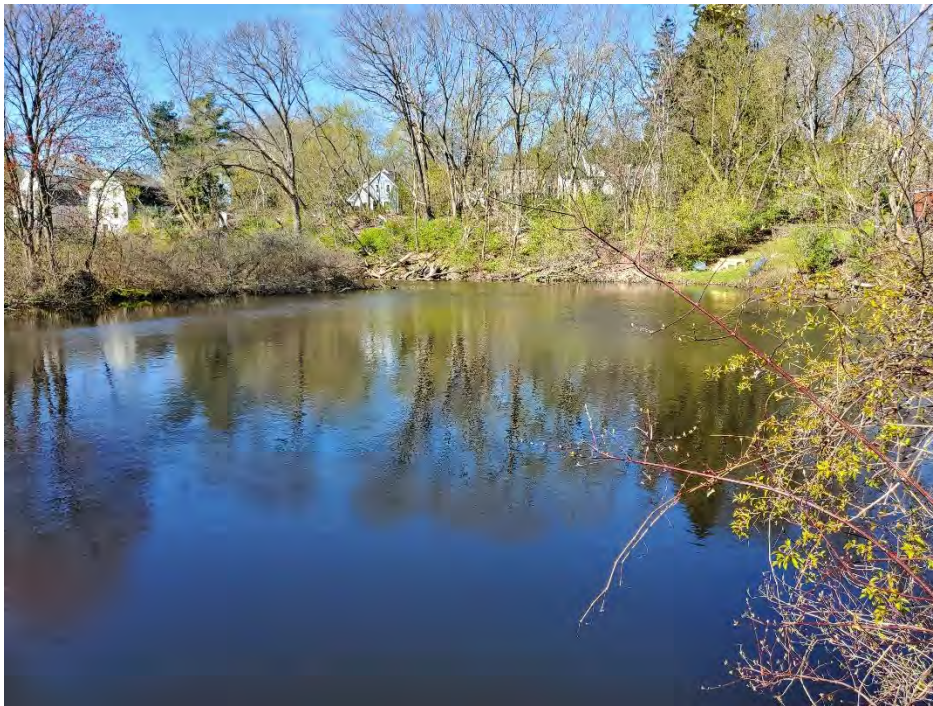
Figure 36. Little River and its eastern and western banks (left and right, respectively), Immediately downstream of the railroad bridge. Looking southwest (downstream) near flag A246.
