Subject: City of Haverhill, MA NPDES Permit #MA 0101621
Consent Decree Submittal (Civil Action No. 16-11698-IT)
Compliance Report Number 10 – January 1, 2021 through June 30, 2021

CITY OF HAVERHILL, MASSACHUSETTS

COMPLIANCE REPORT No. 10

JANUARY THROUGH JUNE 2021

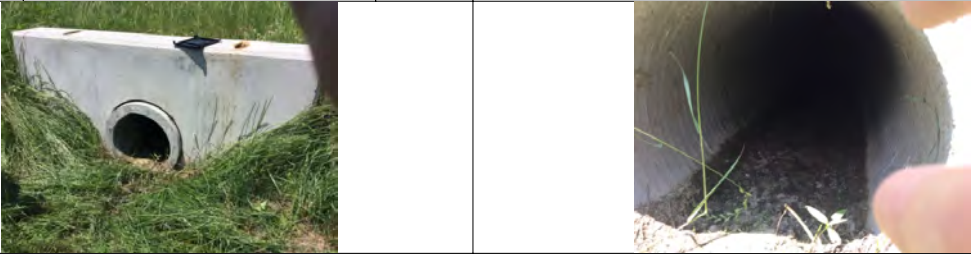
Haverhill IDDE Inspection Form Outfall

SECTION 2: OUTFALL PIPE ASSET DESCRIPTION									
Location	Upstream Asset ID	Material		Shape		Diameter/Dimension (in.)		Submerged	
Outfall Pipe		Reinforced Concrete		Circle		18		In Water:	No
								With Sediment:	No
SECTION 3: OUTFALL PIPE PHYSICAL INDICATORS									
Indicator		Indicator Present?		Indicator Description					
Asset Damage		None							
Deposits/Stains		None							
Pool Quality		None							
Pipe Algae/Growth		None							
*Do physical indicators suggest an illicit discharge is present (Y/N):									
Is Inlet Pipe No.1 Flowing?								Estimated GPM:	
Comments :									
Signature of Inspector :
