CITY OF HAVERHILL, MASSACHUSETTS NPDES PERMIT No. MA0101621 CONSENT DECREE (Civil Action No. 16-11698-IT, 11/10/16)

COMPLIANCE REPORT No. 4 JANUARY THROUGH JUNE 2018

OCTOBER 2018

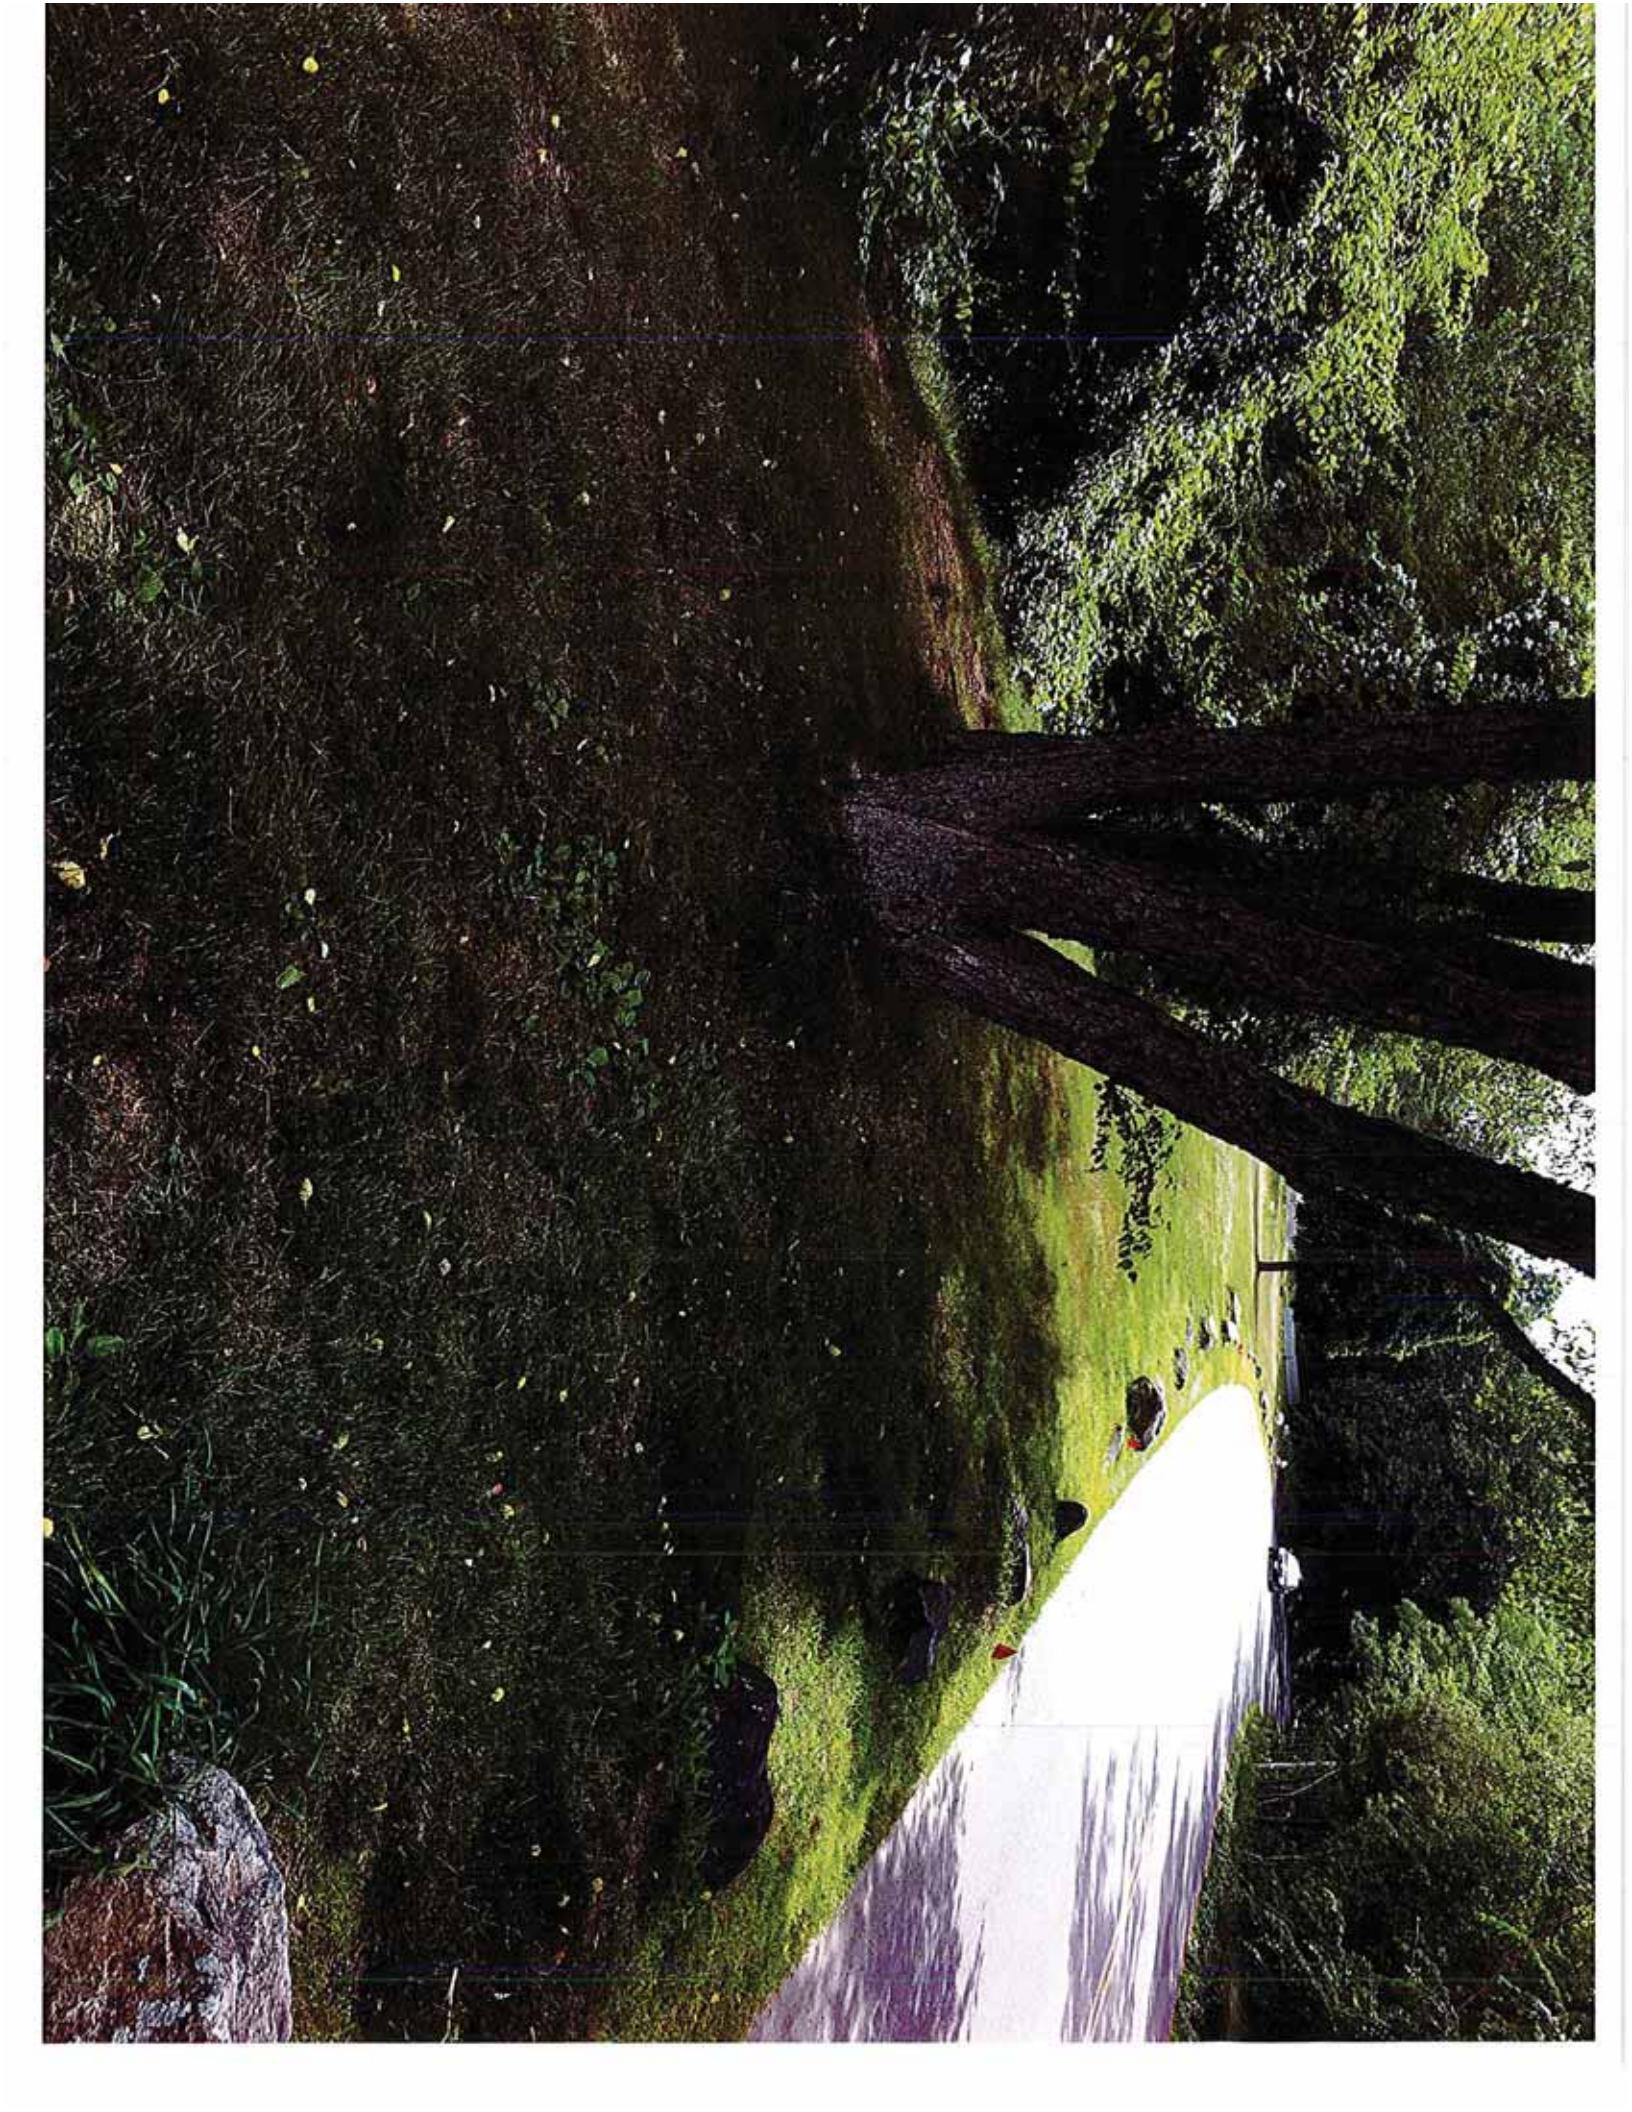
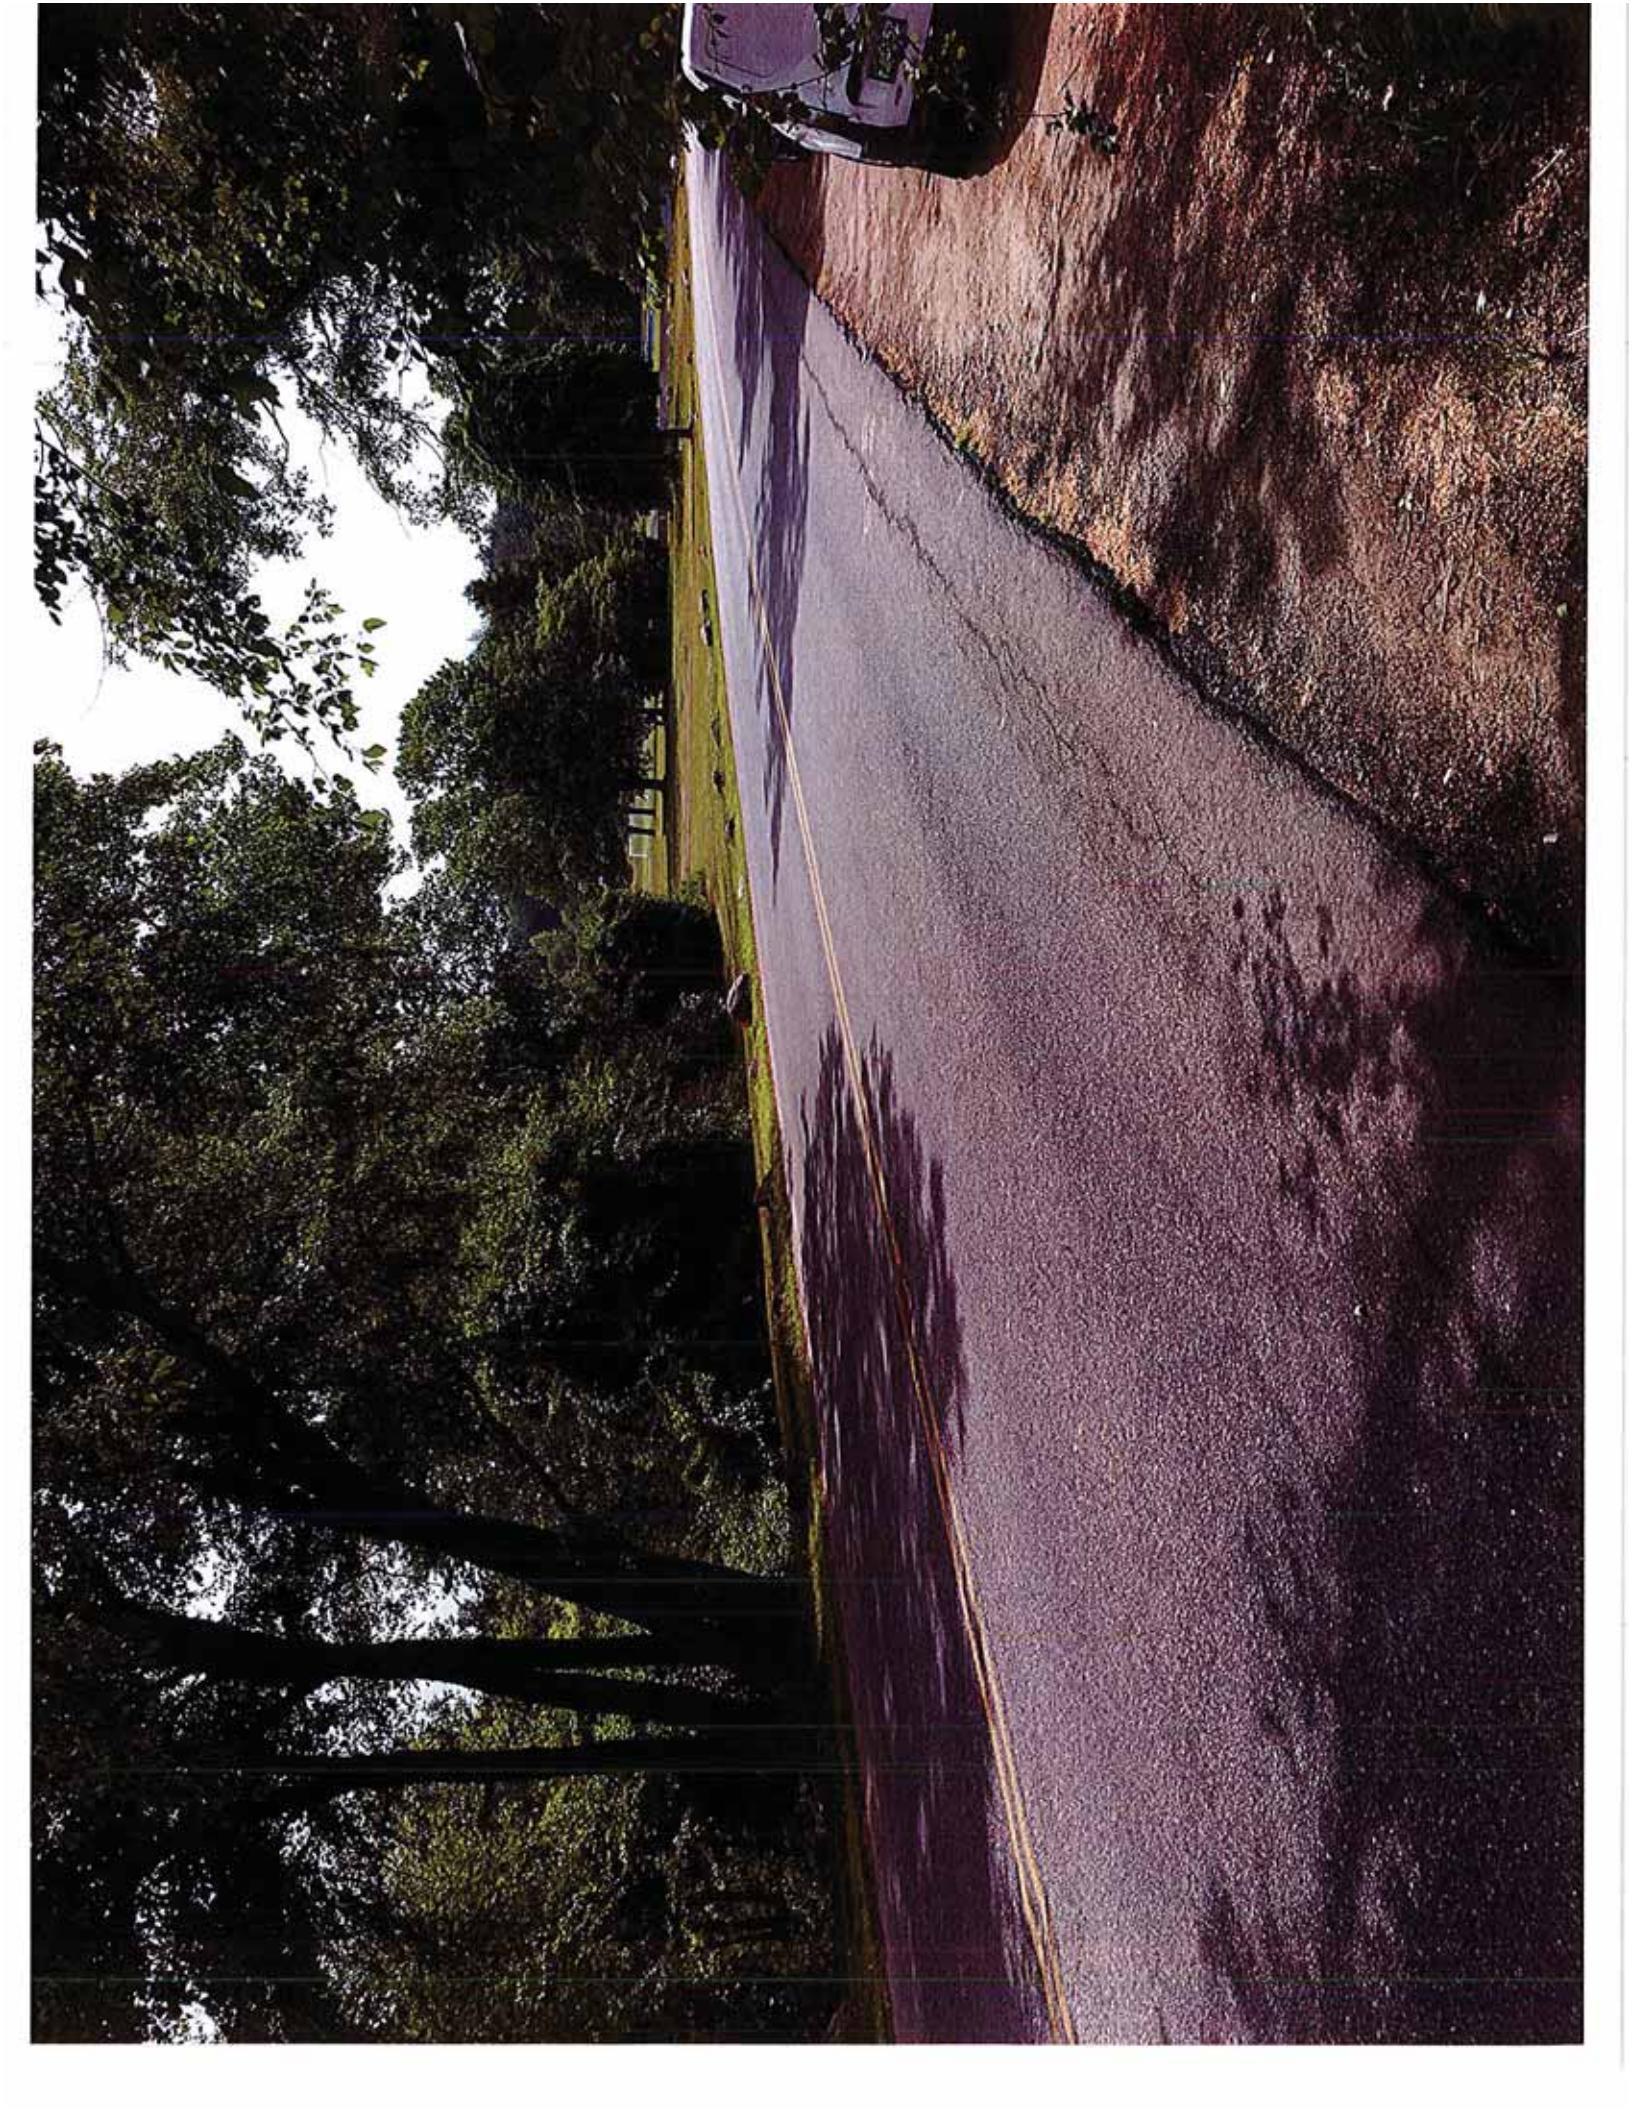
Sub Type 0		ID KL1227	
Description Kenoza Street		Permit	
CRO	DSS COUNTRY	Cross Street	
Location Ref.	Map ID 10374	Map Sheet	
Notes		Recommendations	
Could not locate or	utfall.No signs of drainage system (DMHs, CE	Find outfall

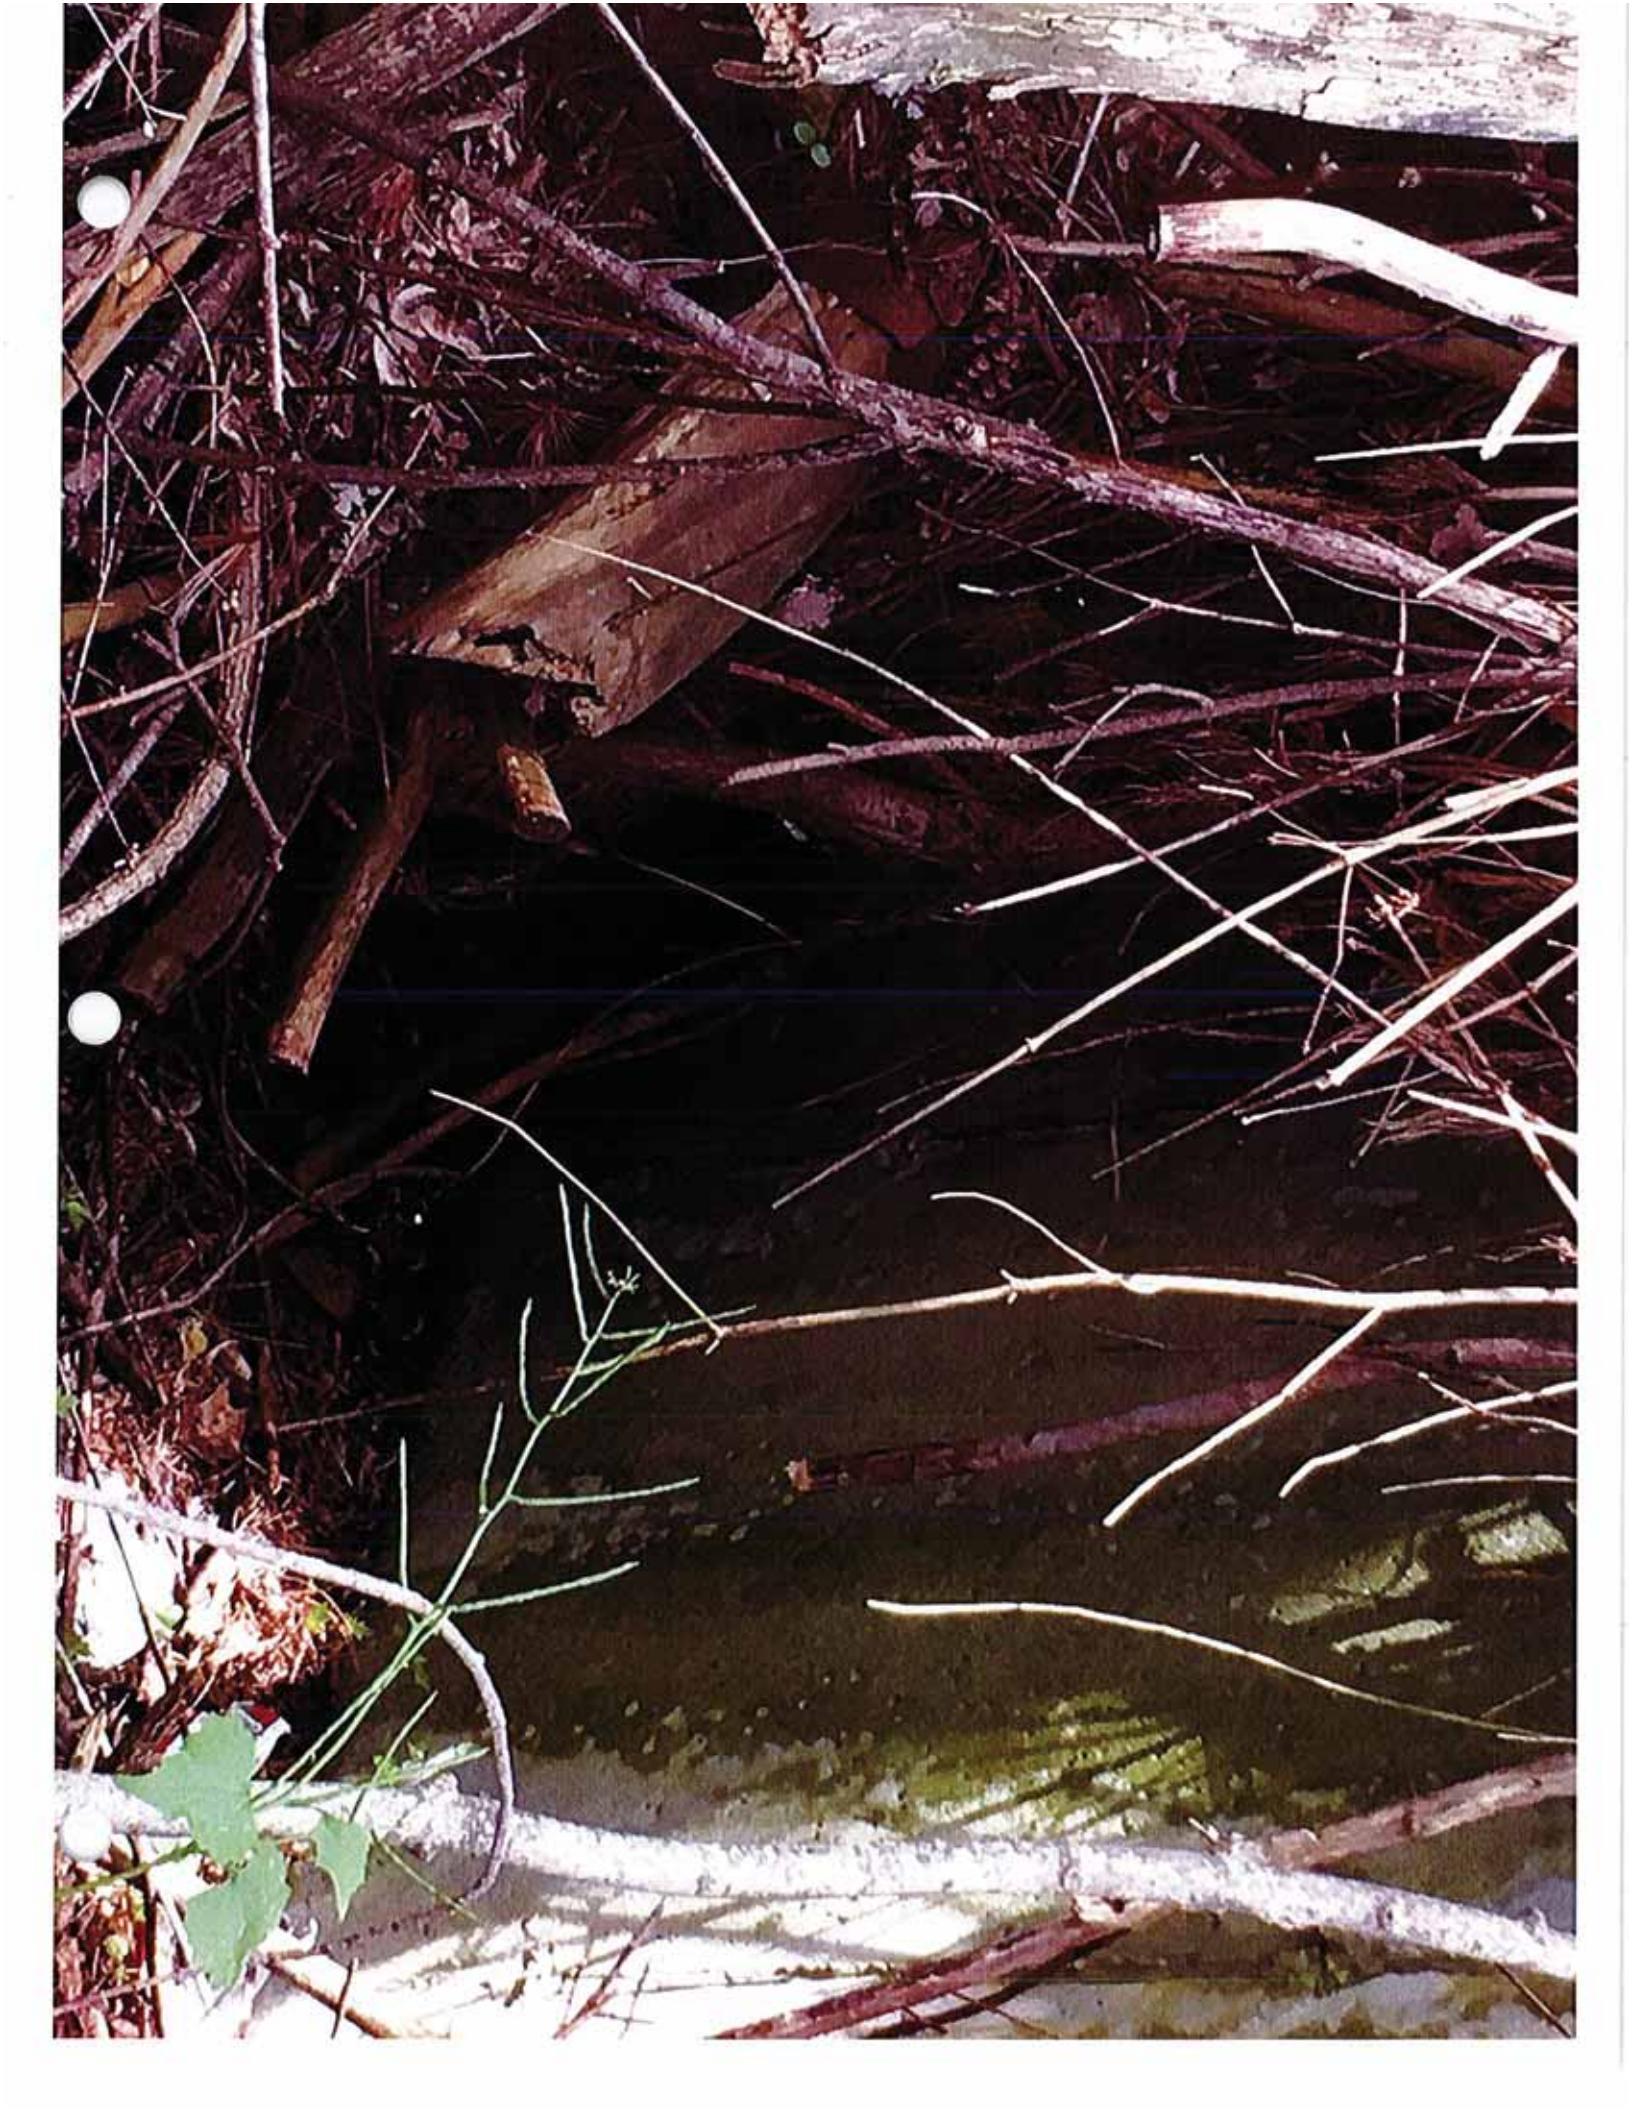
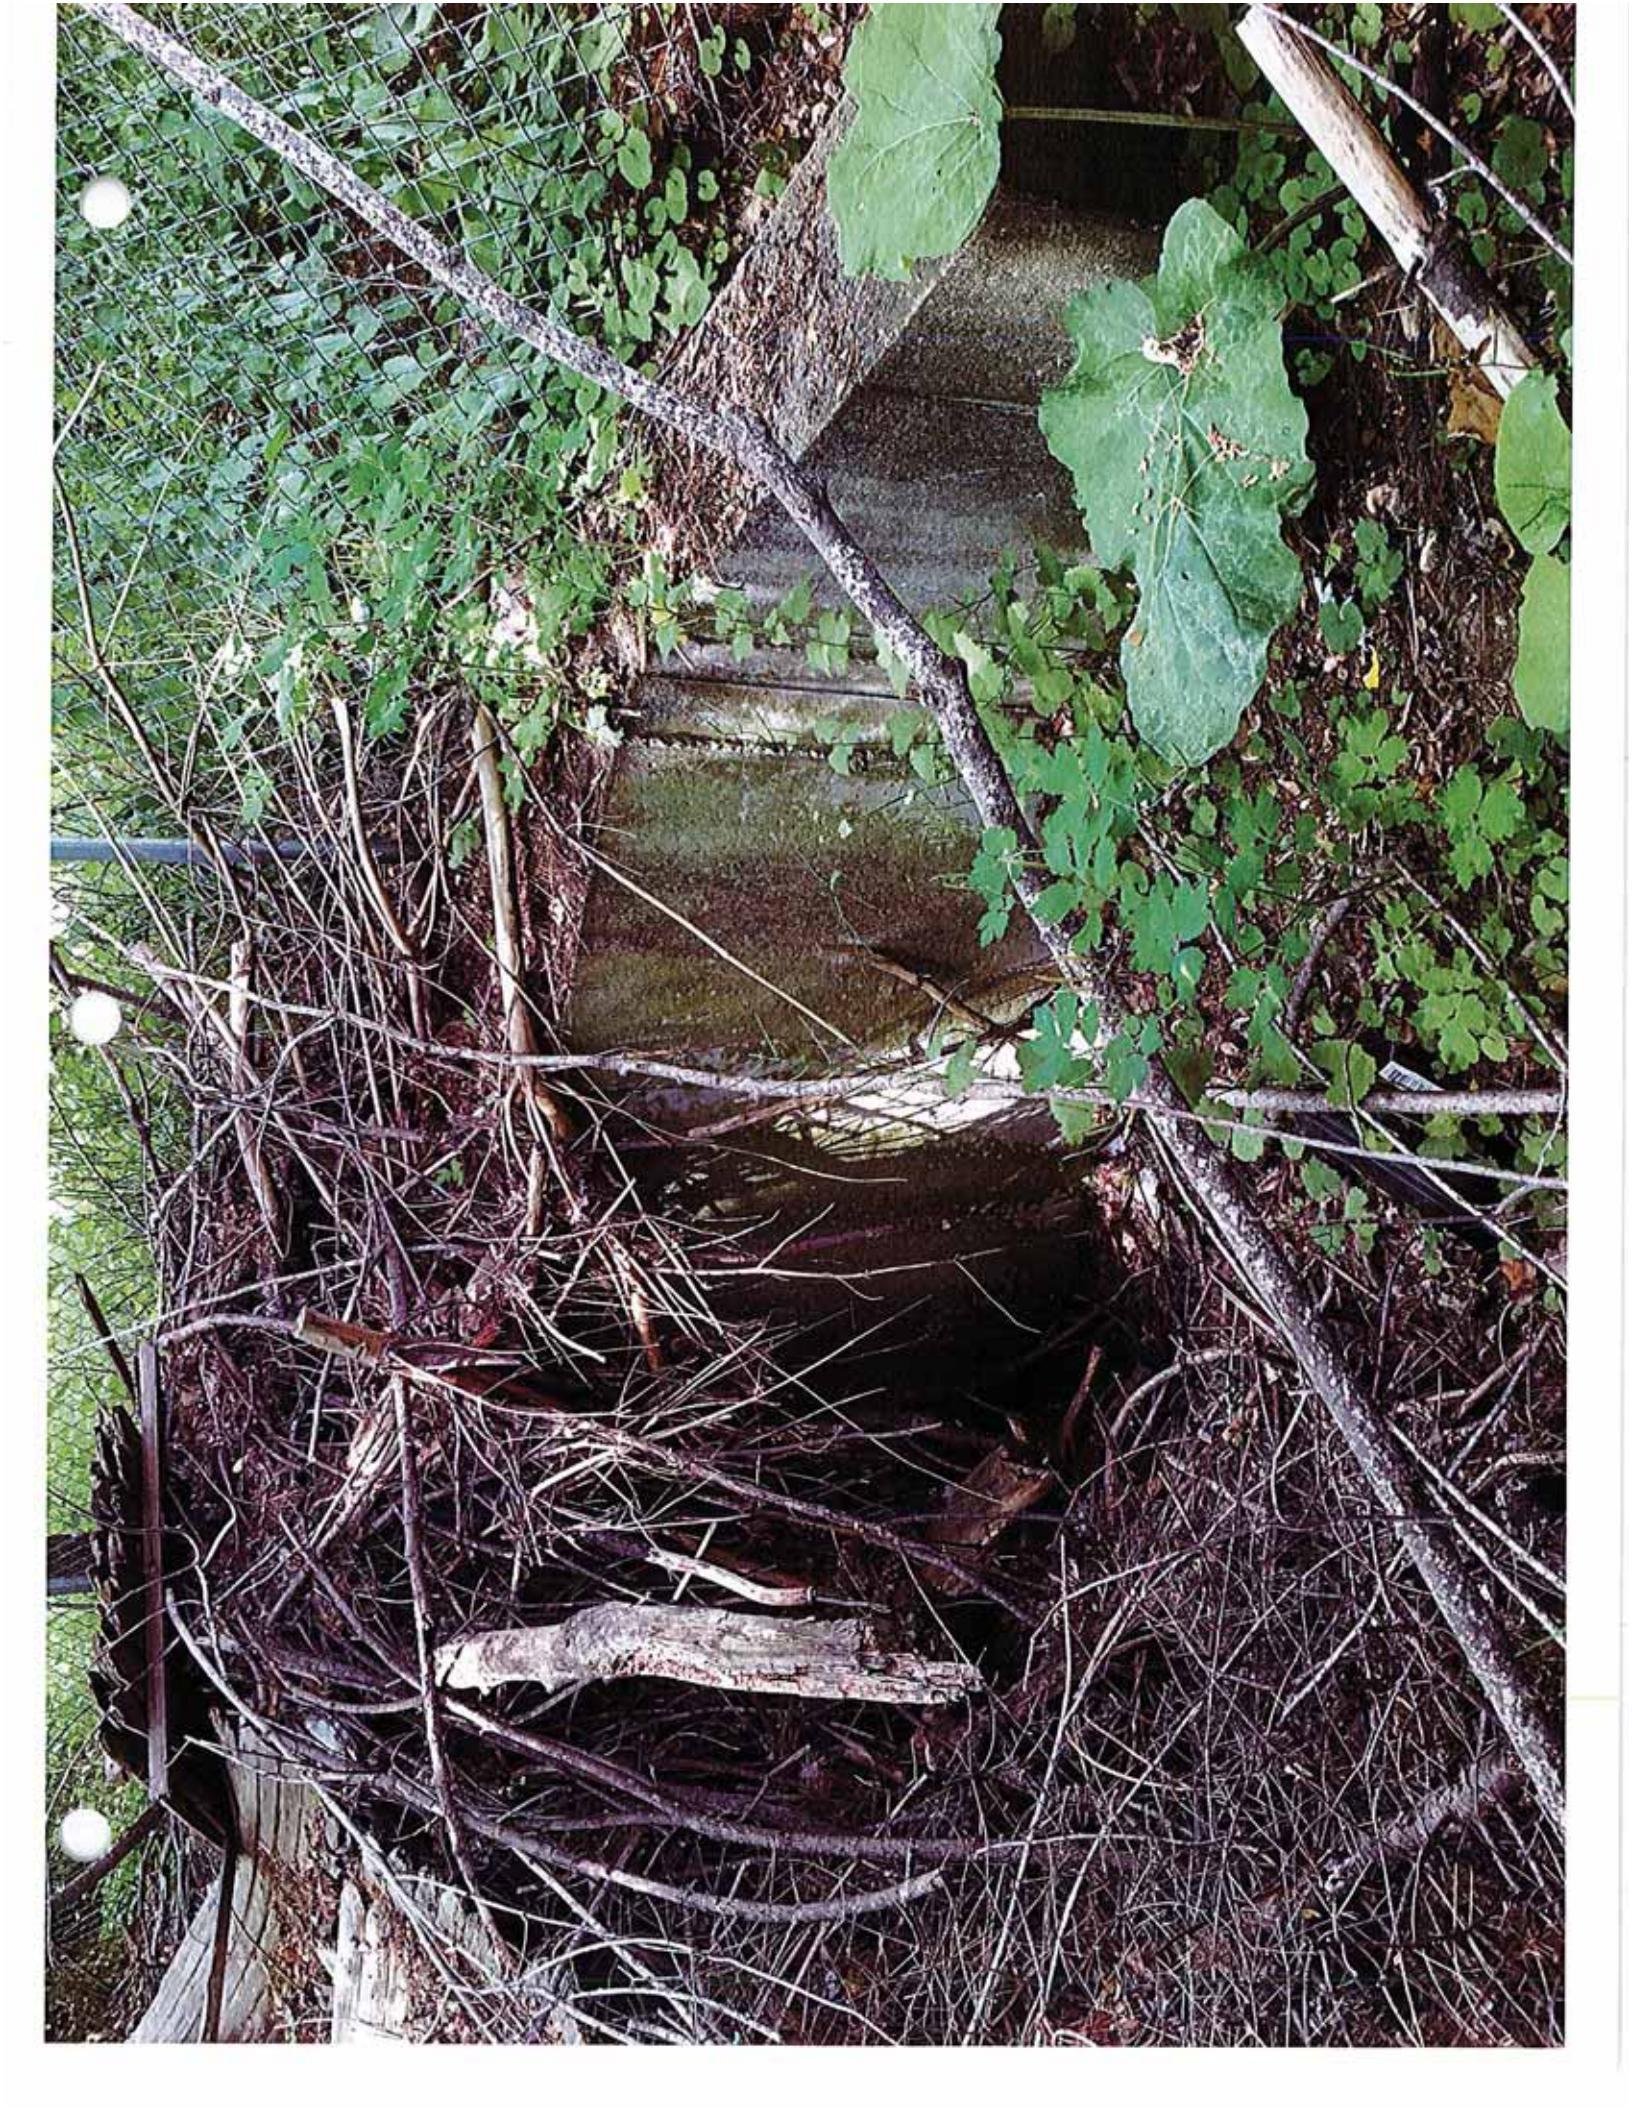
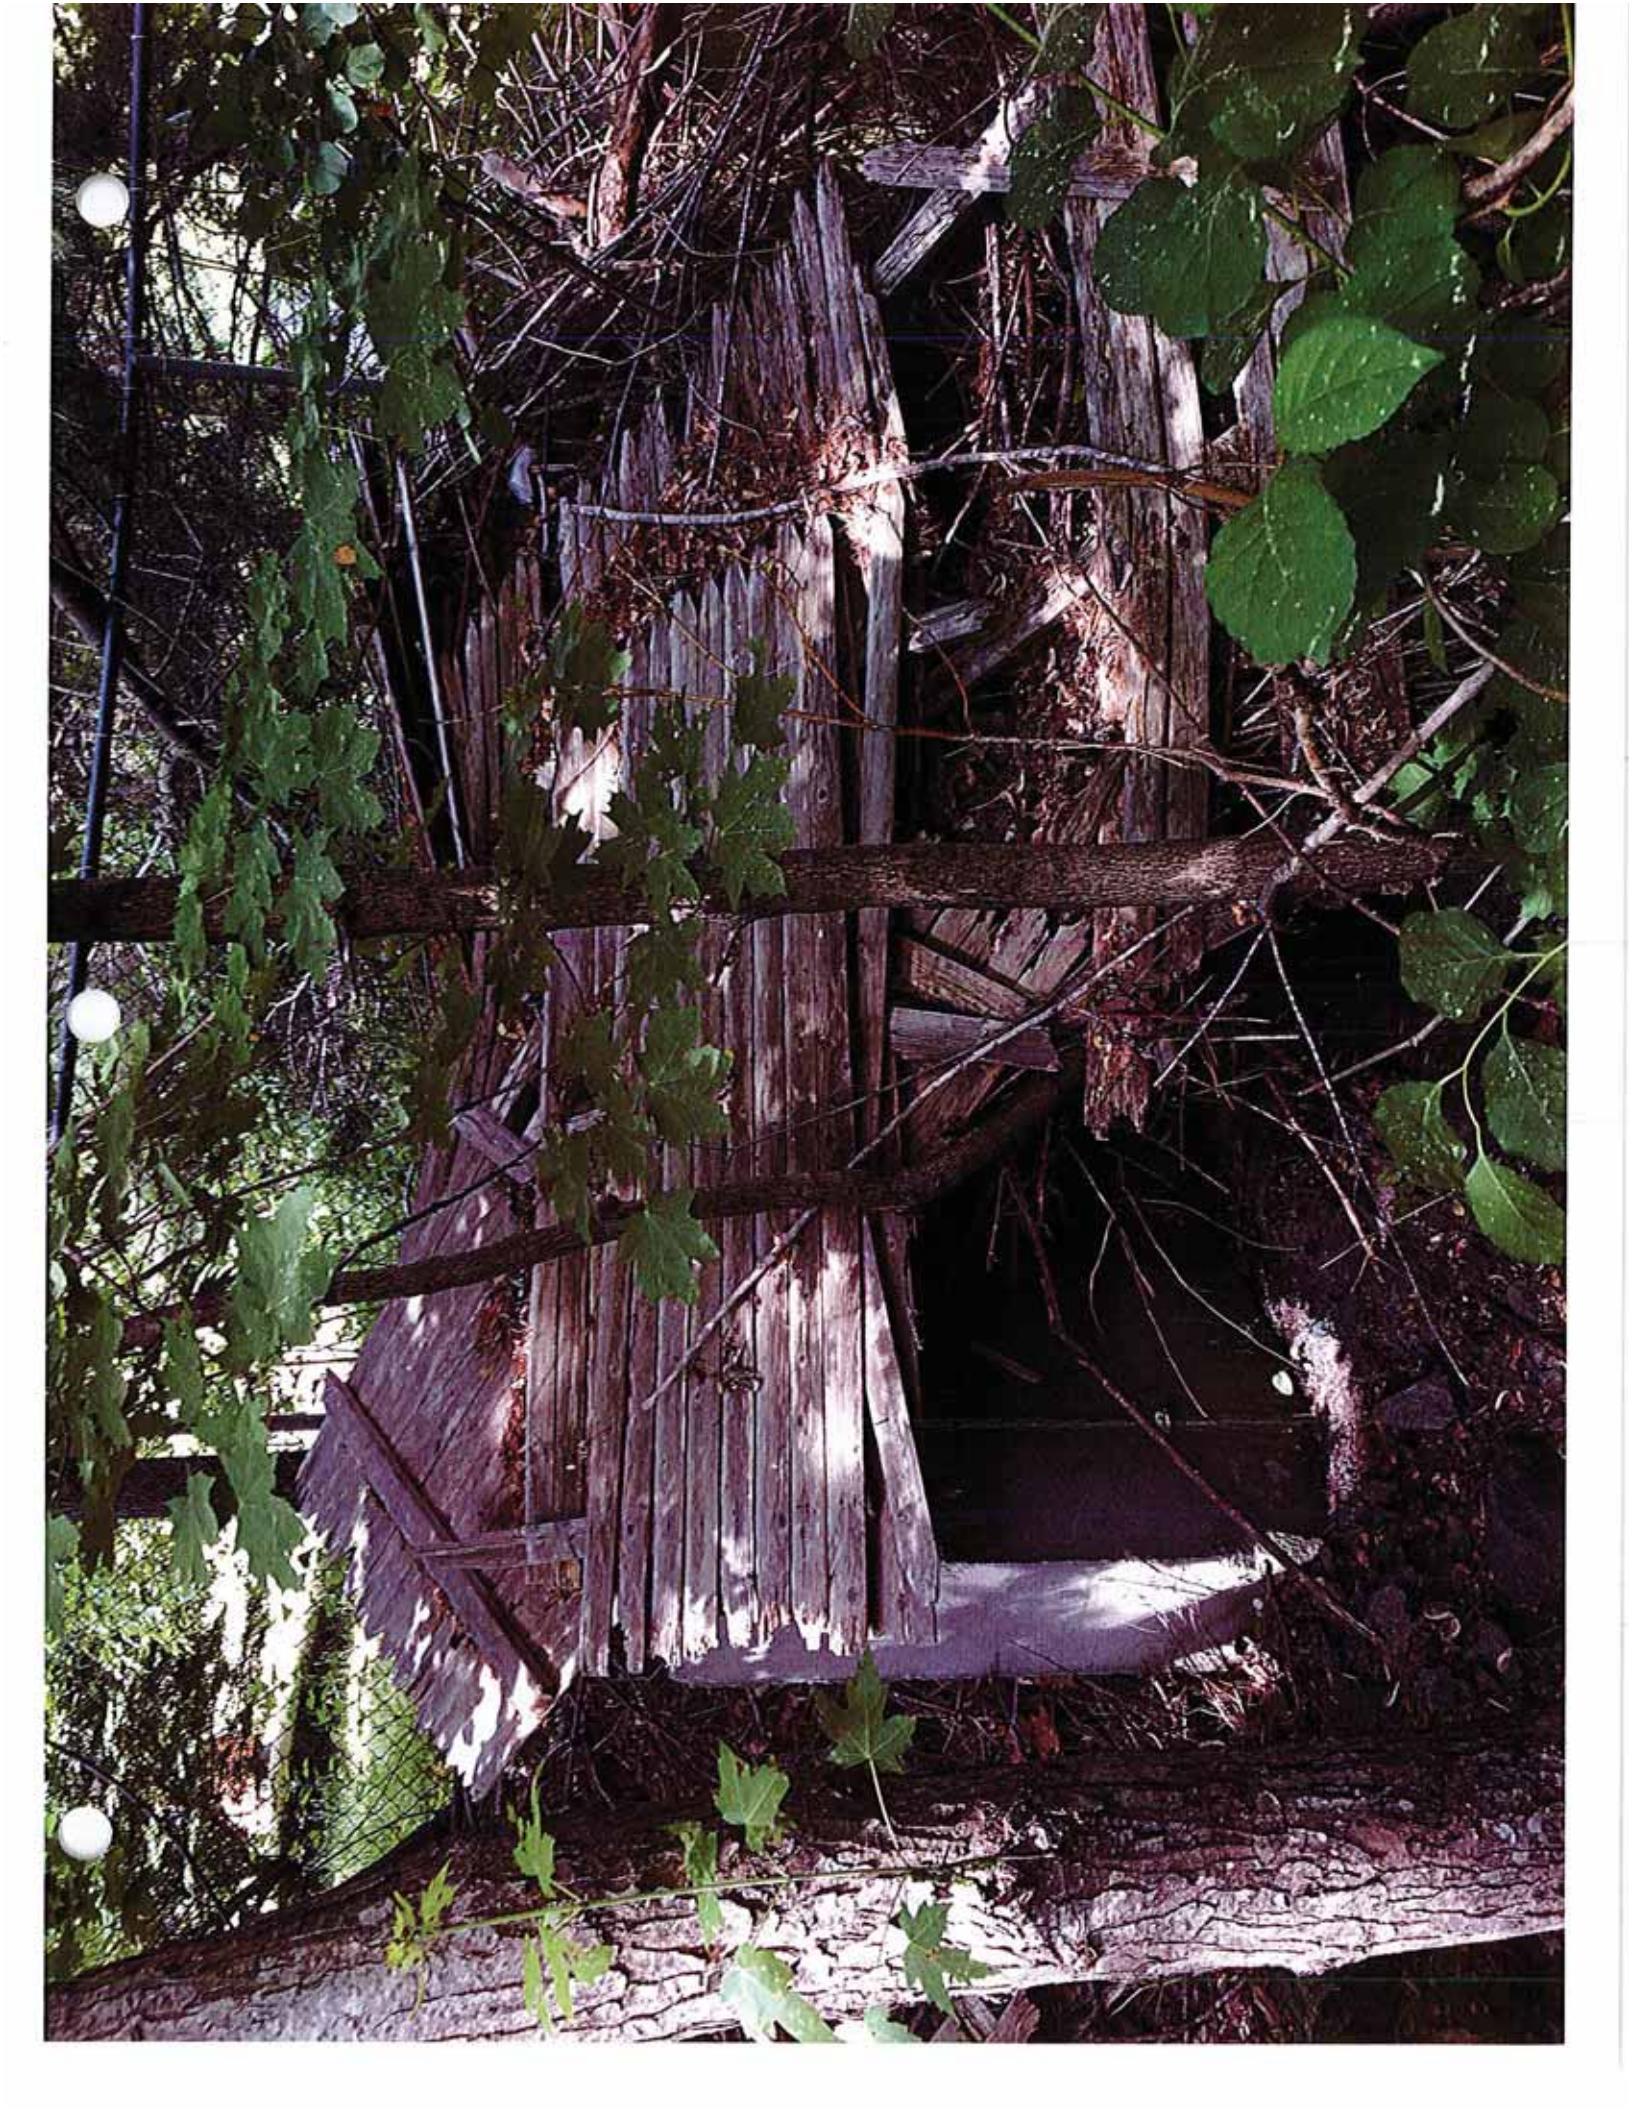
Sub Type 0		ID LR1101	
Description Cross Co	ountry	Permit	
CROSS (COUNTRY	Cross Street	
Location Ref.	Map ID 2B-1820	Map Sheet	
Notes		Recommendations	
LR1101 COVERED IN E	DEBRIS.	REMOVE DEBRIS.
