CITY OF HAVERHILL, MASSACHUSETTS NPDES PERMIT No. MA0101621 CONSENT DECREE (Civil Action No. 16-11698-IT, 11/10/16)

COMPLIANCE REPORT No. 4 JANUARY THROUGH JUNE 2018

OCTOBER 2018

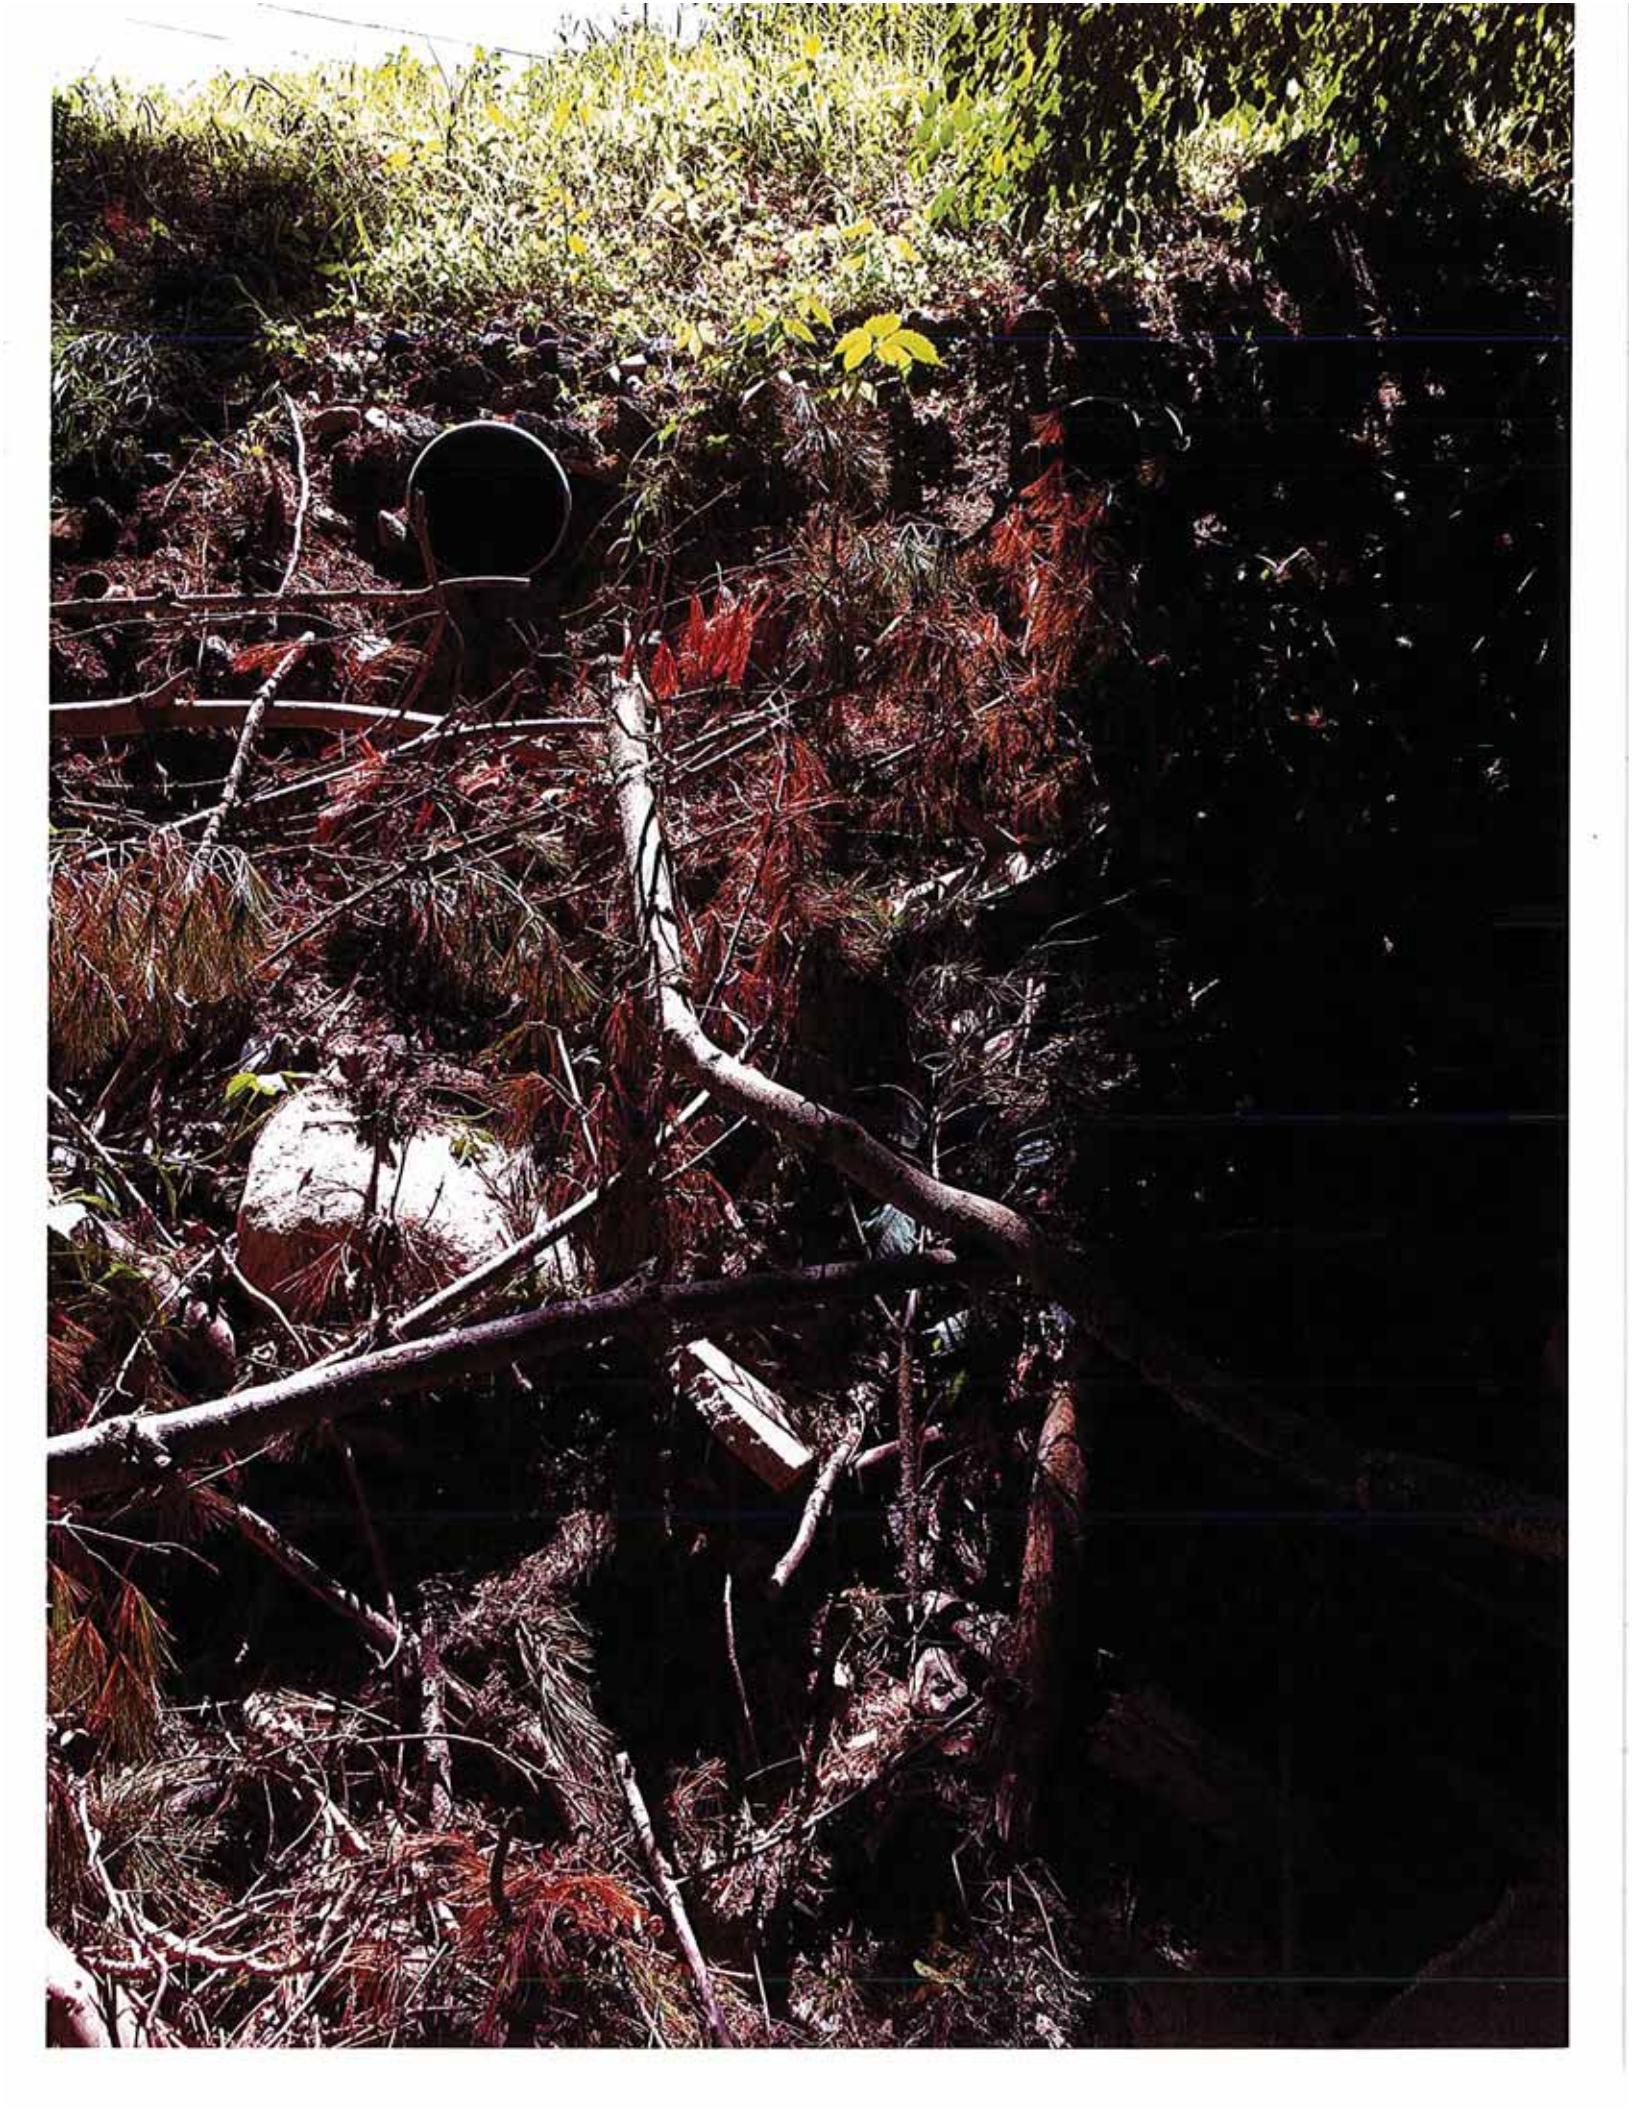
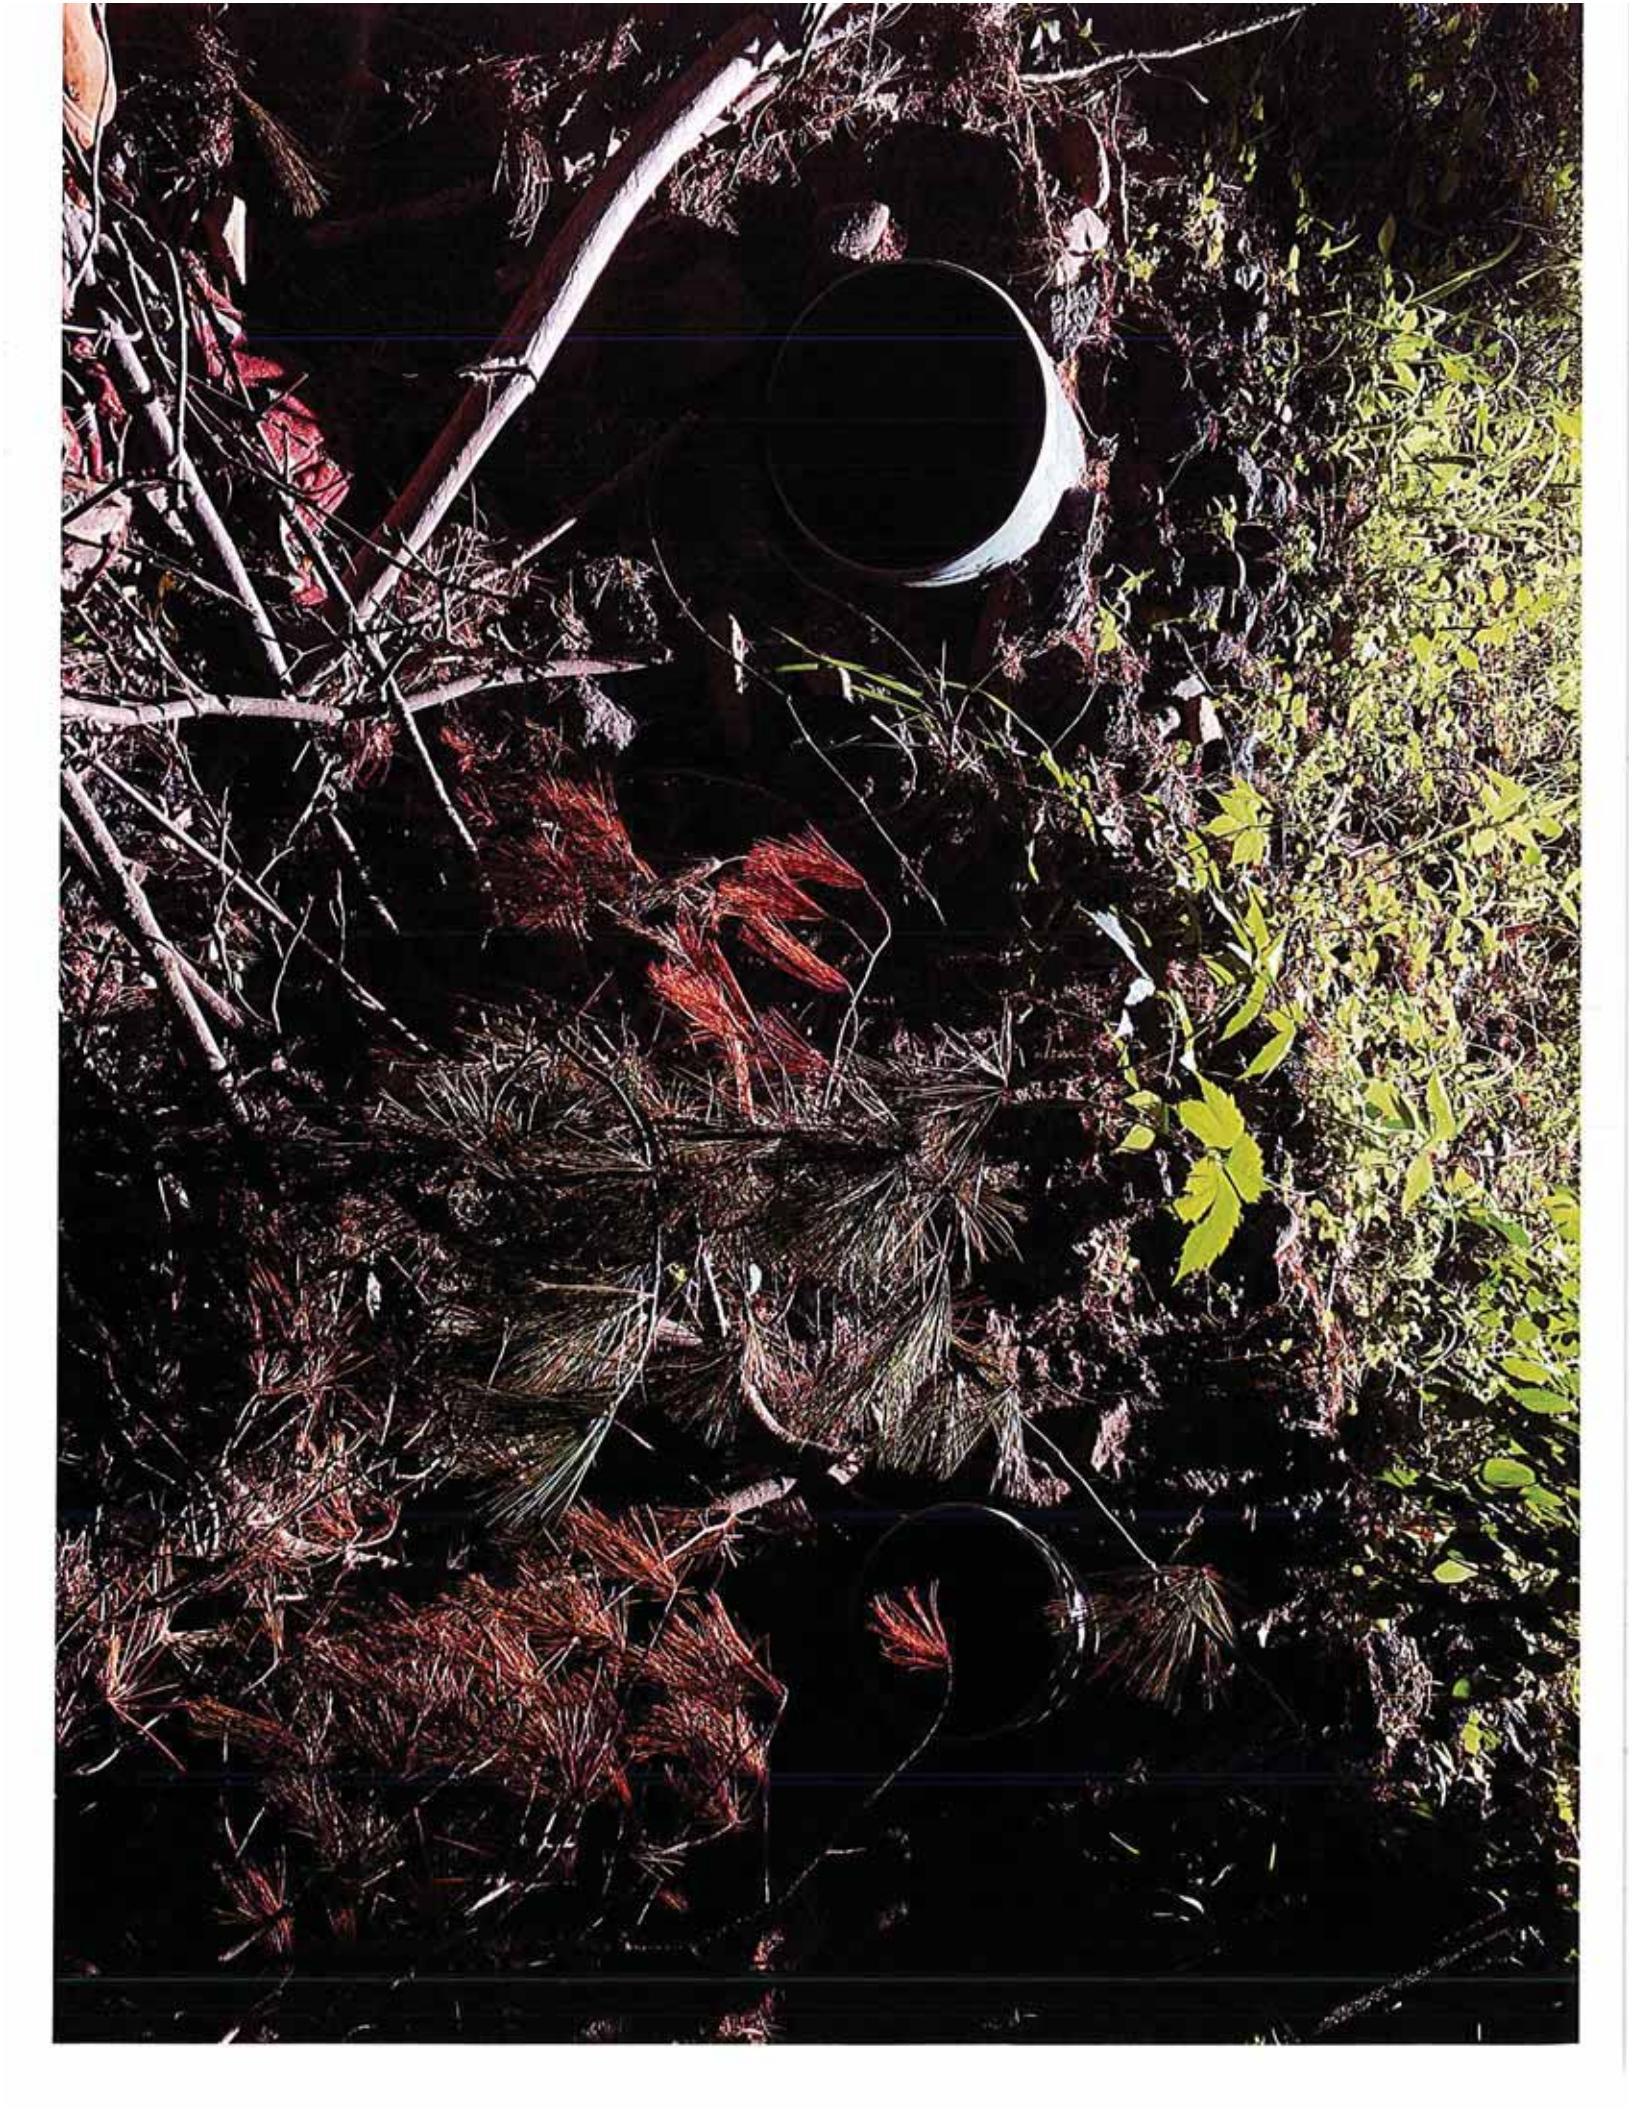
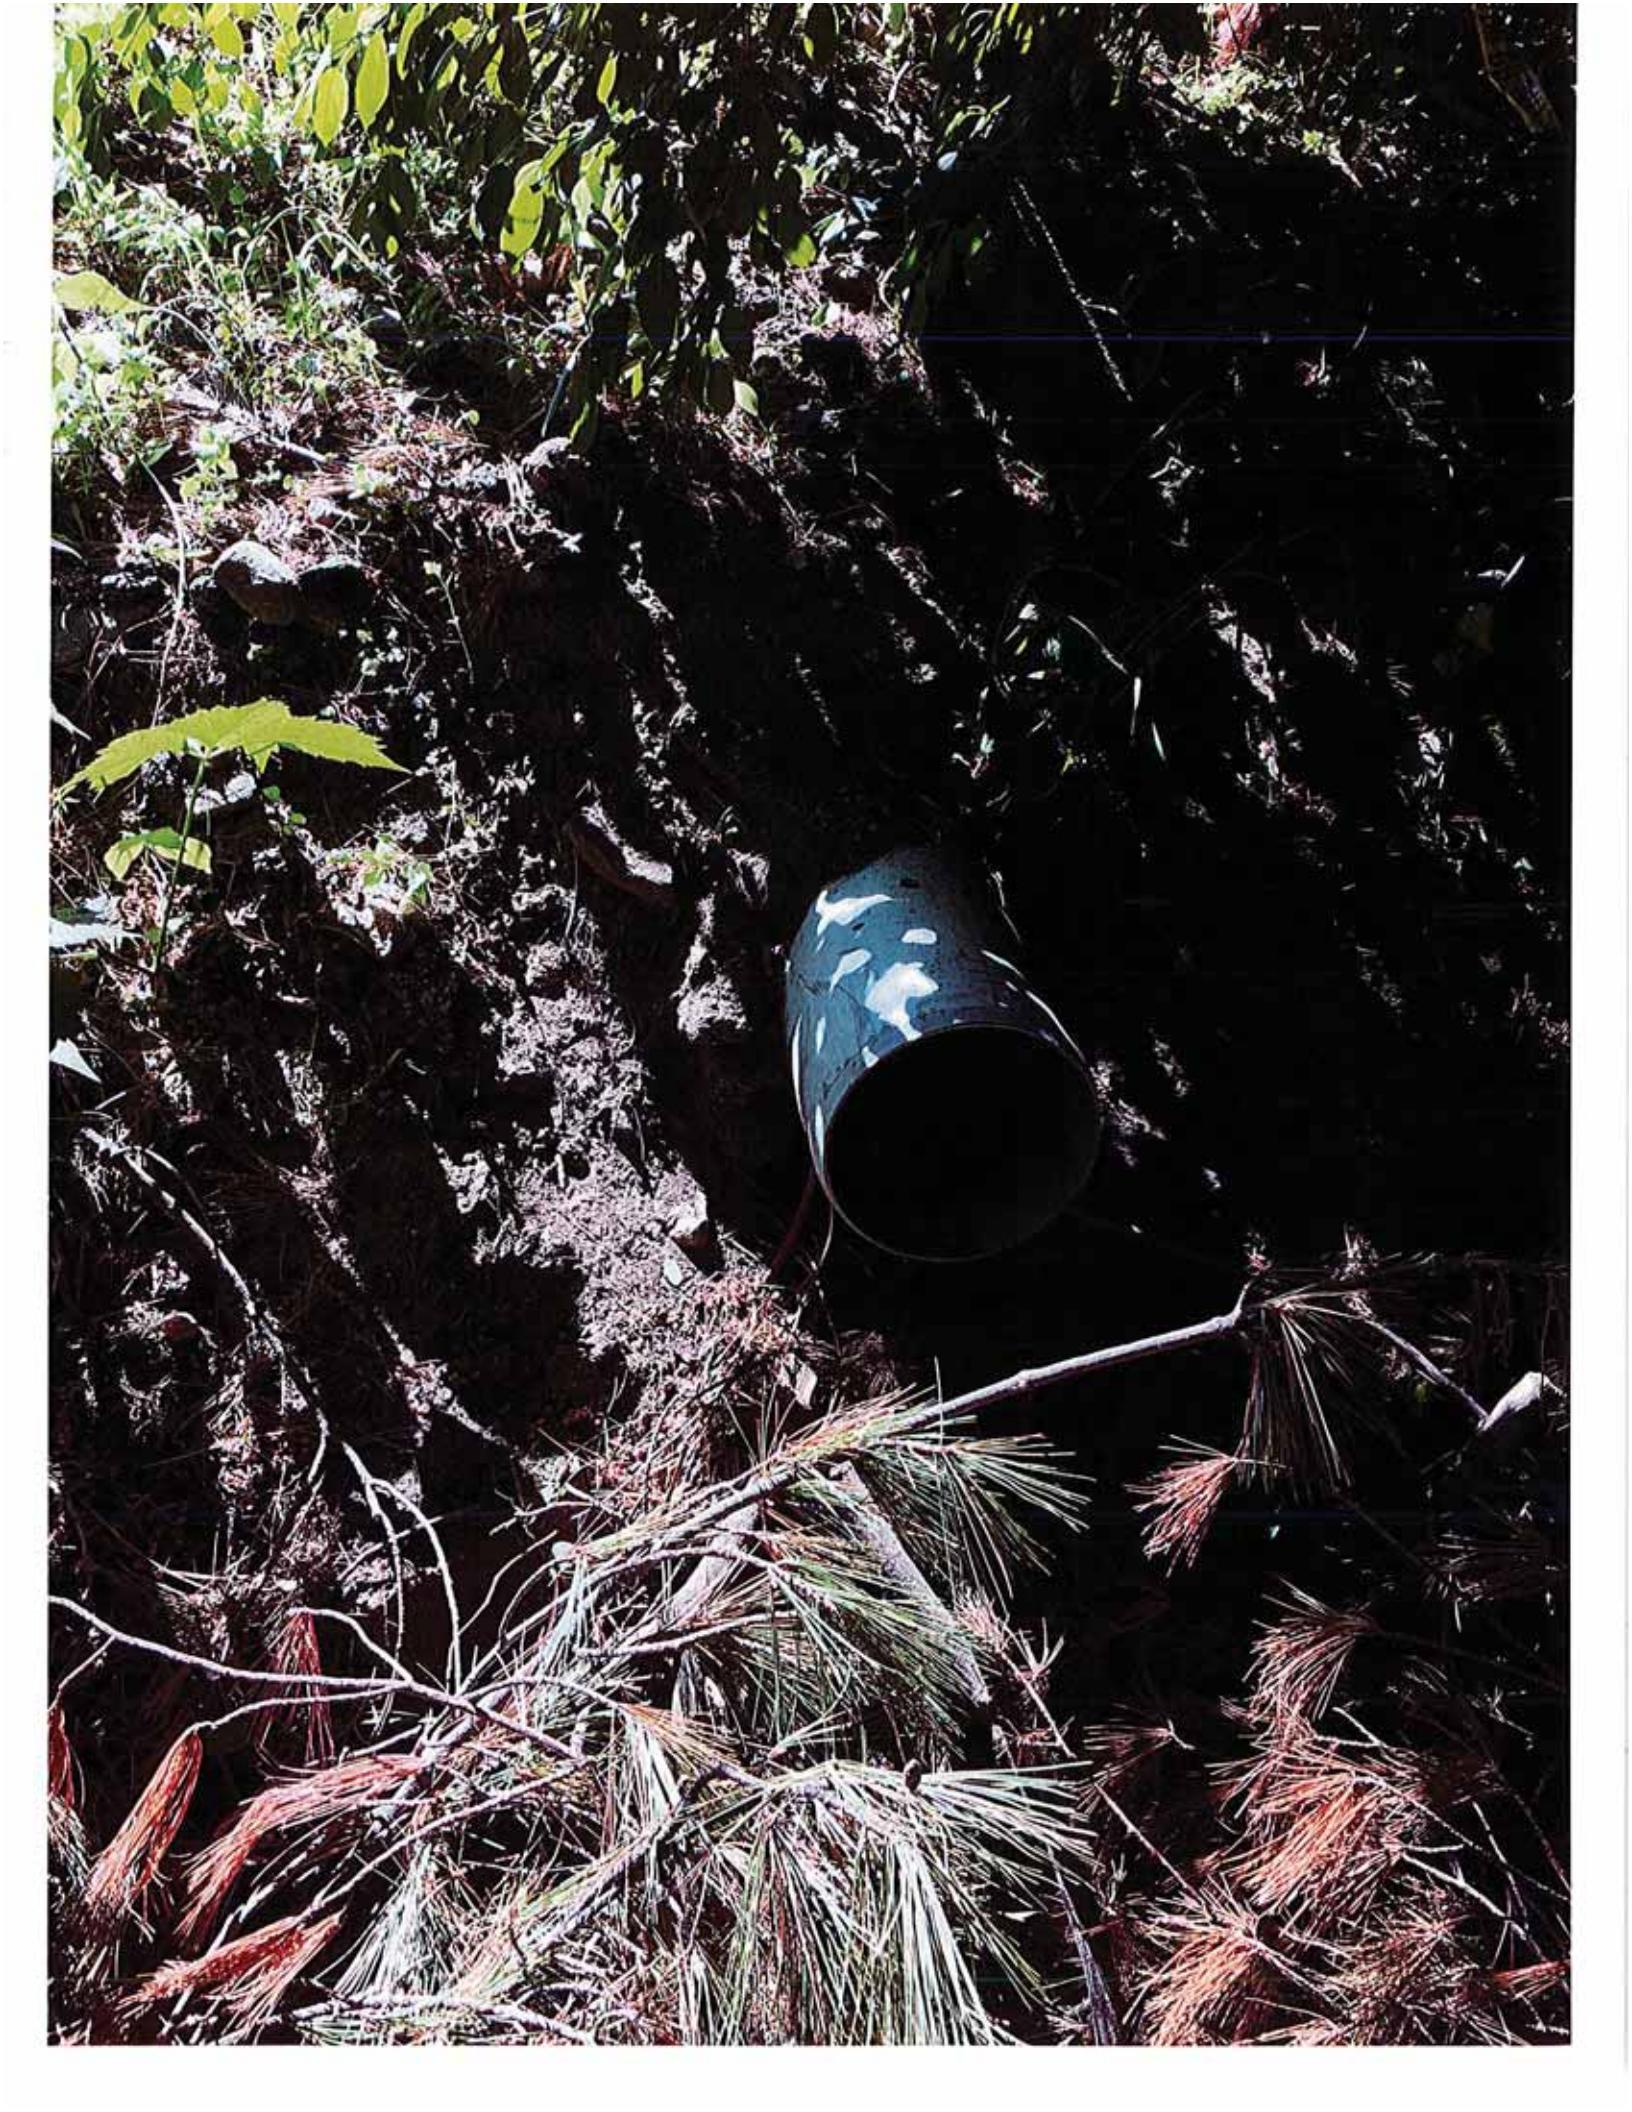
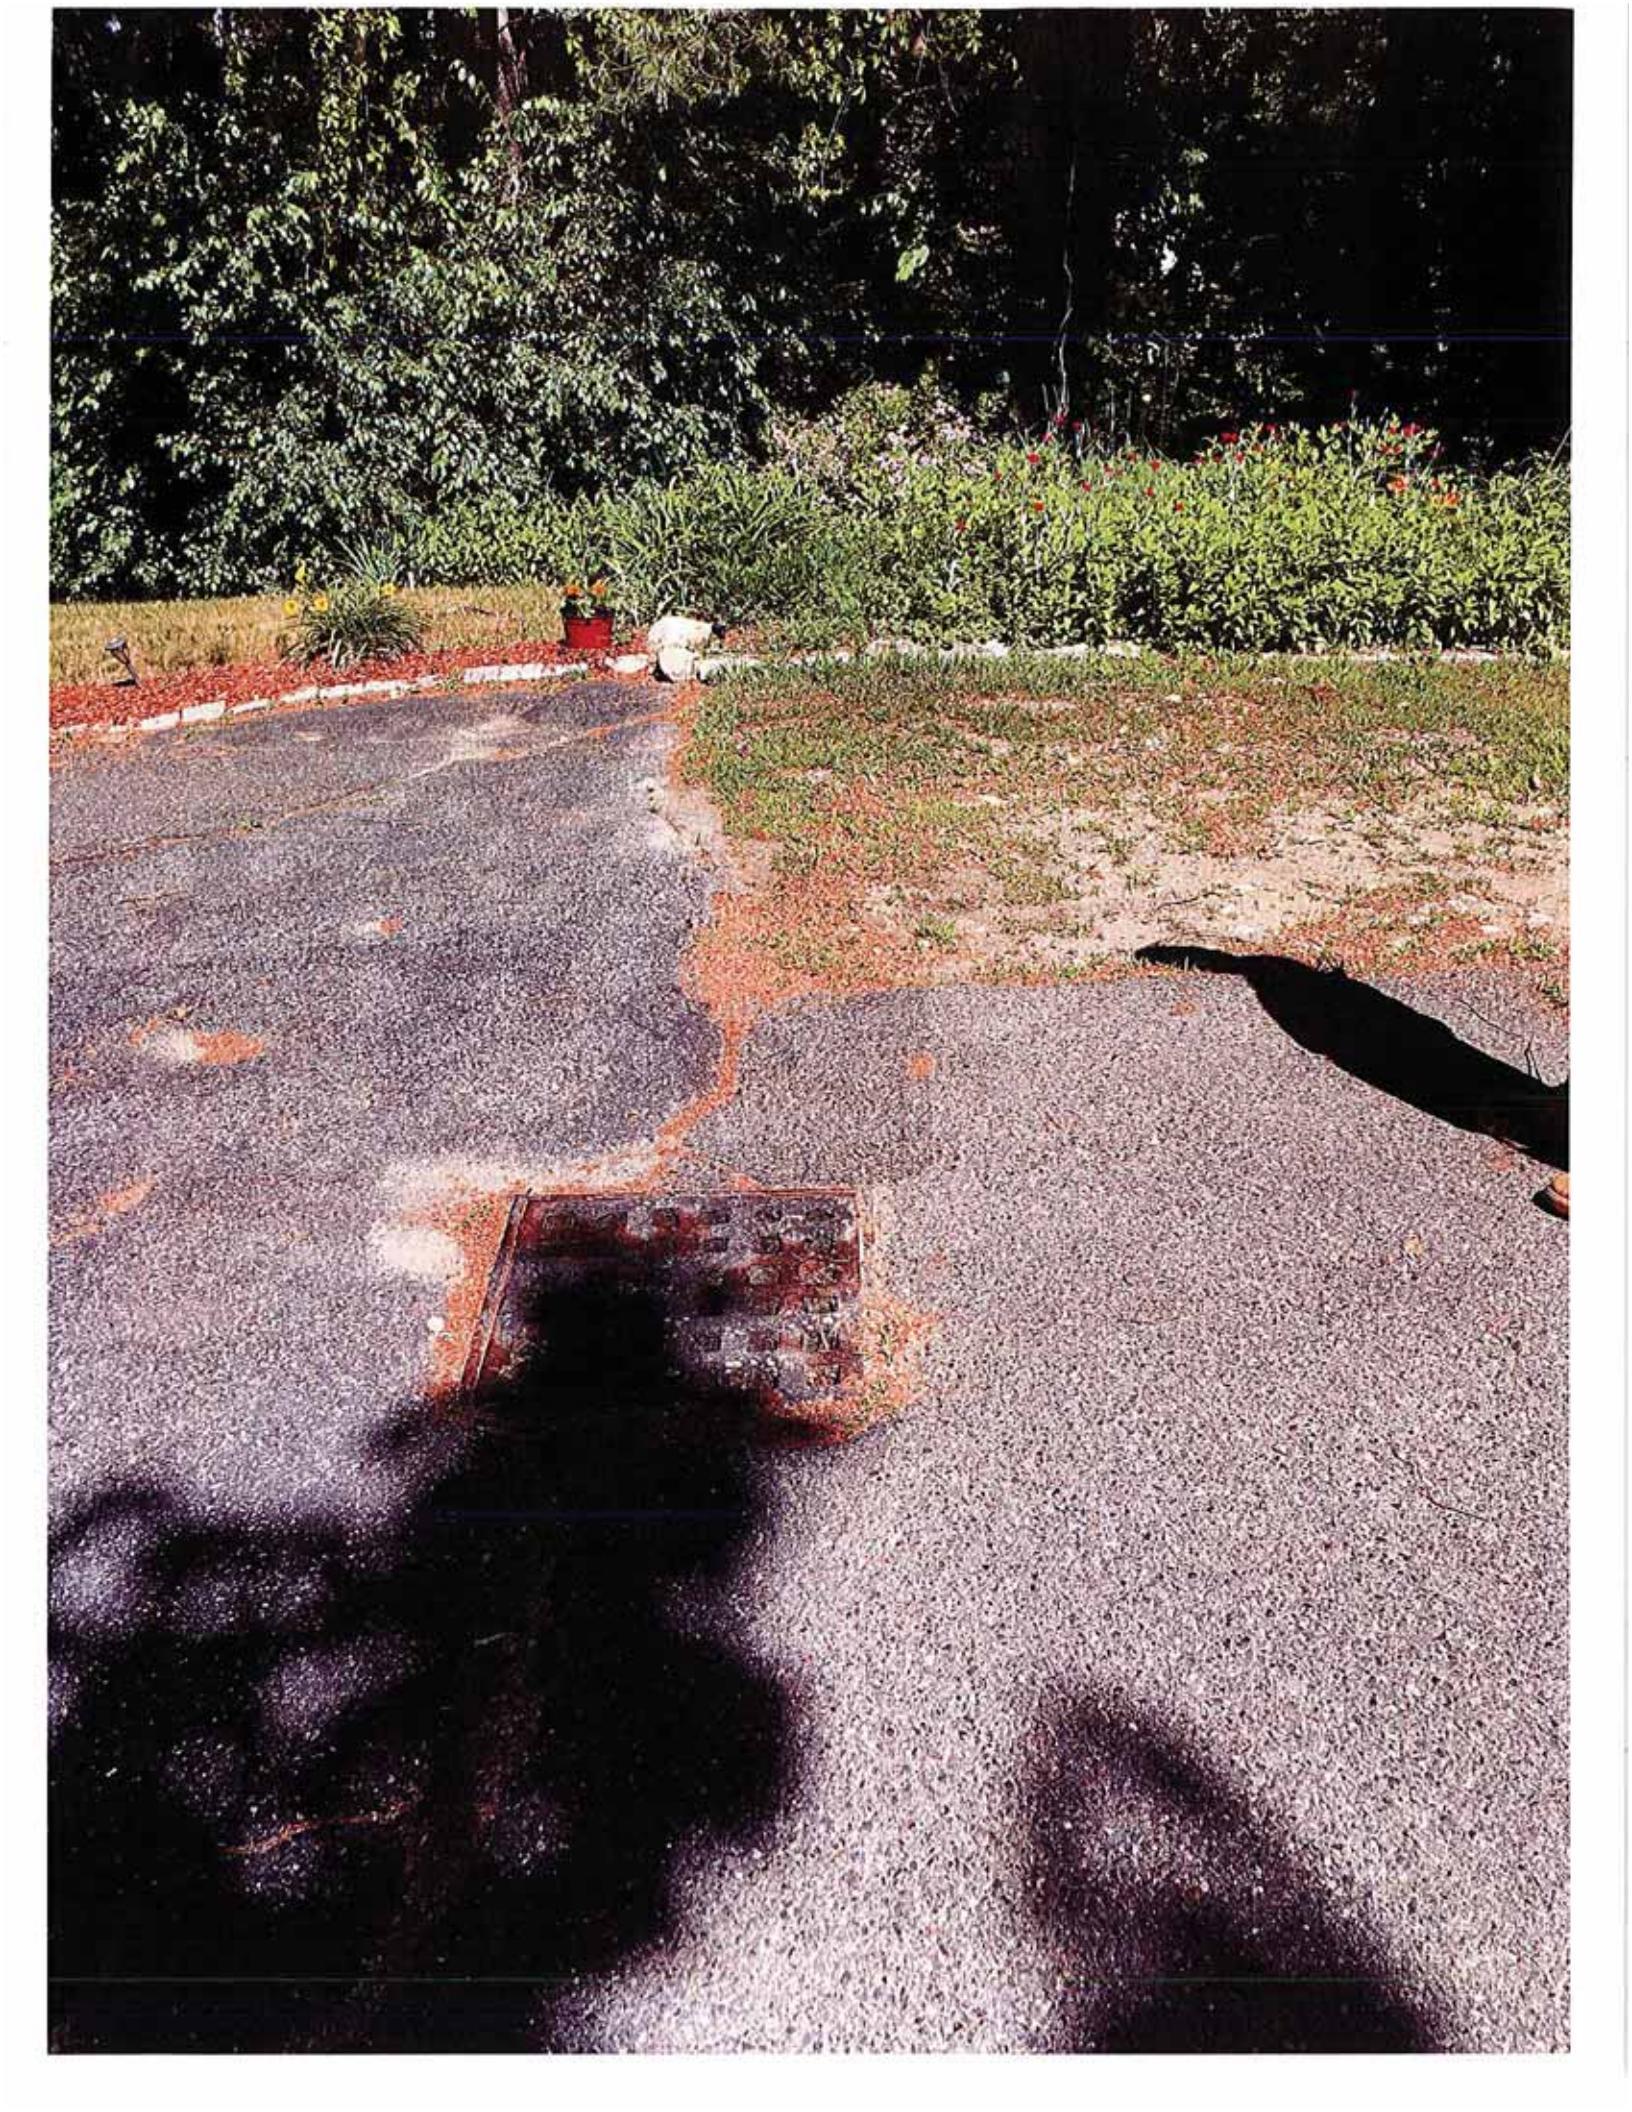
<u></u>			
Sub Type 0		ID LR1150	
Description Mantclair	Road	Permit	
CROSS	COUNTRY	Cross Street	
Location Ref. Map ID 11071		Map Sheet	
Notes		Recommendations	
LR1150 - OUTFALL IS	CLEAN, GOOD CONDITION
