Subject: City of Haverhill, MA NPDES Permit #MA 0101621 Consent Decree Submittal (Civil Action No. 16-11698-IT) Compliance Report Number 16

CITY OF HAVERHILL, MASSACHUSETTS NPDES PERMIT No. MA0101621 CONSENT DECREE (Civil Action No. 16-11698-IT, 11/10/16)

COMPLIANCE REPORT No. 16 JANUARY- JUNE 2024

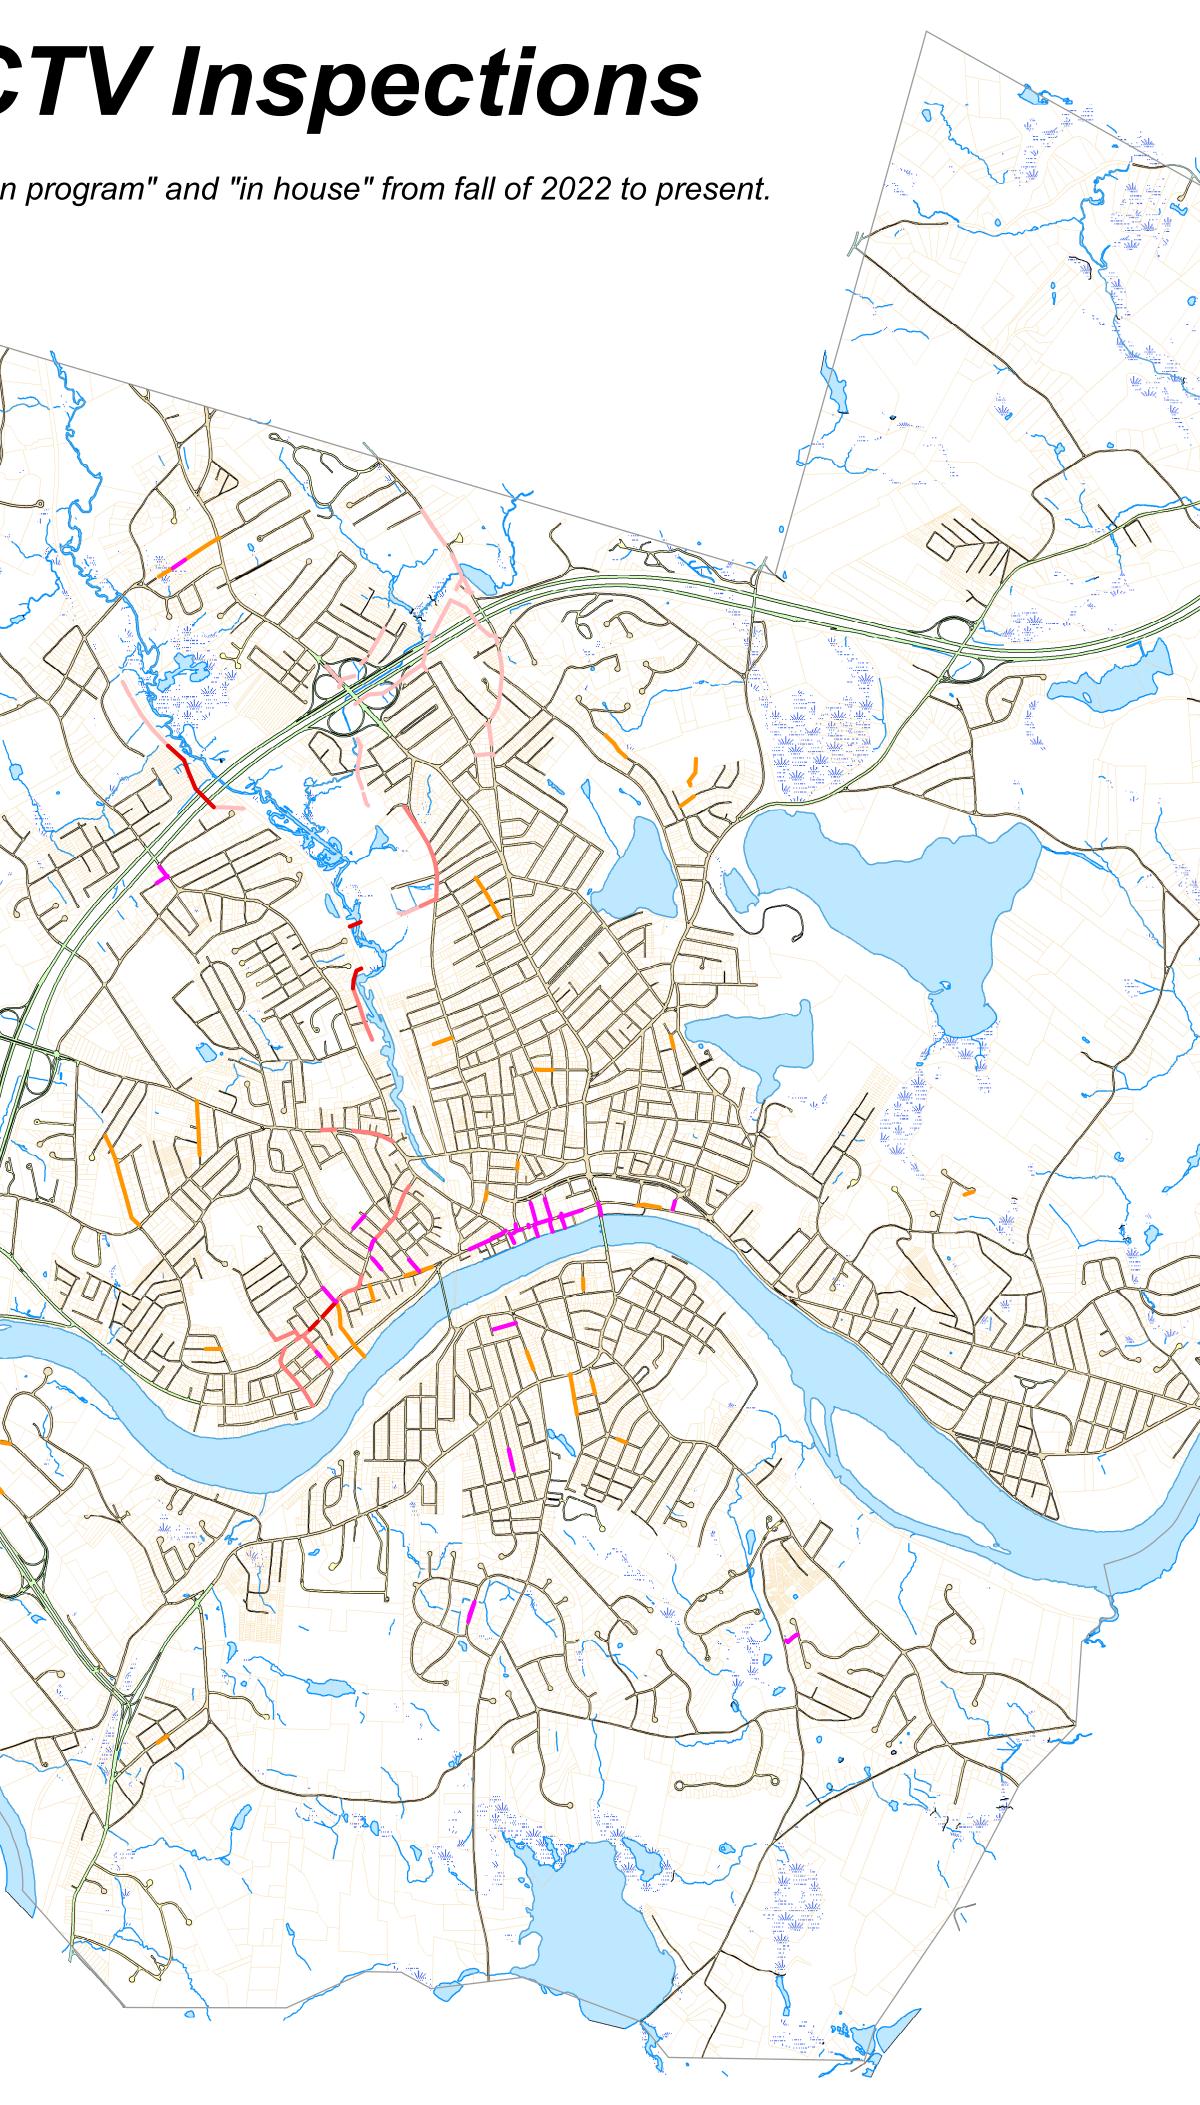
Sewer and drain inspections done through our "5 year inspection program" and "in house" from fall of 2022 to present.

Approximately 25,075 feet has been inspected through our "5 Year CCT Inspection Program" and 38,839 feet has been inspected through "In House" inspections since fall of 2022.
